Dead Bed Tilt Repair

Our coach has the type bed that needs to be raised at the back in order to make room for the bedroom and full wall slides to close. Diana puts the bed up part way each morning. She was retracting the bed when it stopped moving after little over a foot of travel. Jim and Kerry Pinkerton came over and helped me troubleshoot and fix the problem. It was a broken wire, which Kerry was able to solder back onto a PC board on the rear of the motor. It was NOT an easy task getting to the point of being able to solder the connection after we found the problem. The end result was that the repair was made, everything put back together, bed motor recalibrated, and we were back in business. However, we also found a bearing under one of the rails and discovered it was for one of the 4 rollers that run in each track when the bed is extended or retracted. We were unable to repair that, and it will be a task for REV at some future date. The bed will work without it. Even though we bought our coach new, some work had obviously been done on the system at some previous time. Attached is the “rest of the story.” The file is too big to email. I have 5 other files if anyone would lik

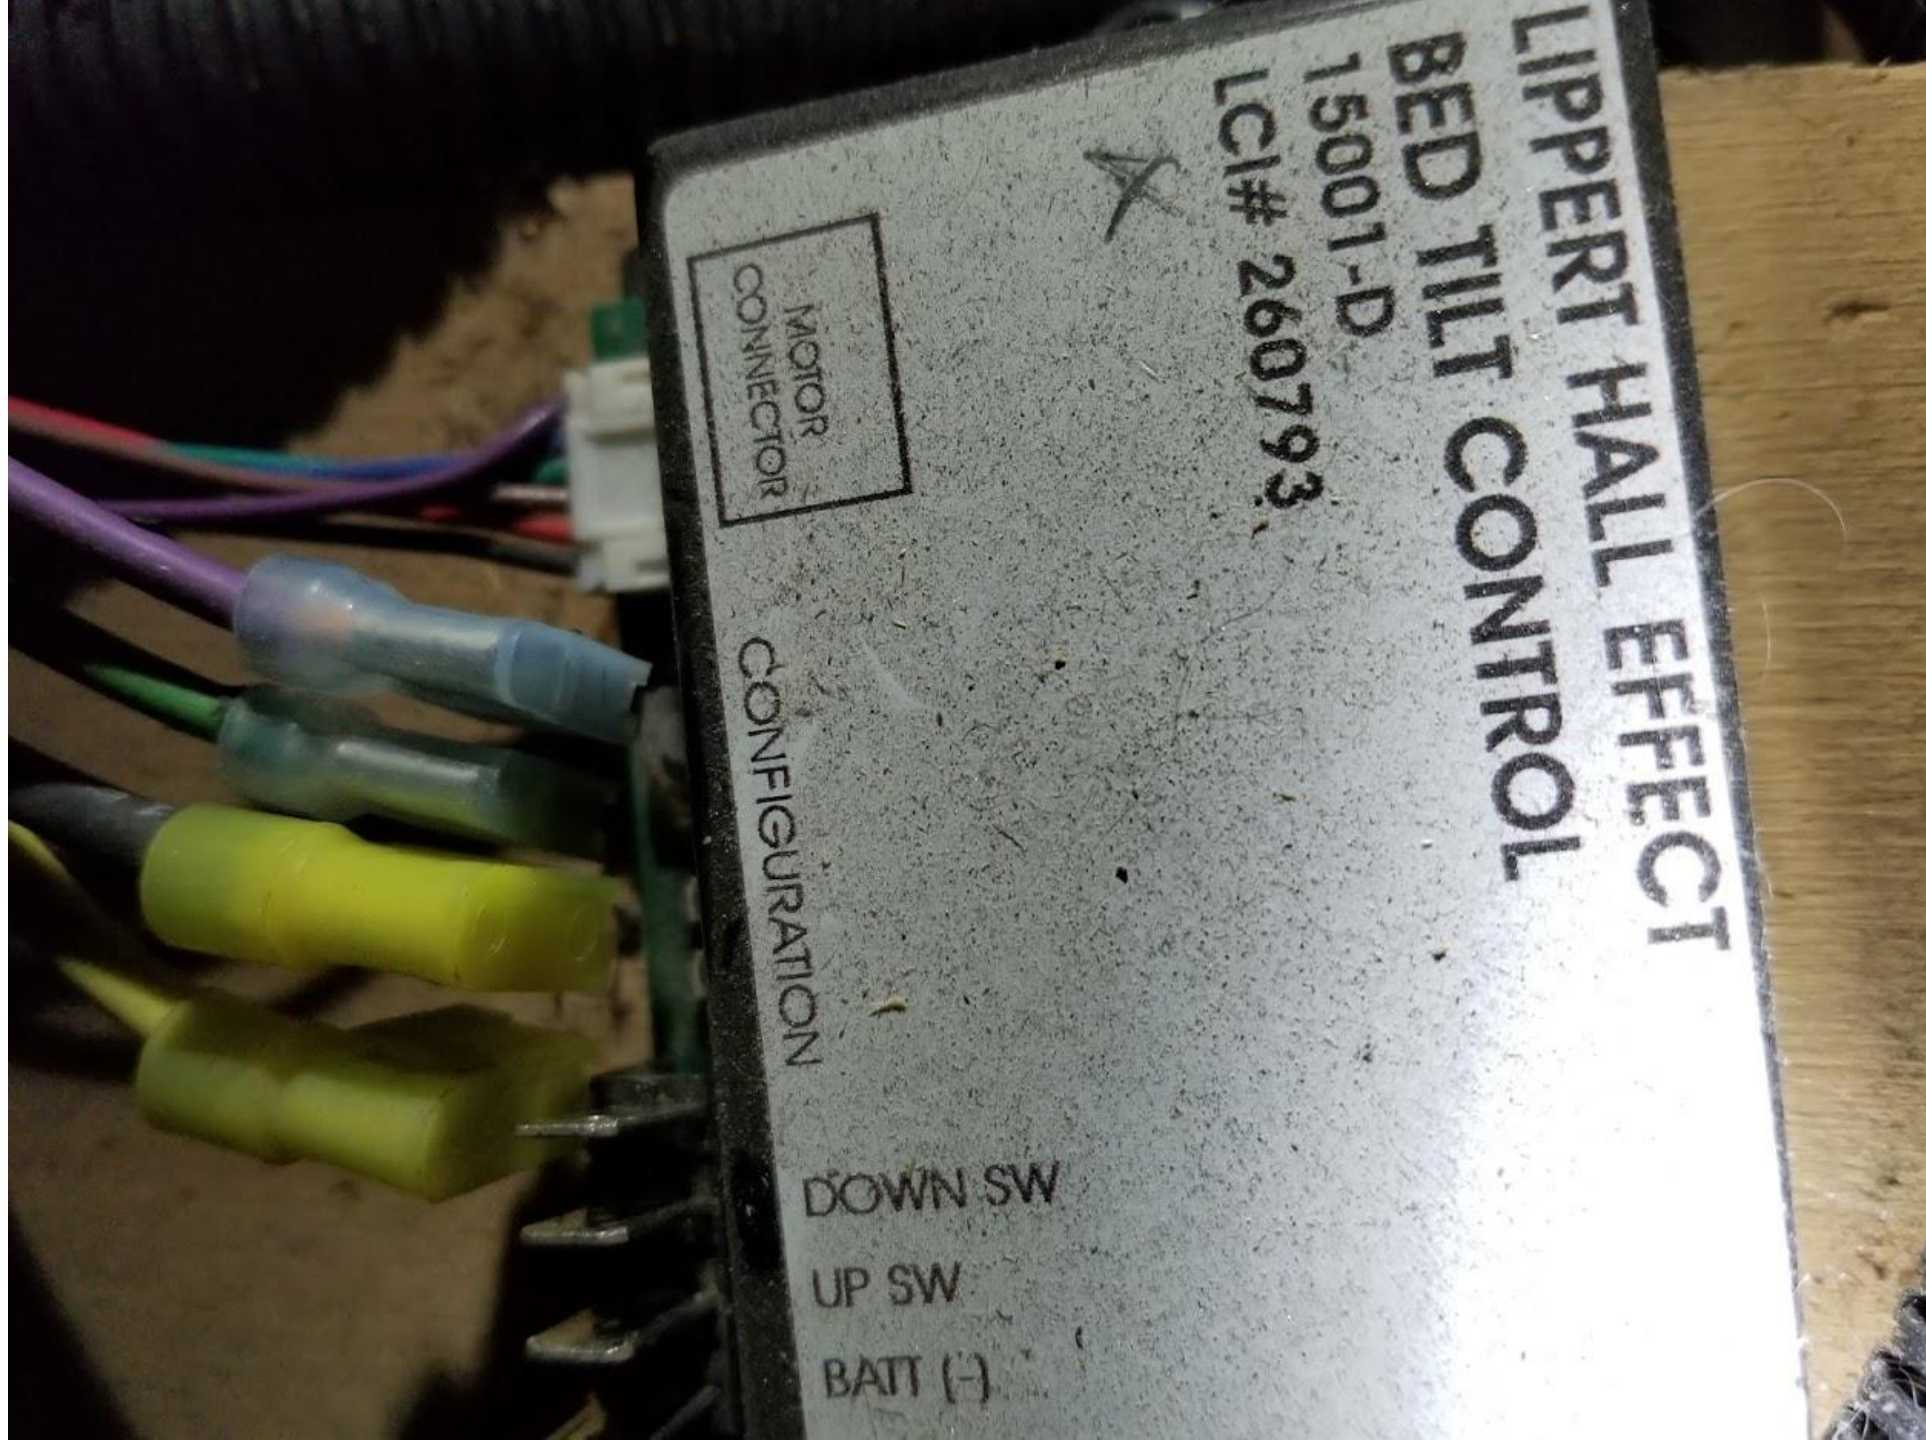
- ❑ When you get the boards out you will see the bed controller (photo at right) The spade connectors are labeled. Take a photo before disconnecting so you get them back in right order. Otherwise the bed may operate backwards, e.g., go up when you press down.

- ❑ We saw no problems with the wire connections, but the controller has two LEDs – 1 red and 1 green. The LEDs are used for calibration and possible identification of motor issues. Both were flashing rapidly. We called Lippert and were told that the signal from the controller wasn't getting to the motor. Note that, overall, Lipper wasn't particularly helpful. REV tech support send some drawings and information that was useful.

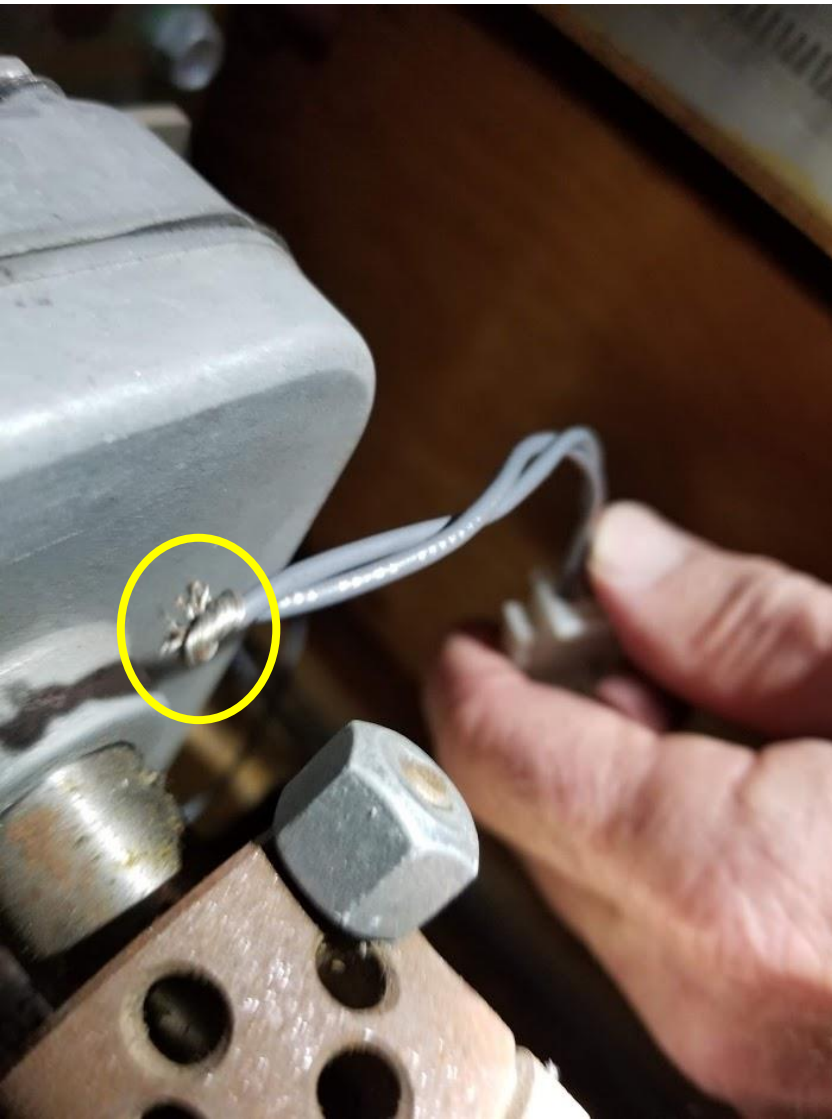
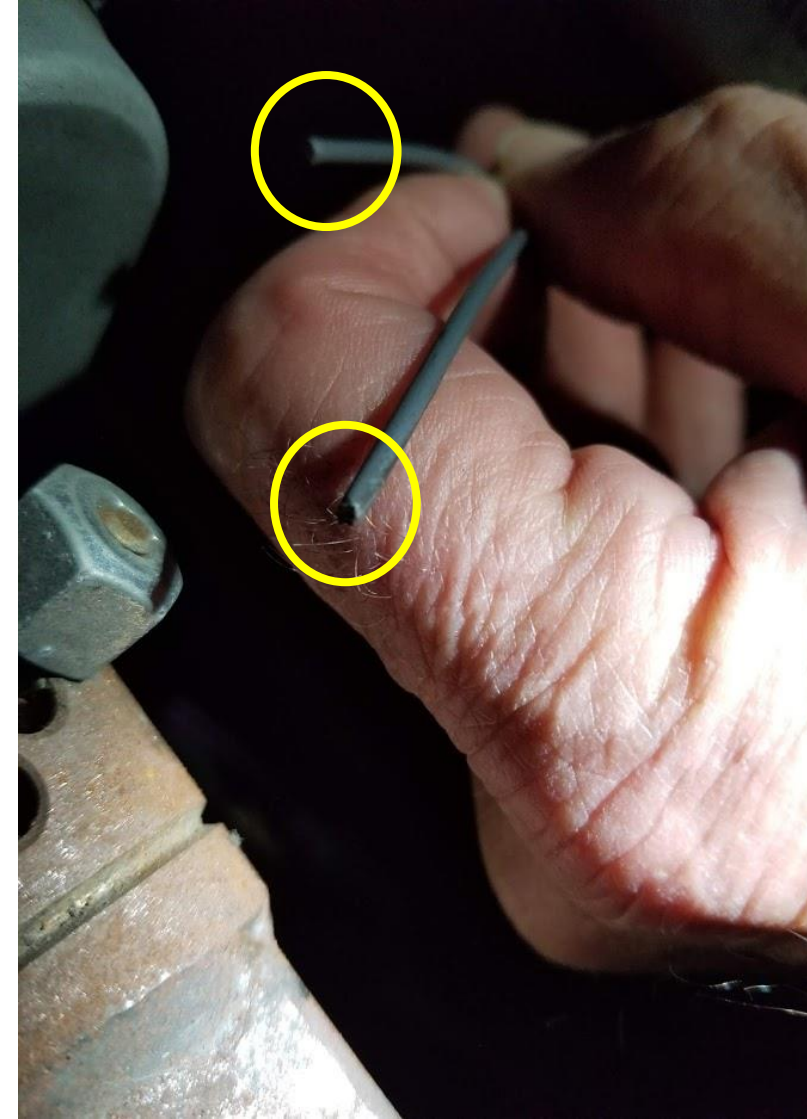
At the foot end of the bed frame, in the same space where the controller is located, we found the two wires (shown on left), which were spliced exactly as shown, and the two loose wires shown in the photo on the right. The spliced wires looked like they might go to the controller, and the loose wires were attached to a magnetic switch at the foot of the bed frame.

It appeared that the two spliced-together wires were at one time attached to the two loose wires and that someone had modified them by cutting the wires and splicing the ends to make the system work. Jury-rigged would be a good description. We did determine that this modification was not the source of the malfunction.

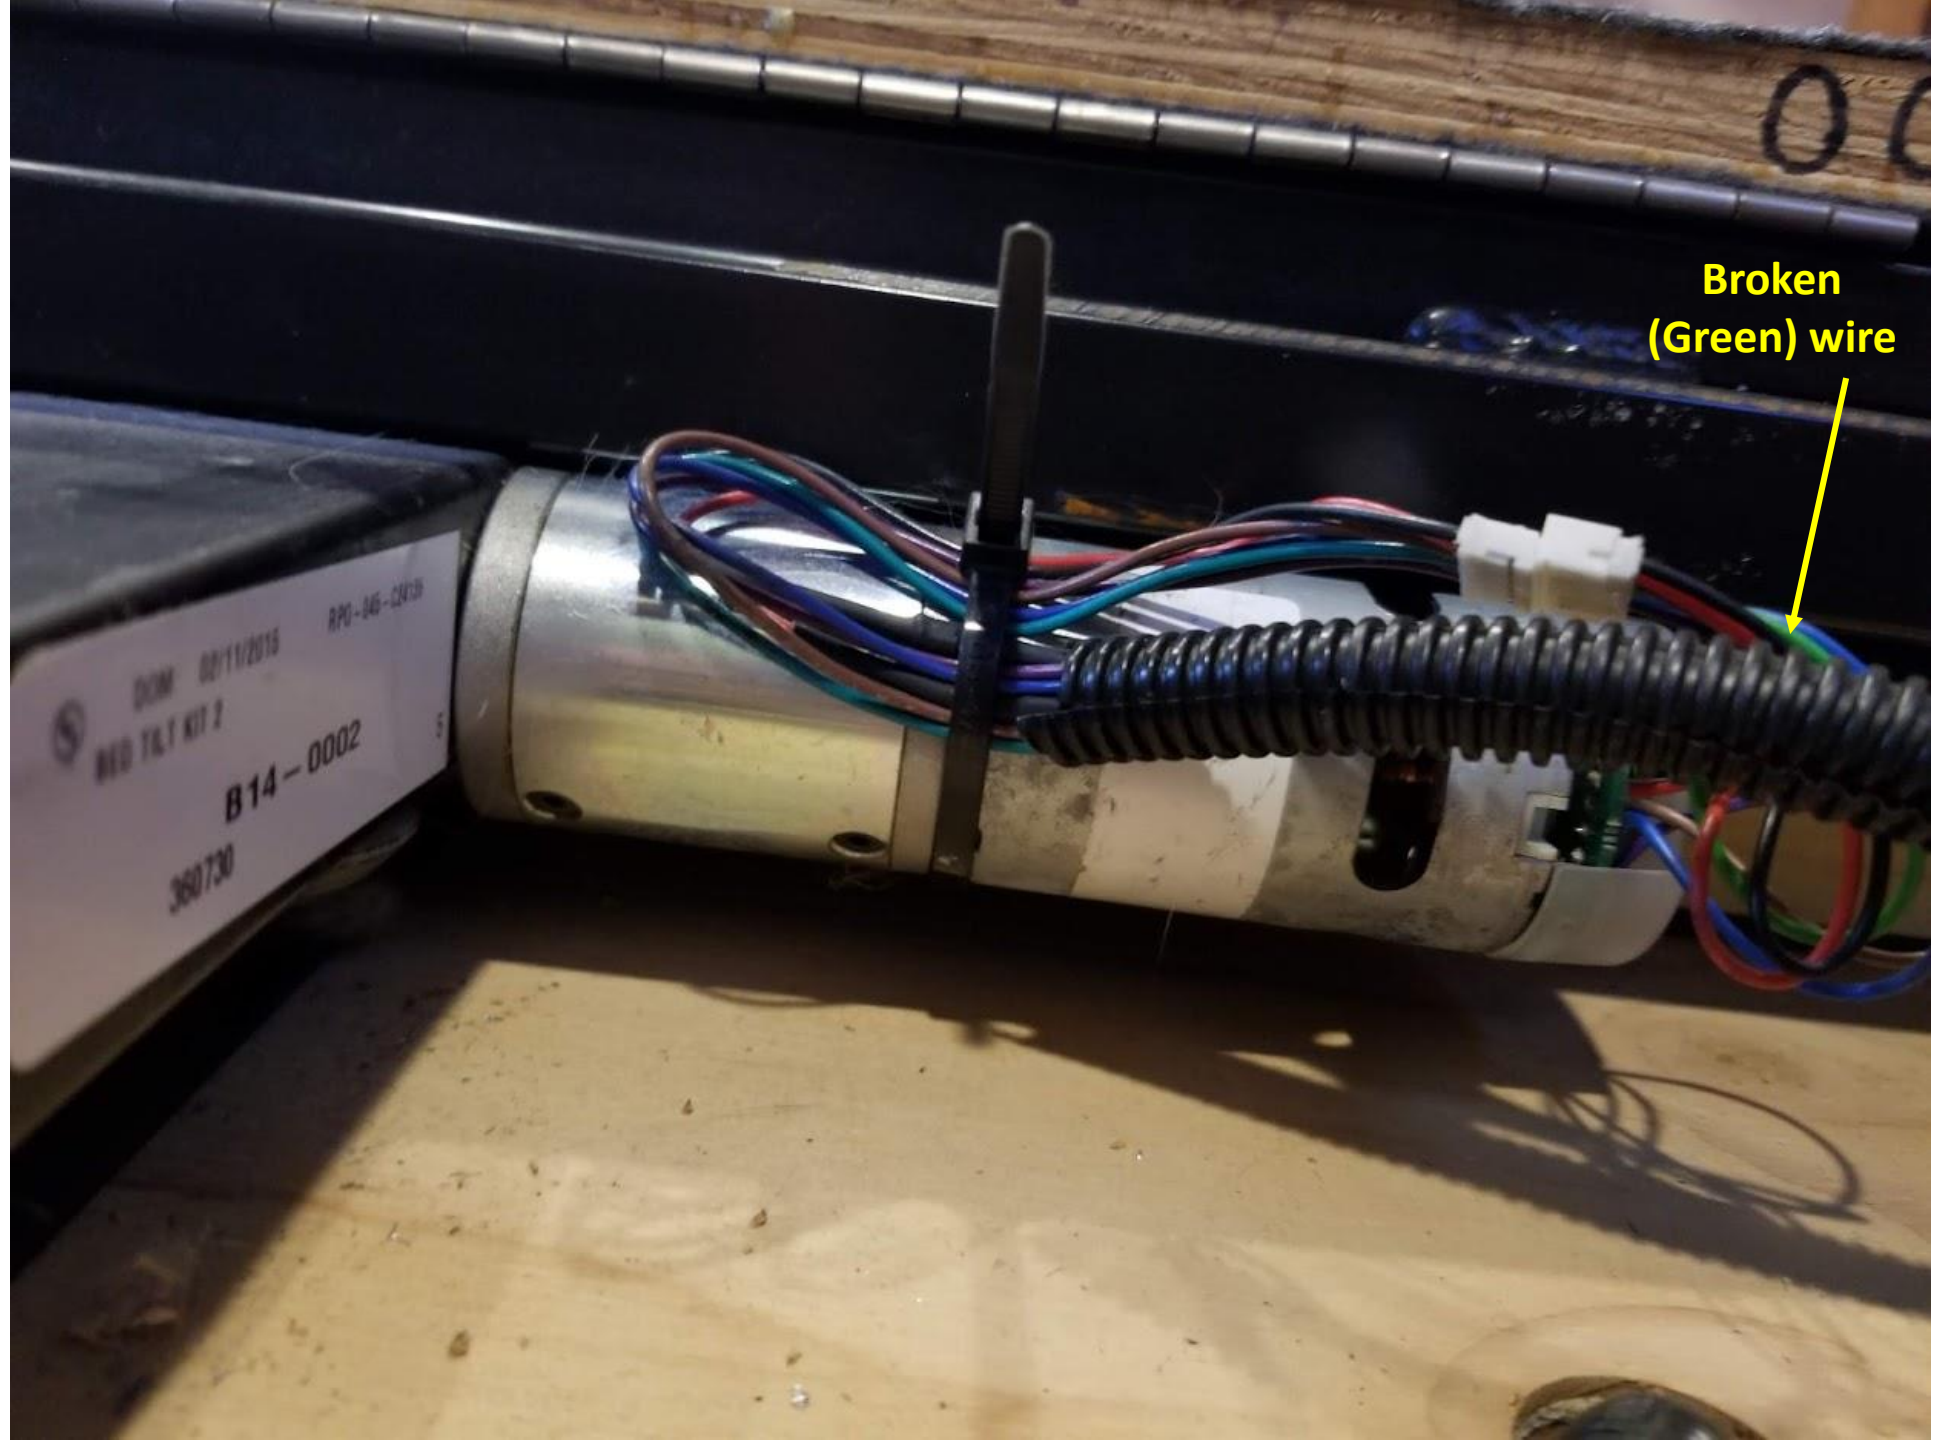
**Broken
(Green) wire**

This is a photo of the removed rail assembly, clearly showing the rod between the two rails.

Even with instructions from Lippert, we could not figure out how to remove the motor, so we removed the whole rail assembly so we could get at the motor to re-solder the broken wire.

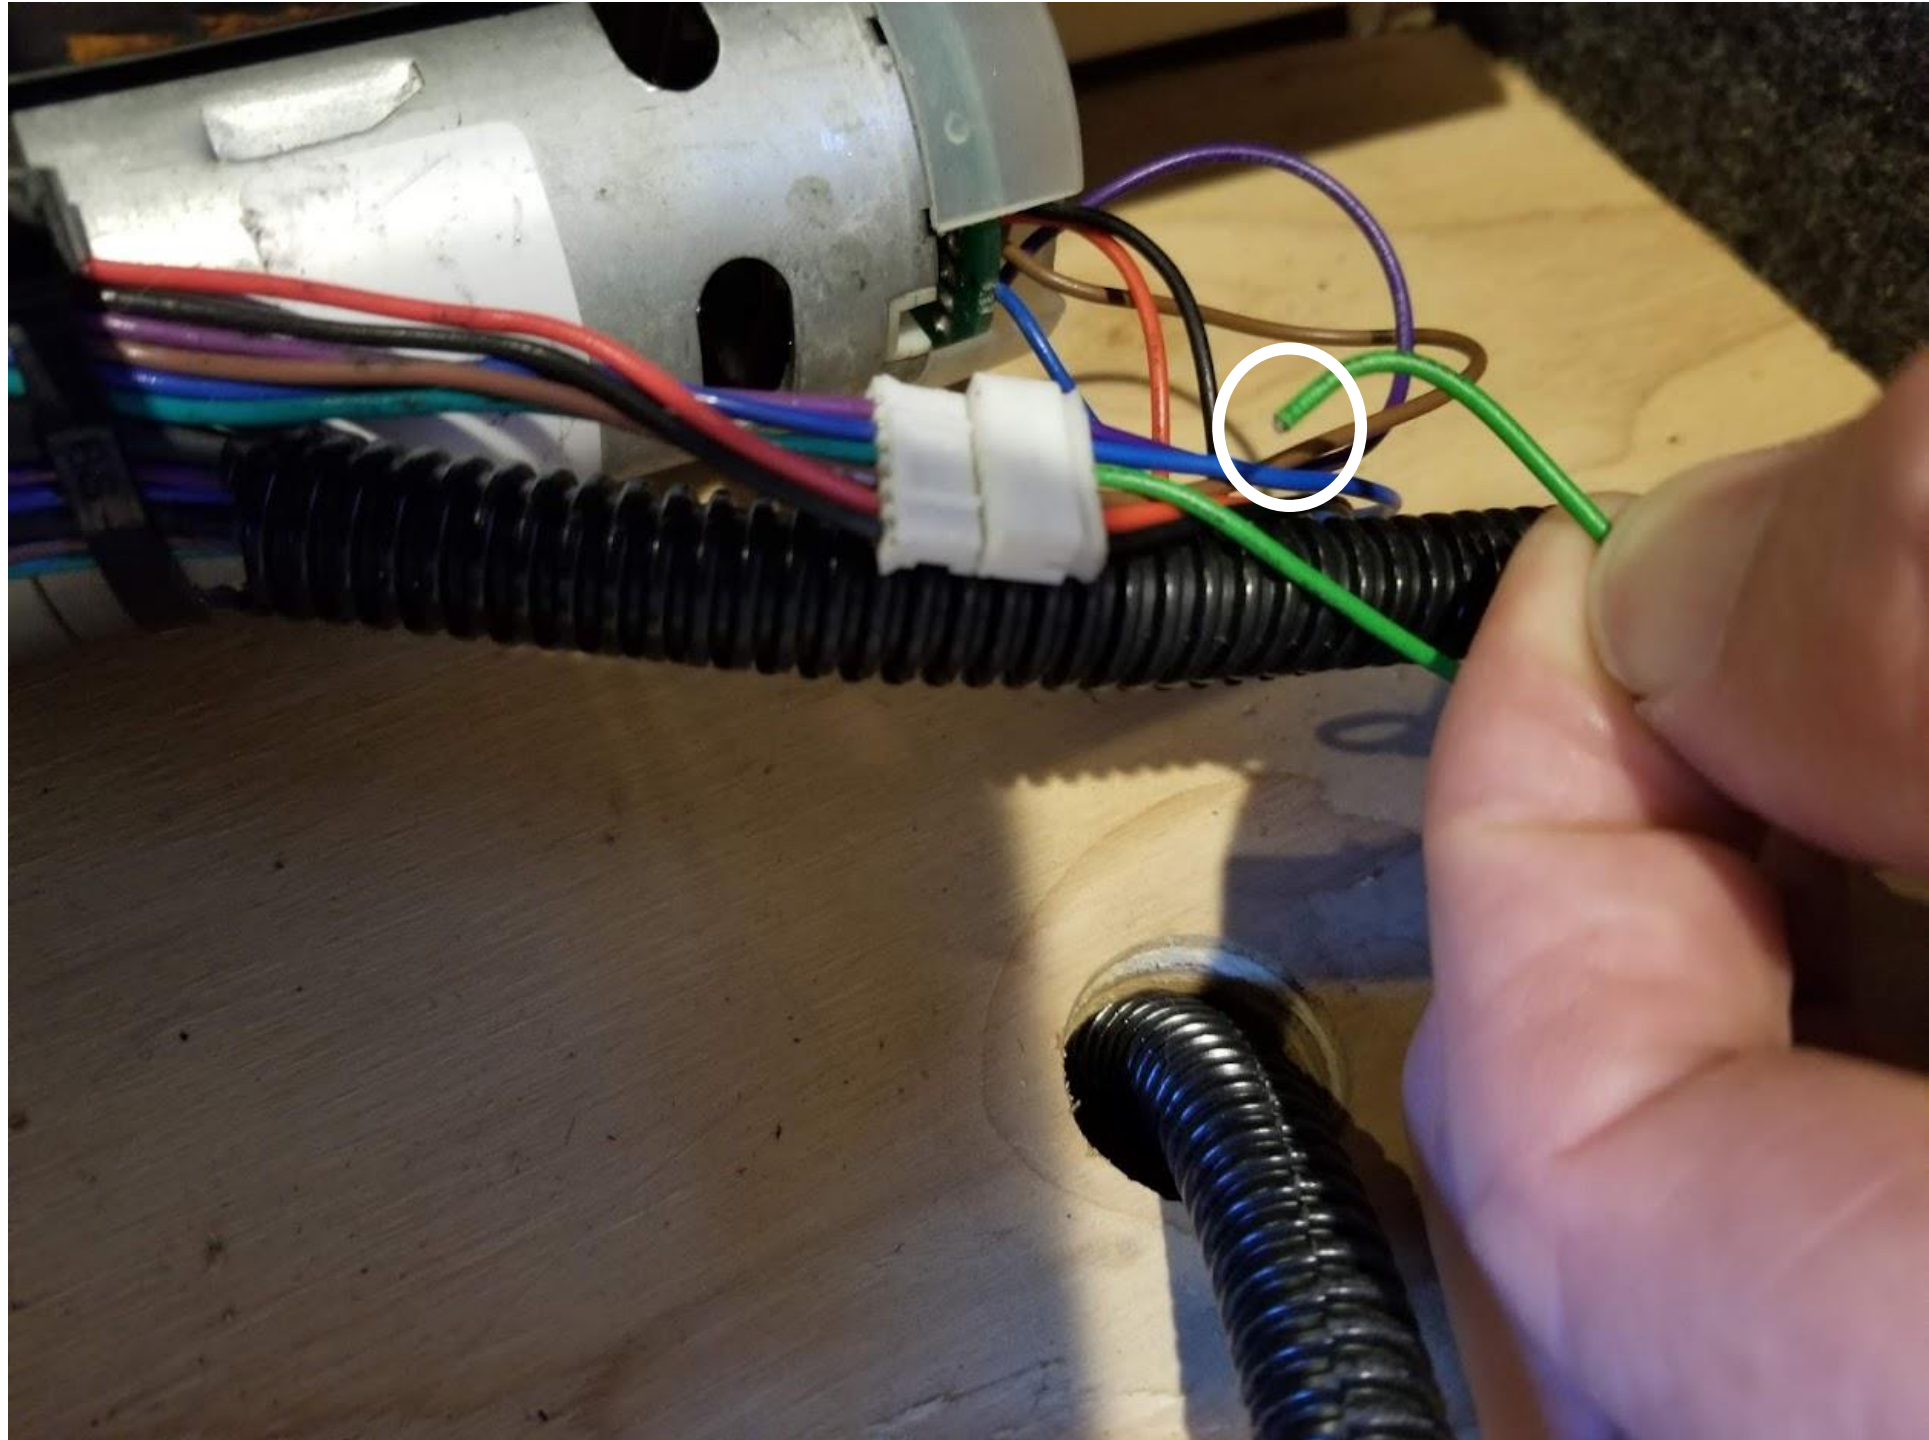
This photo shows the broke wire, stripped and ready to solder.

The repair consisted of tinning the broken wire, then heating the back of the PC board connection location to melt the solder there. Then the wire was pushed into the connector hole containing liquified solder and heat removed. The wire was secure when the solder cooled.

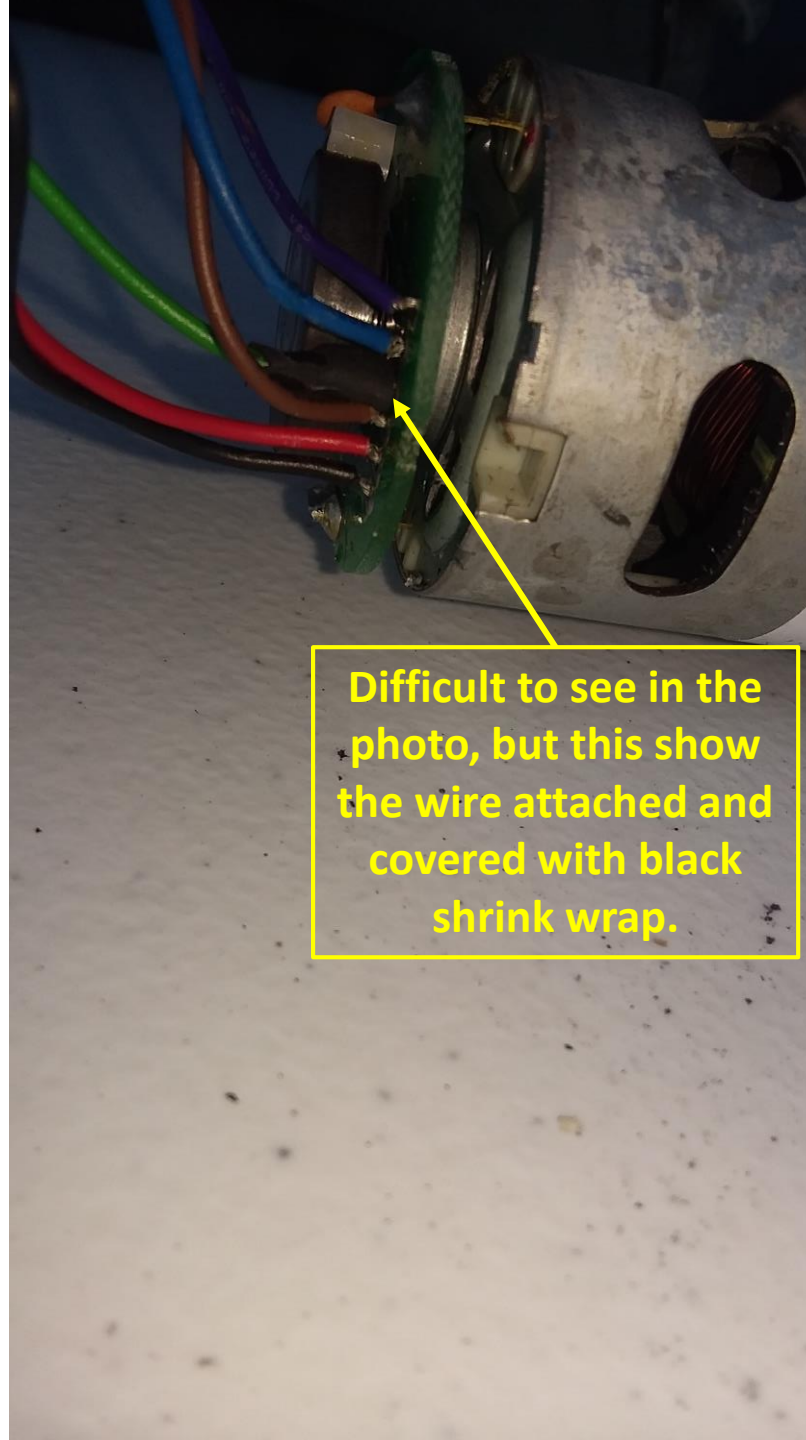
Difficult to see in the photo, but this show the wire attached and covered with black shrink wrap.
