Repair of Broken Full-Wall Slide Lock Motor Mount

Rick Blaher

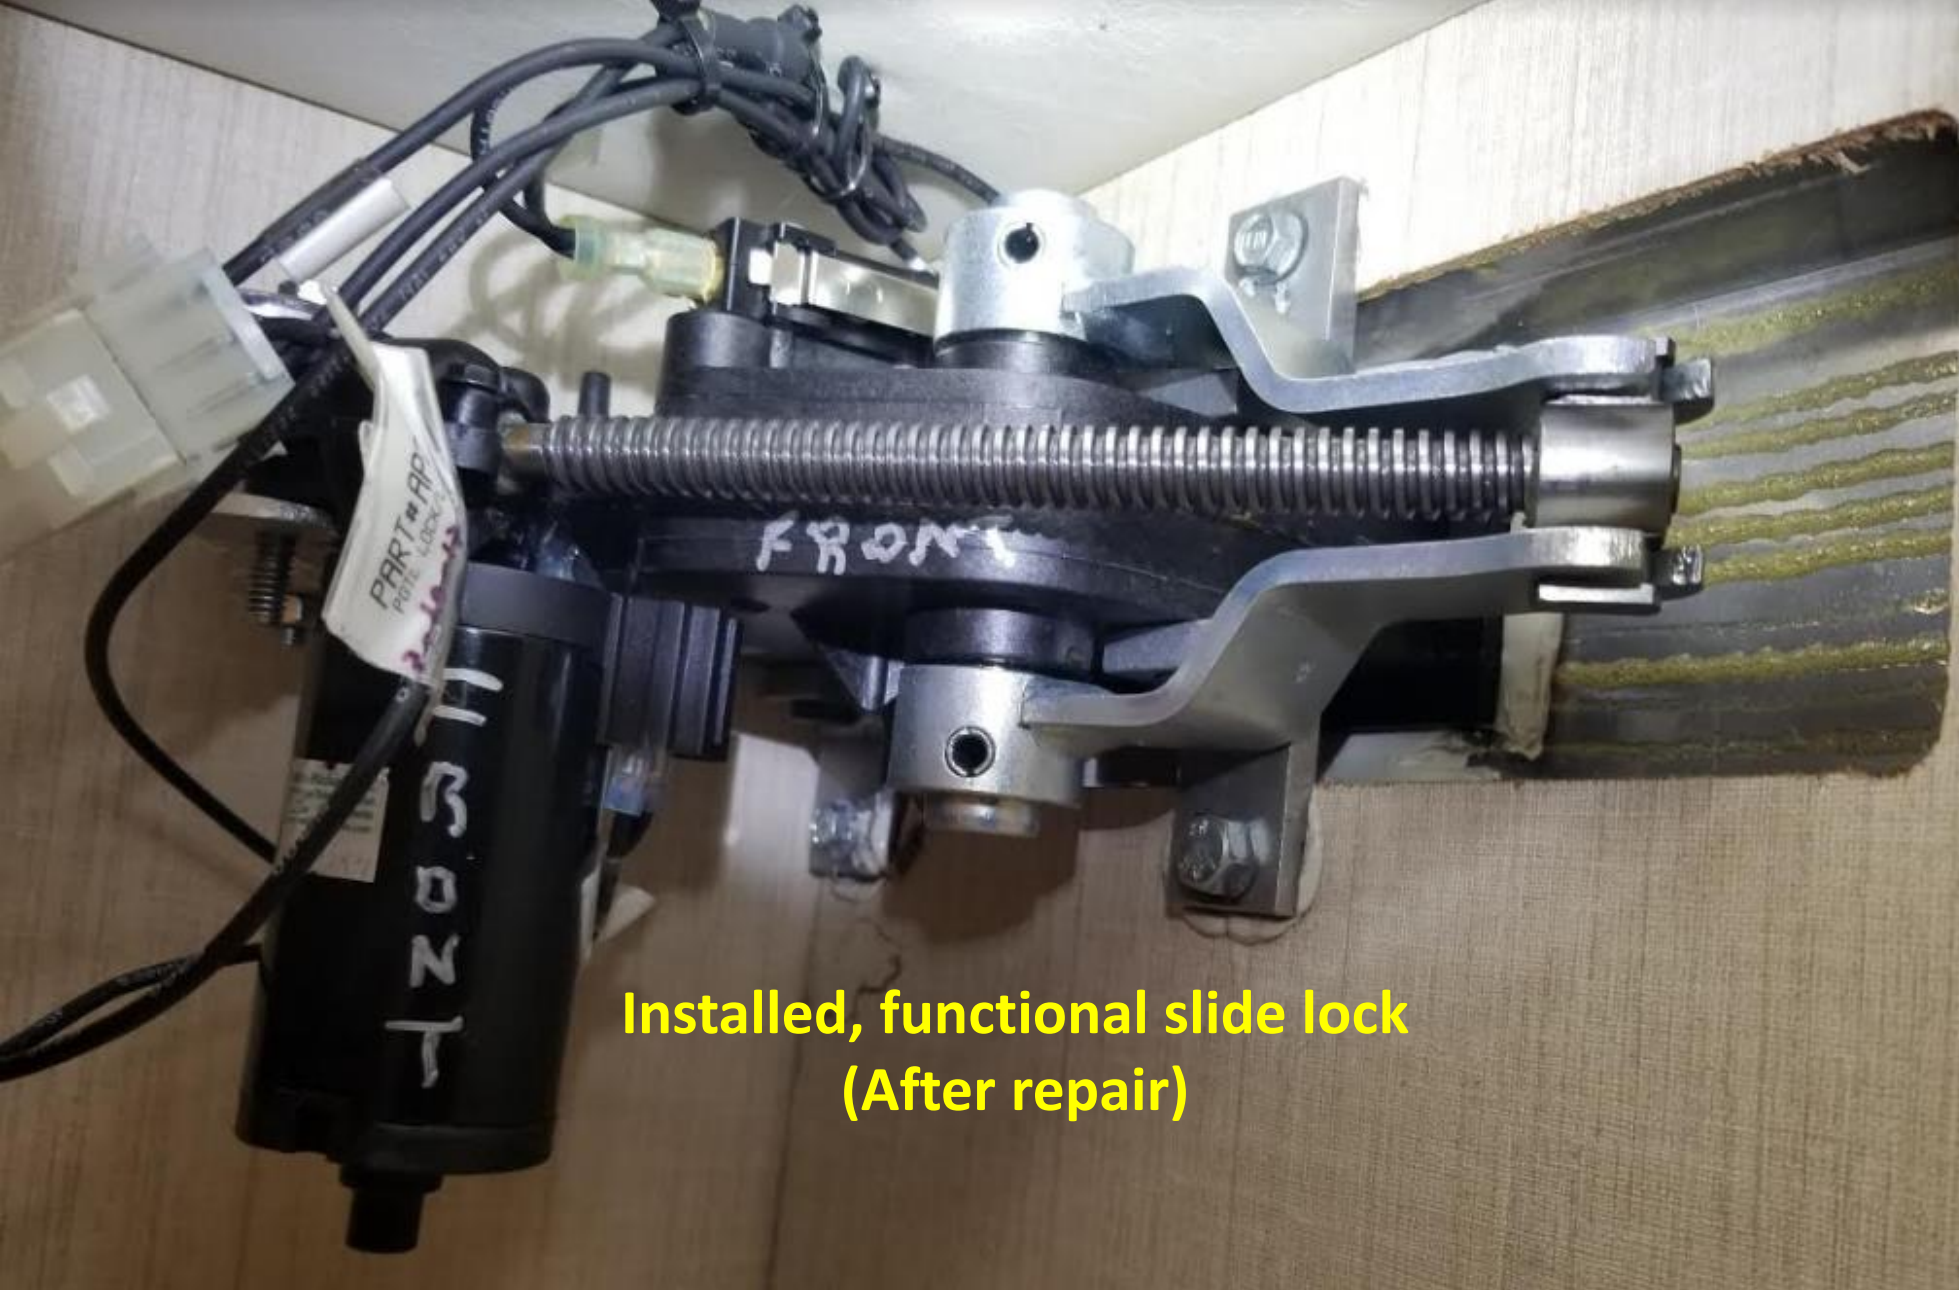
**Installed, functional slide lock
(After repair)**

Note that the slide motor hangs DOWN. These locks are mirror images of each other so if you don't put the motors on the correct side, you'll have two lefts or two rights. Mark each assembly with a permanent marker.

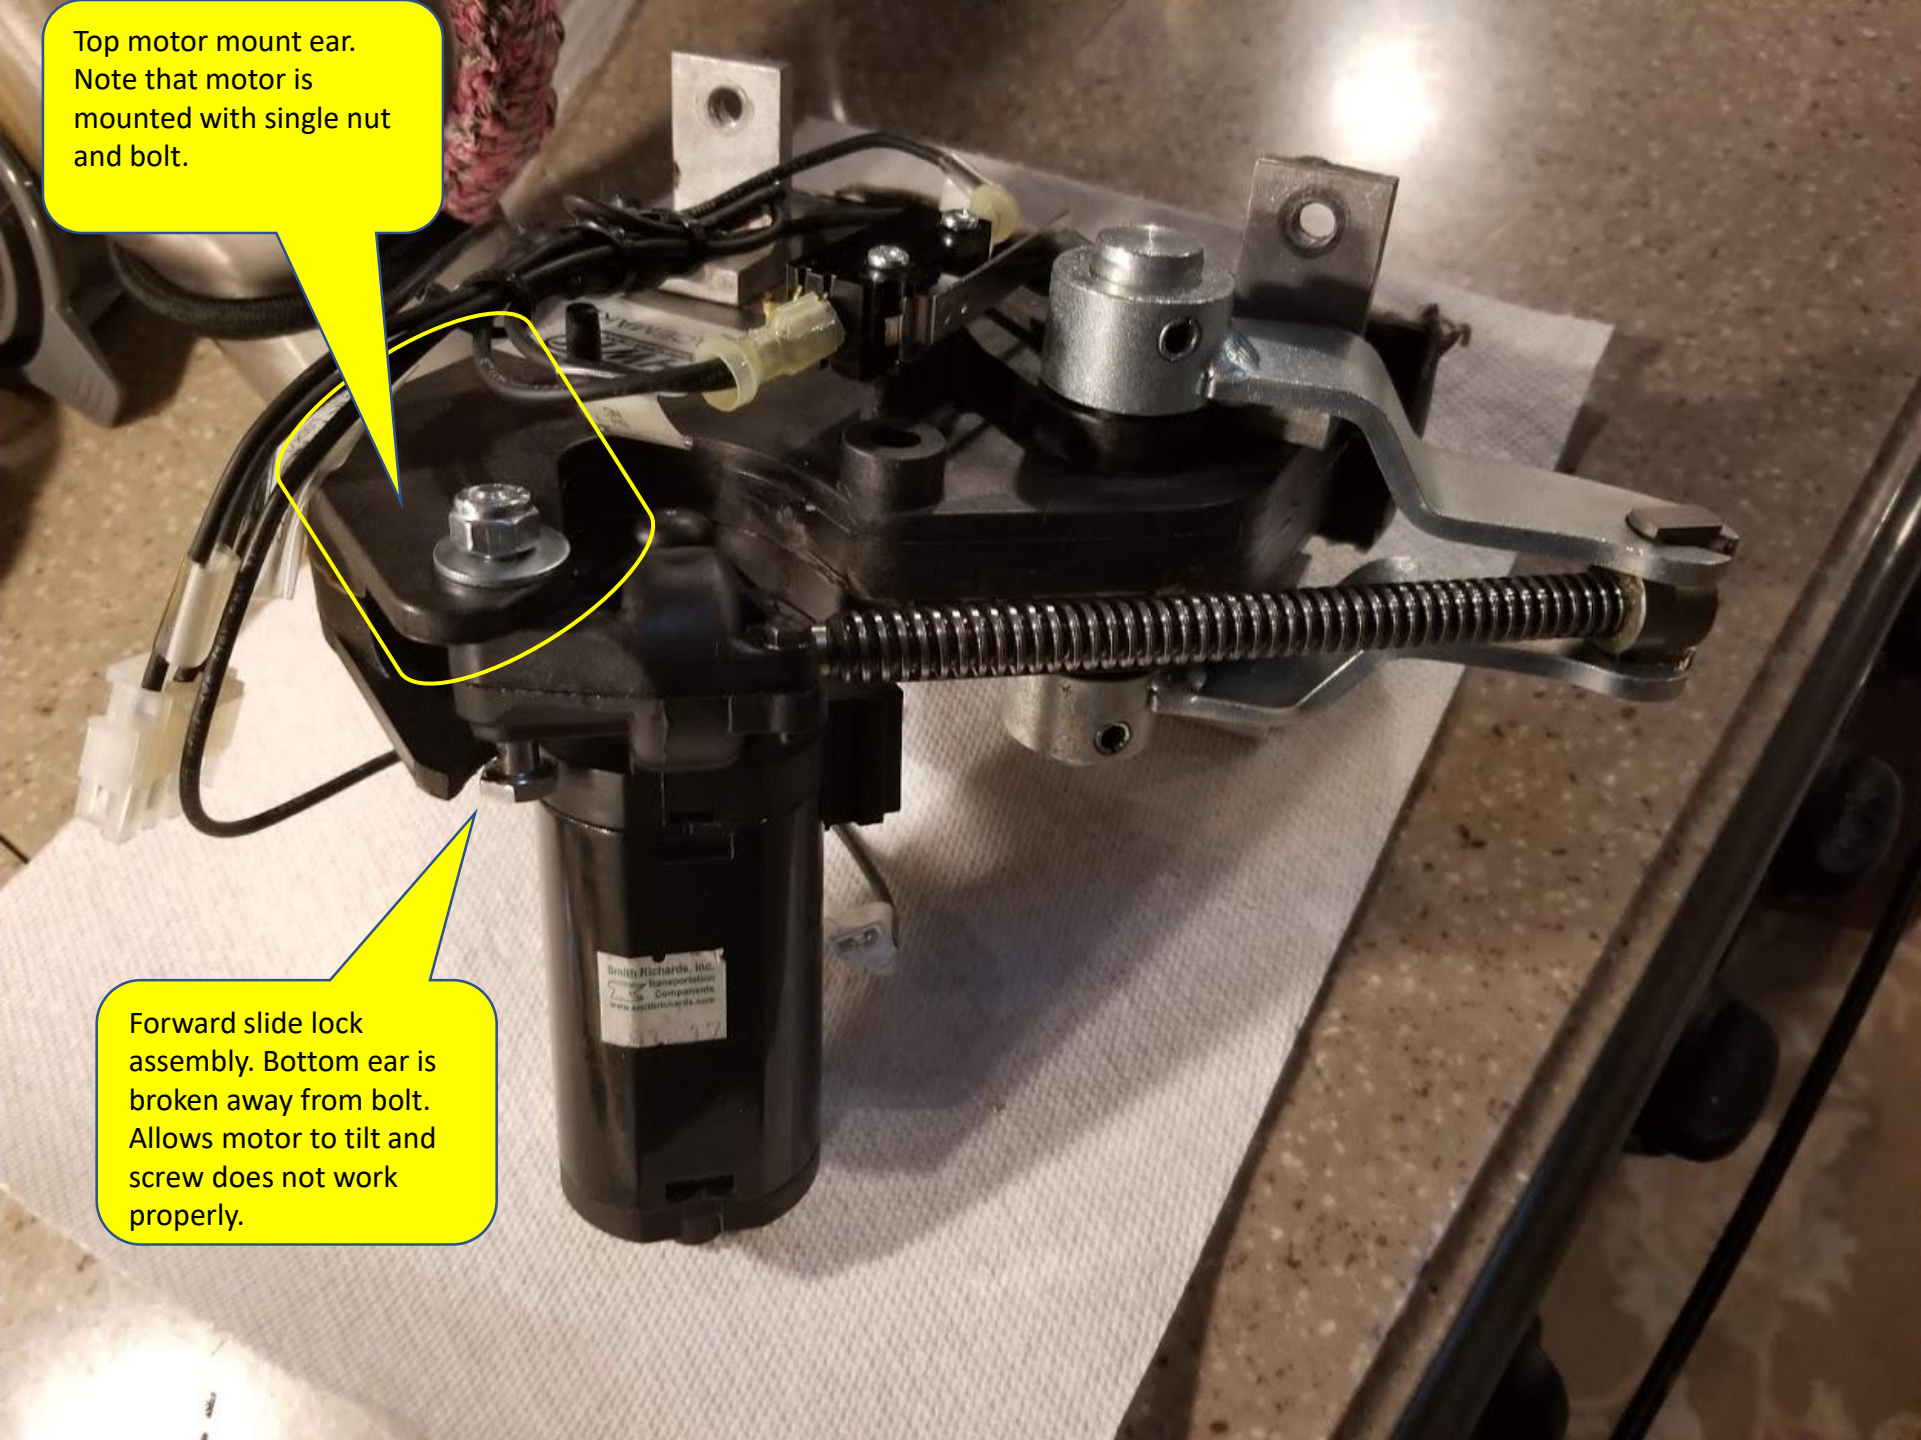
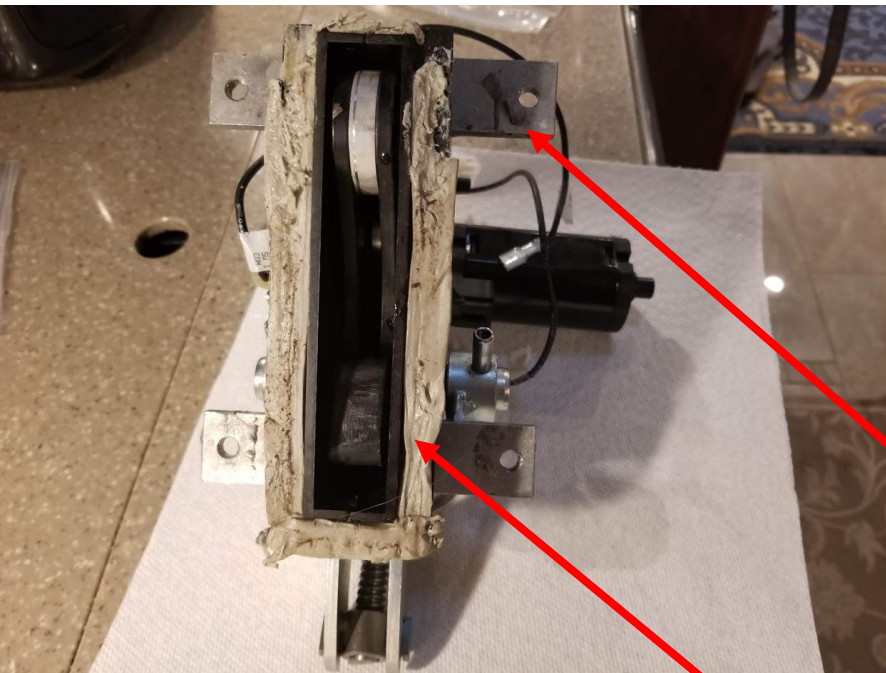
Top motor mount ear.
Note that motor is
mounted with single nut
and bolt.

Forward slide lock
assembly. Bottom ear is
broken away from bolt.
Allows motor to tilt and
screw does not work
properly.

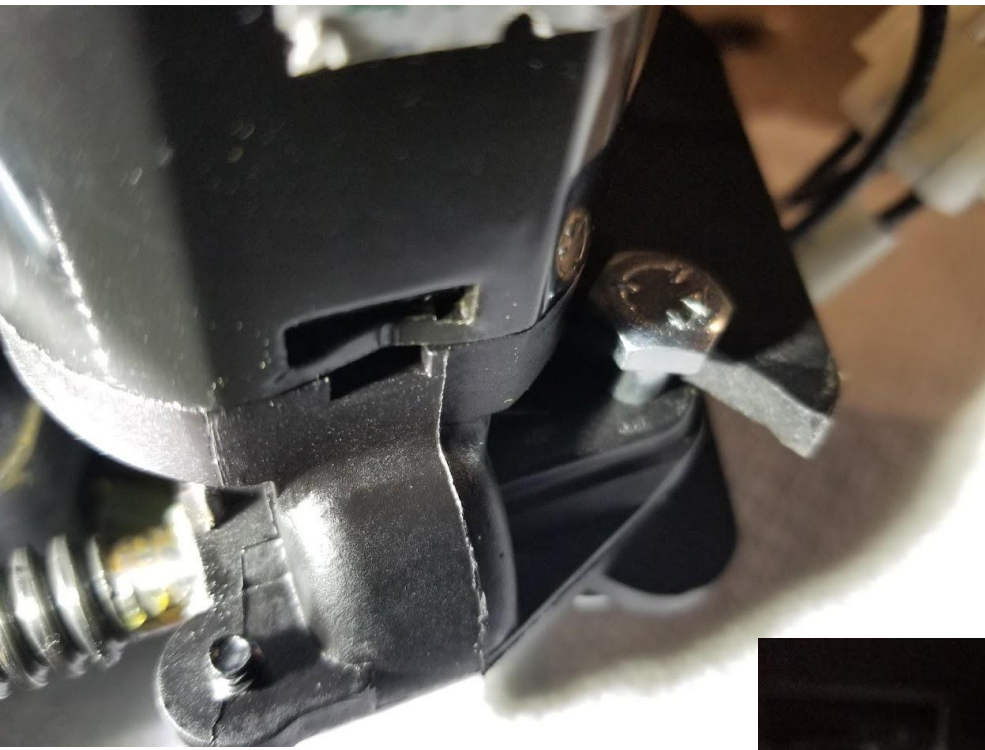
4 attachment tabs attach the lock assembly to the end of the slide wall. Remove/Install with $\frac{1}{4}$ " drive, 6" extension, and $\frac{3}{8}$ " deep socket. The top attachment toward the outside is the hardest one to remove and re-install because it is not visible and has to be done by feel.

Note also the BUTYL weather seal around the outside of the slide lock slot. Replace this with new seal, available at hardware stores.

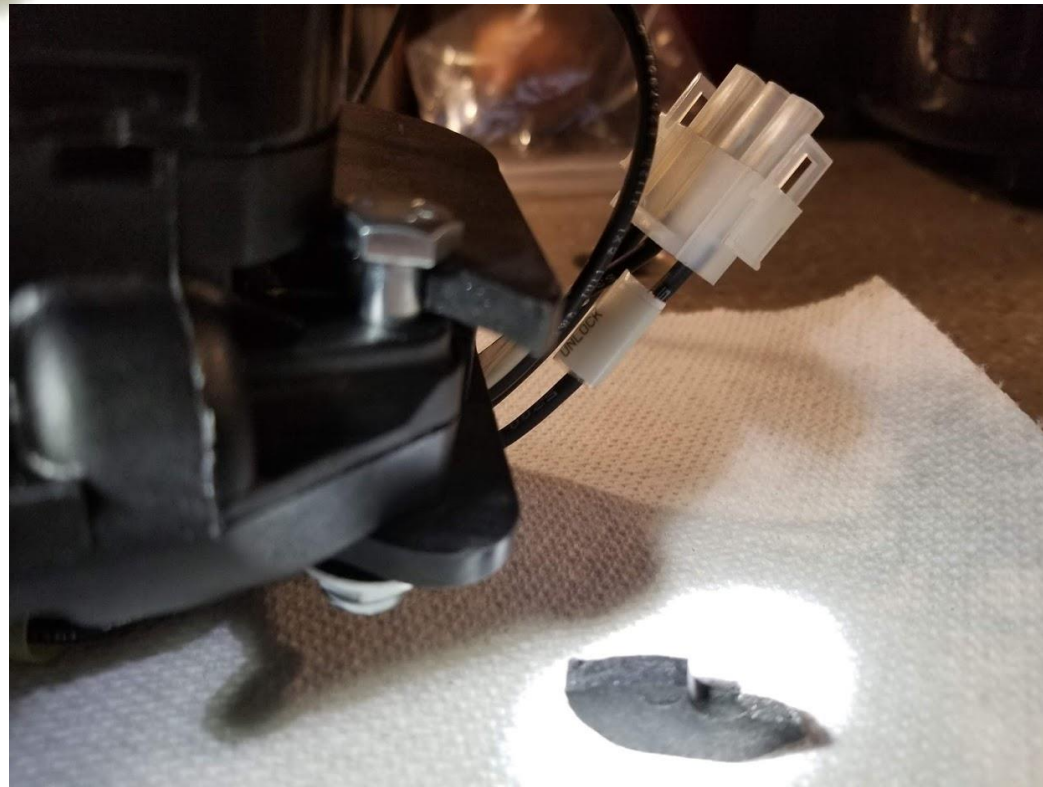
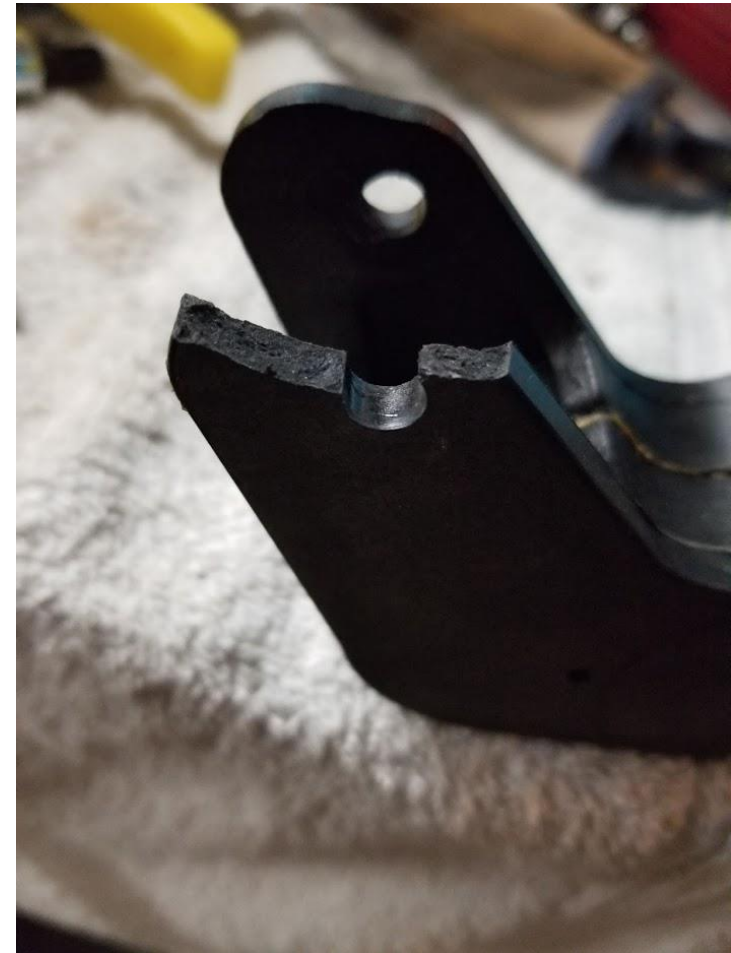
These photos show the broken ear and the piece that broke off. Rick has had three broken assemblies in 2 years – all broken similarly.

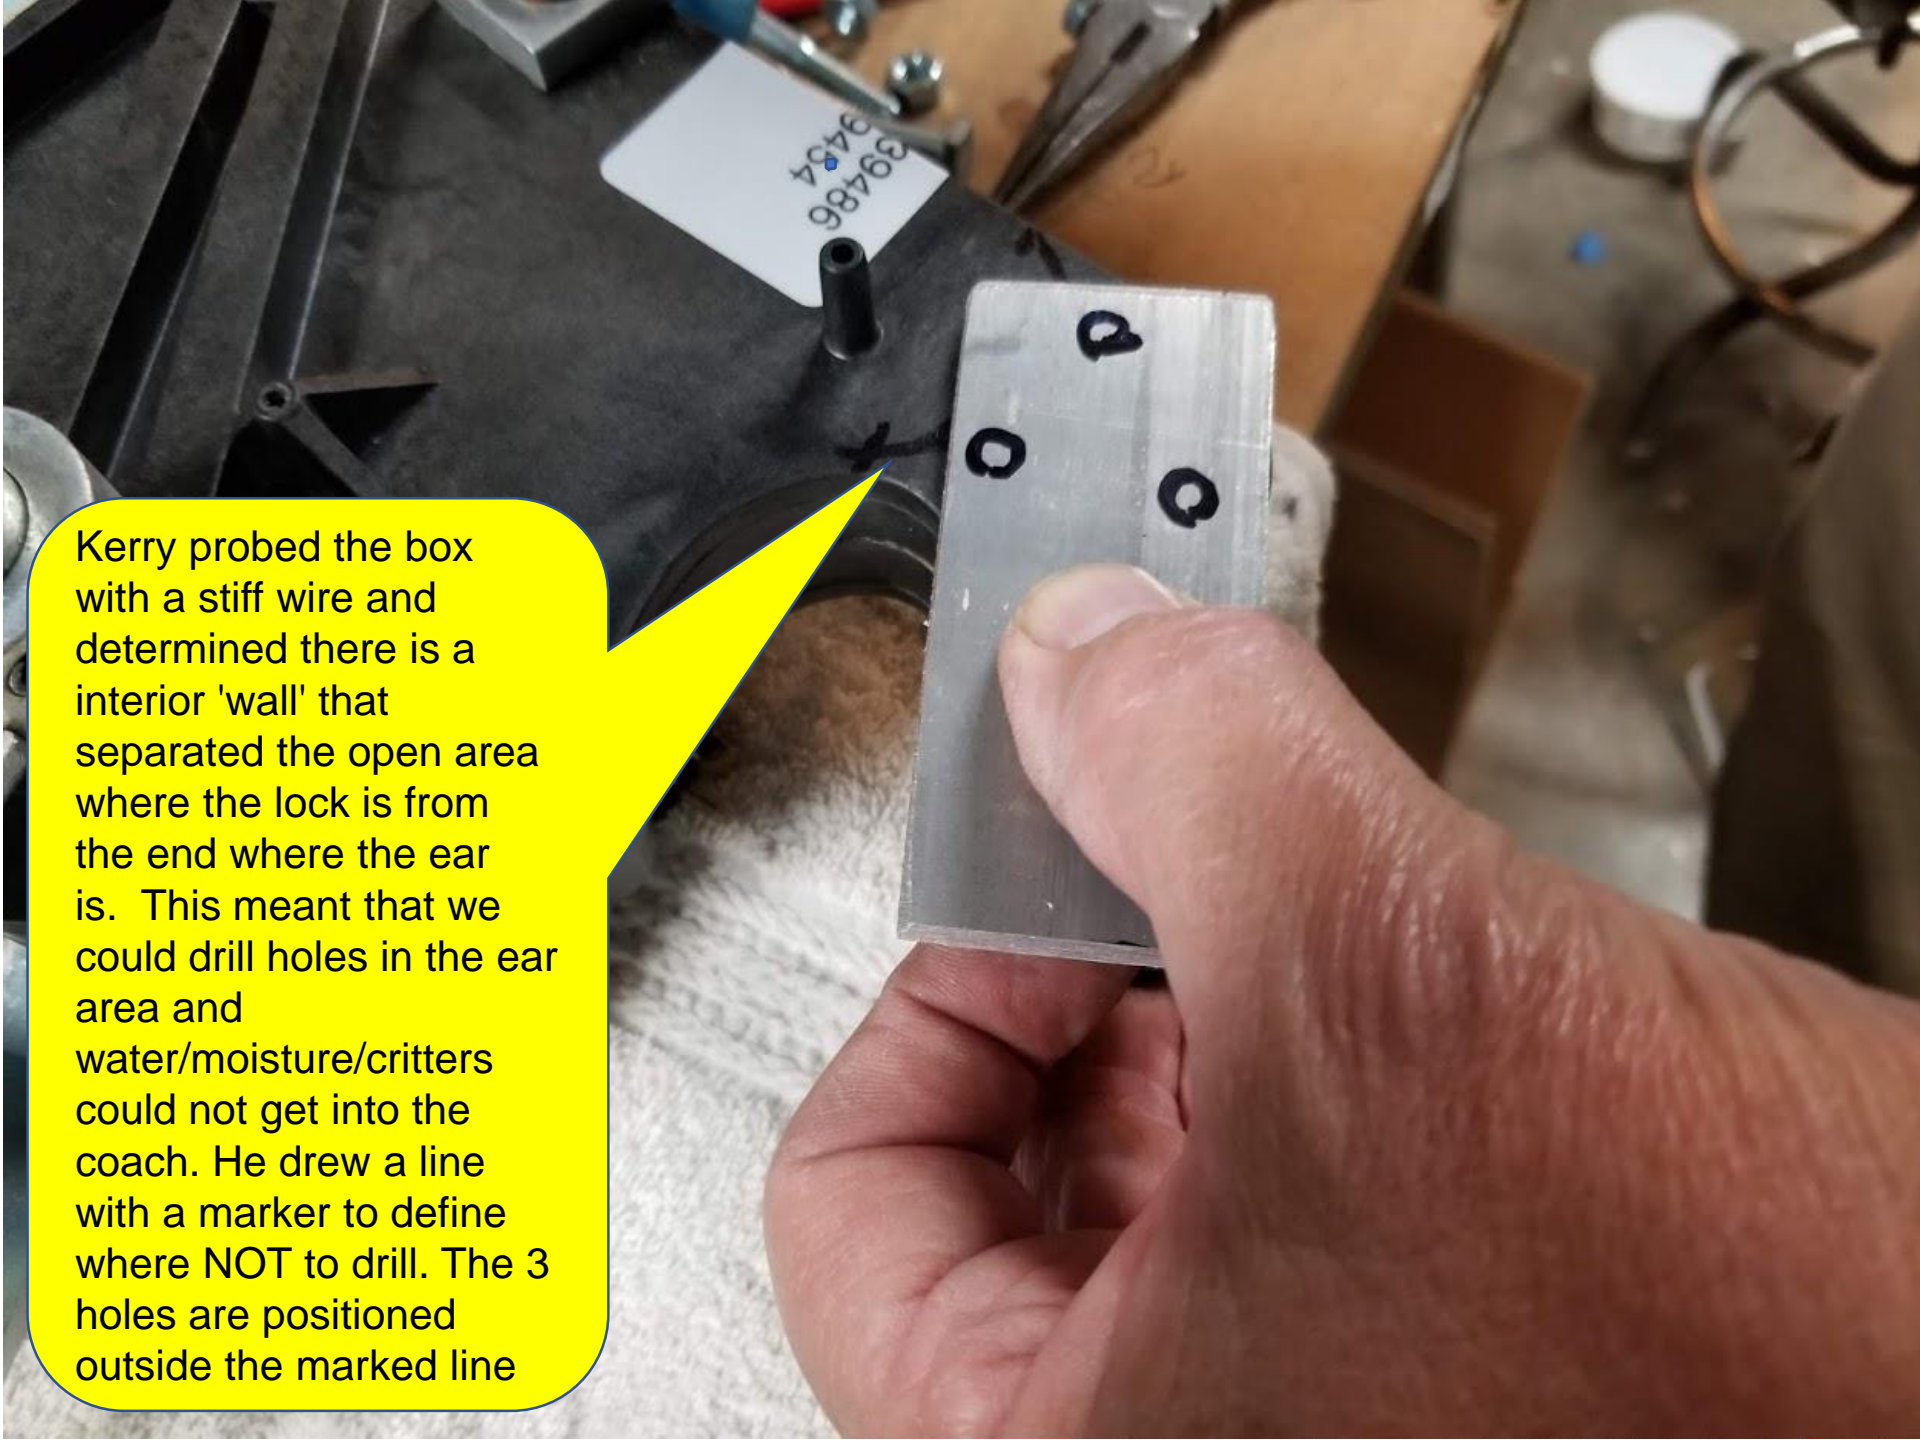
Kerry probed the box with a stiff wire and determined there is an interior 'wall' that separated the open area where the lock is from the end where the ear is. This meant that we could drill holes in the ear area and water/moisture/critters could not get into the coach. He drew a line with a marker to define where NOT to drill. The 3 holes are positioned outside the marked line

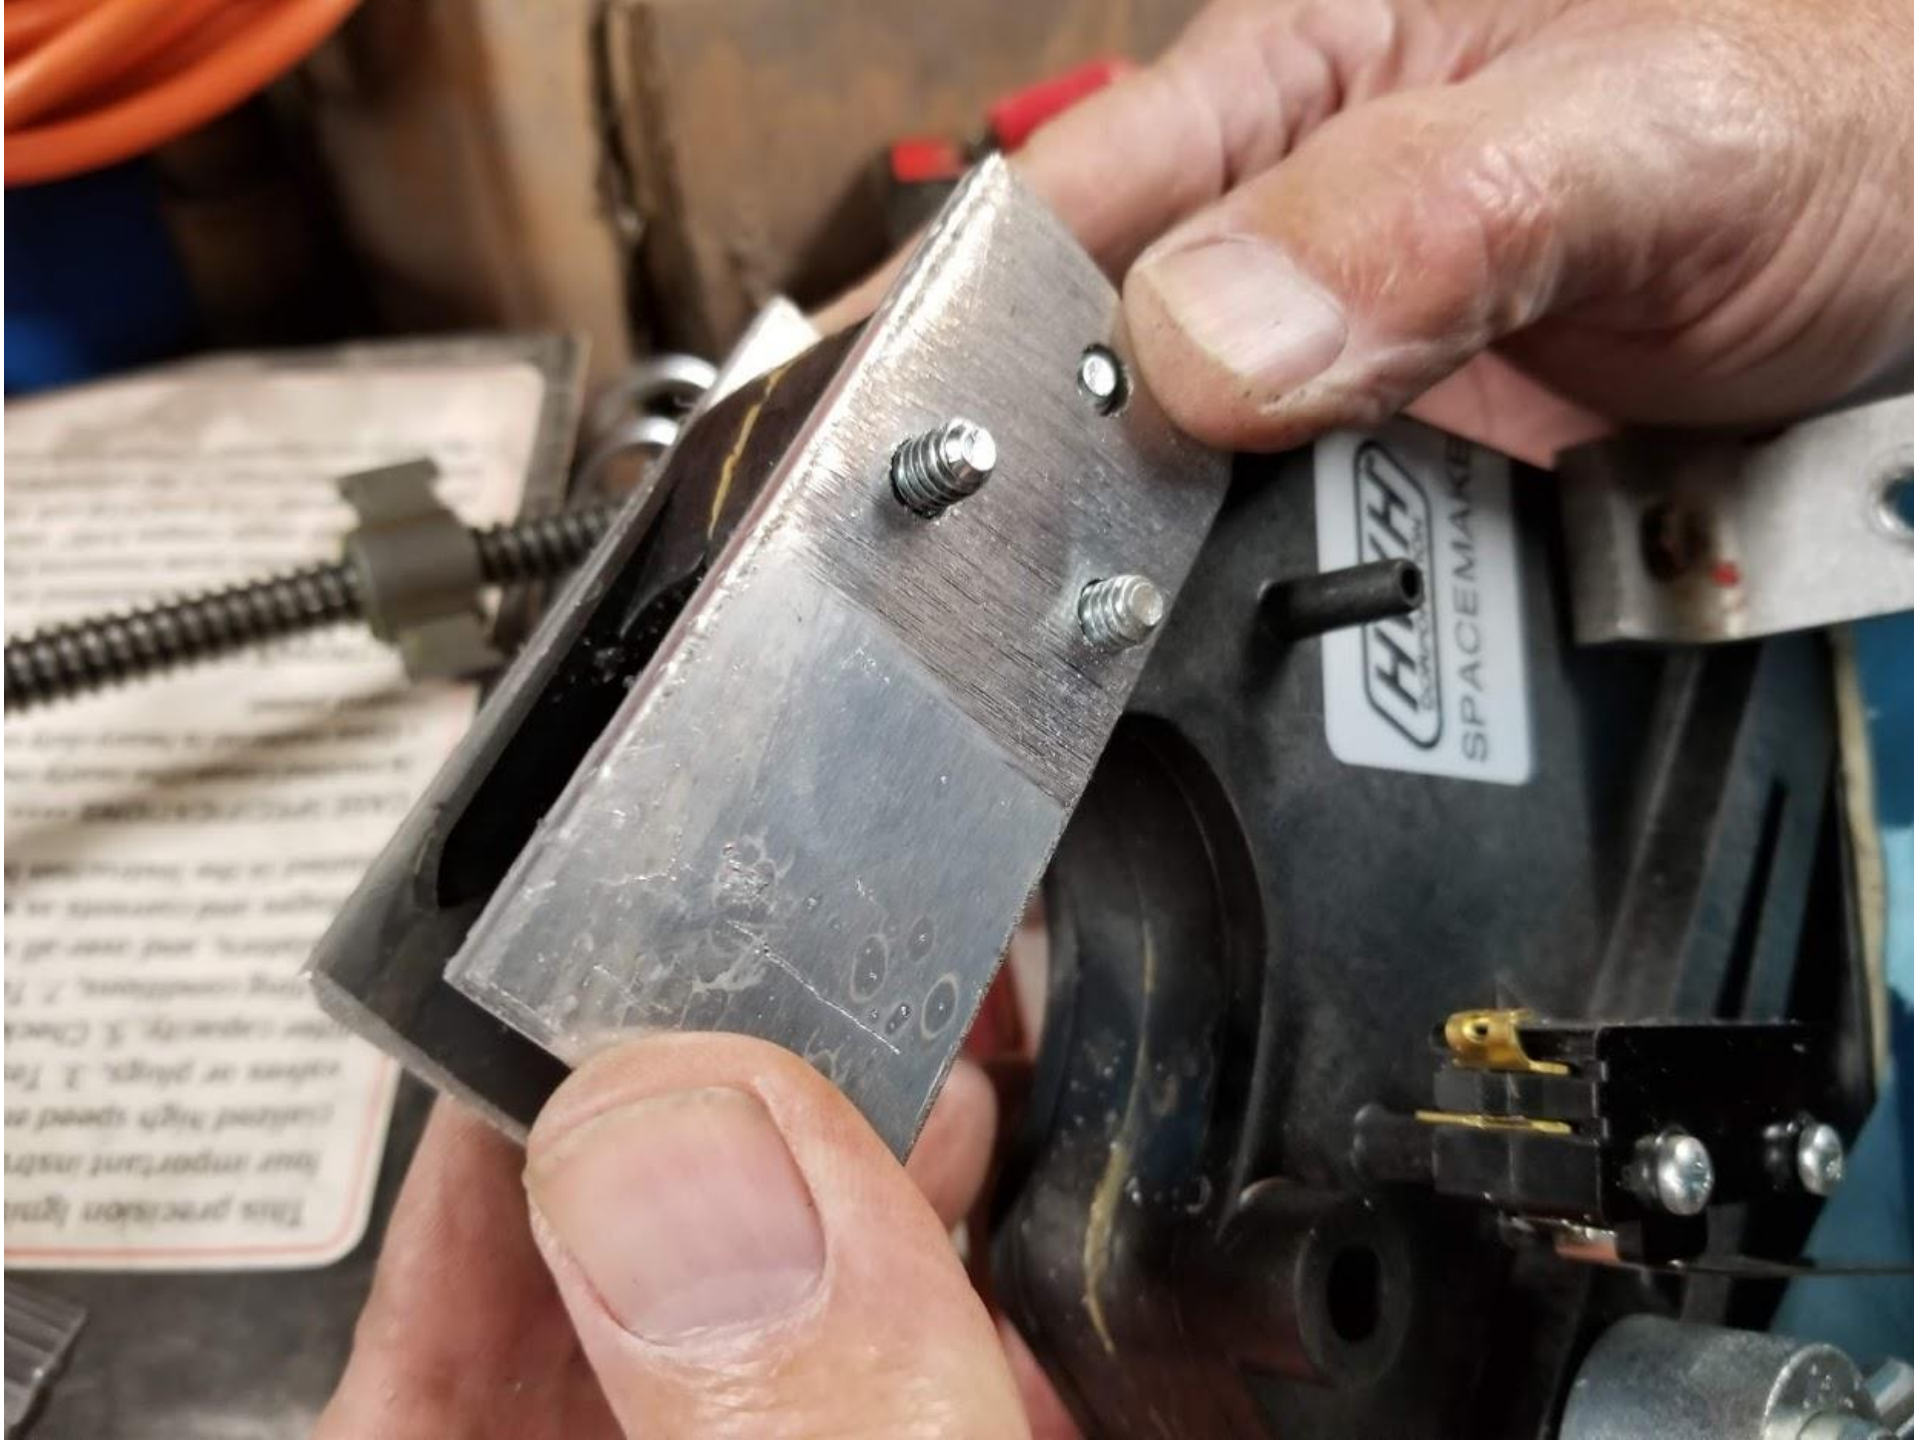
Note the relationship of the plate compared to the pin at the corner of the white tag. While holding the overlay in place, mark locations for 3 holes. The assembly mount is hollow beneath where these are marked, so you will be able to drill through the assembly for the new mounting holes without impacting the integrity of the mount.

Drill three ¼-inch holes through the marked plate.

Use the drilled plate as a template and drill the second plate.

Then, mark the hole locations on the mount and drill through the mount.

Insert ¼" – 20 bolts through the plates to test the hole alignment.

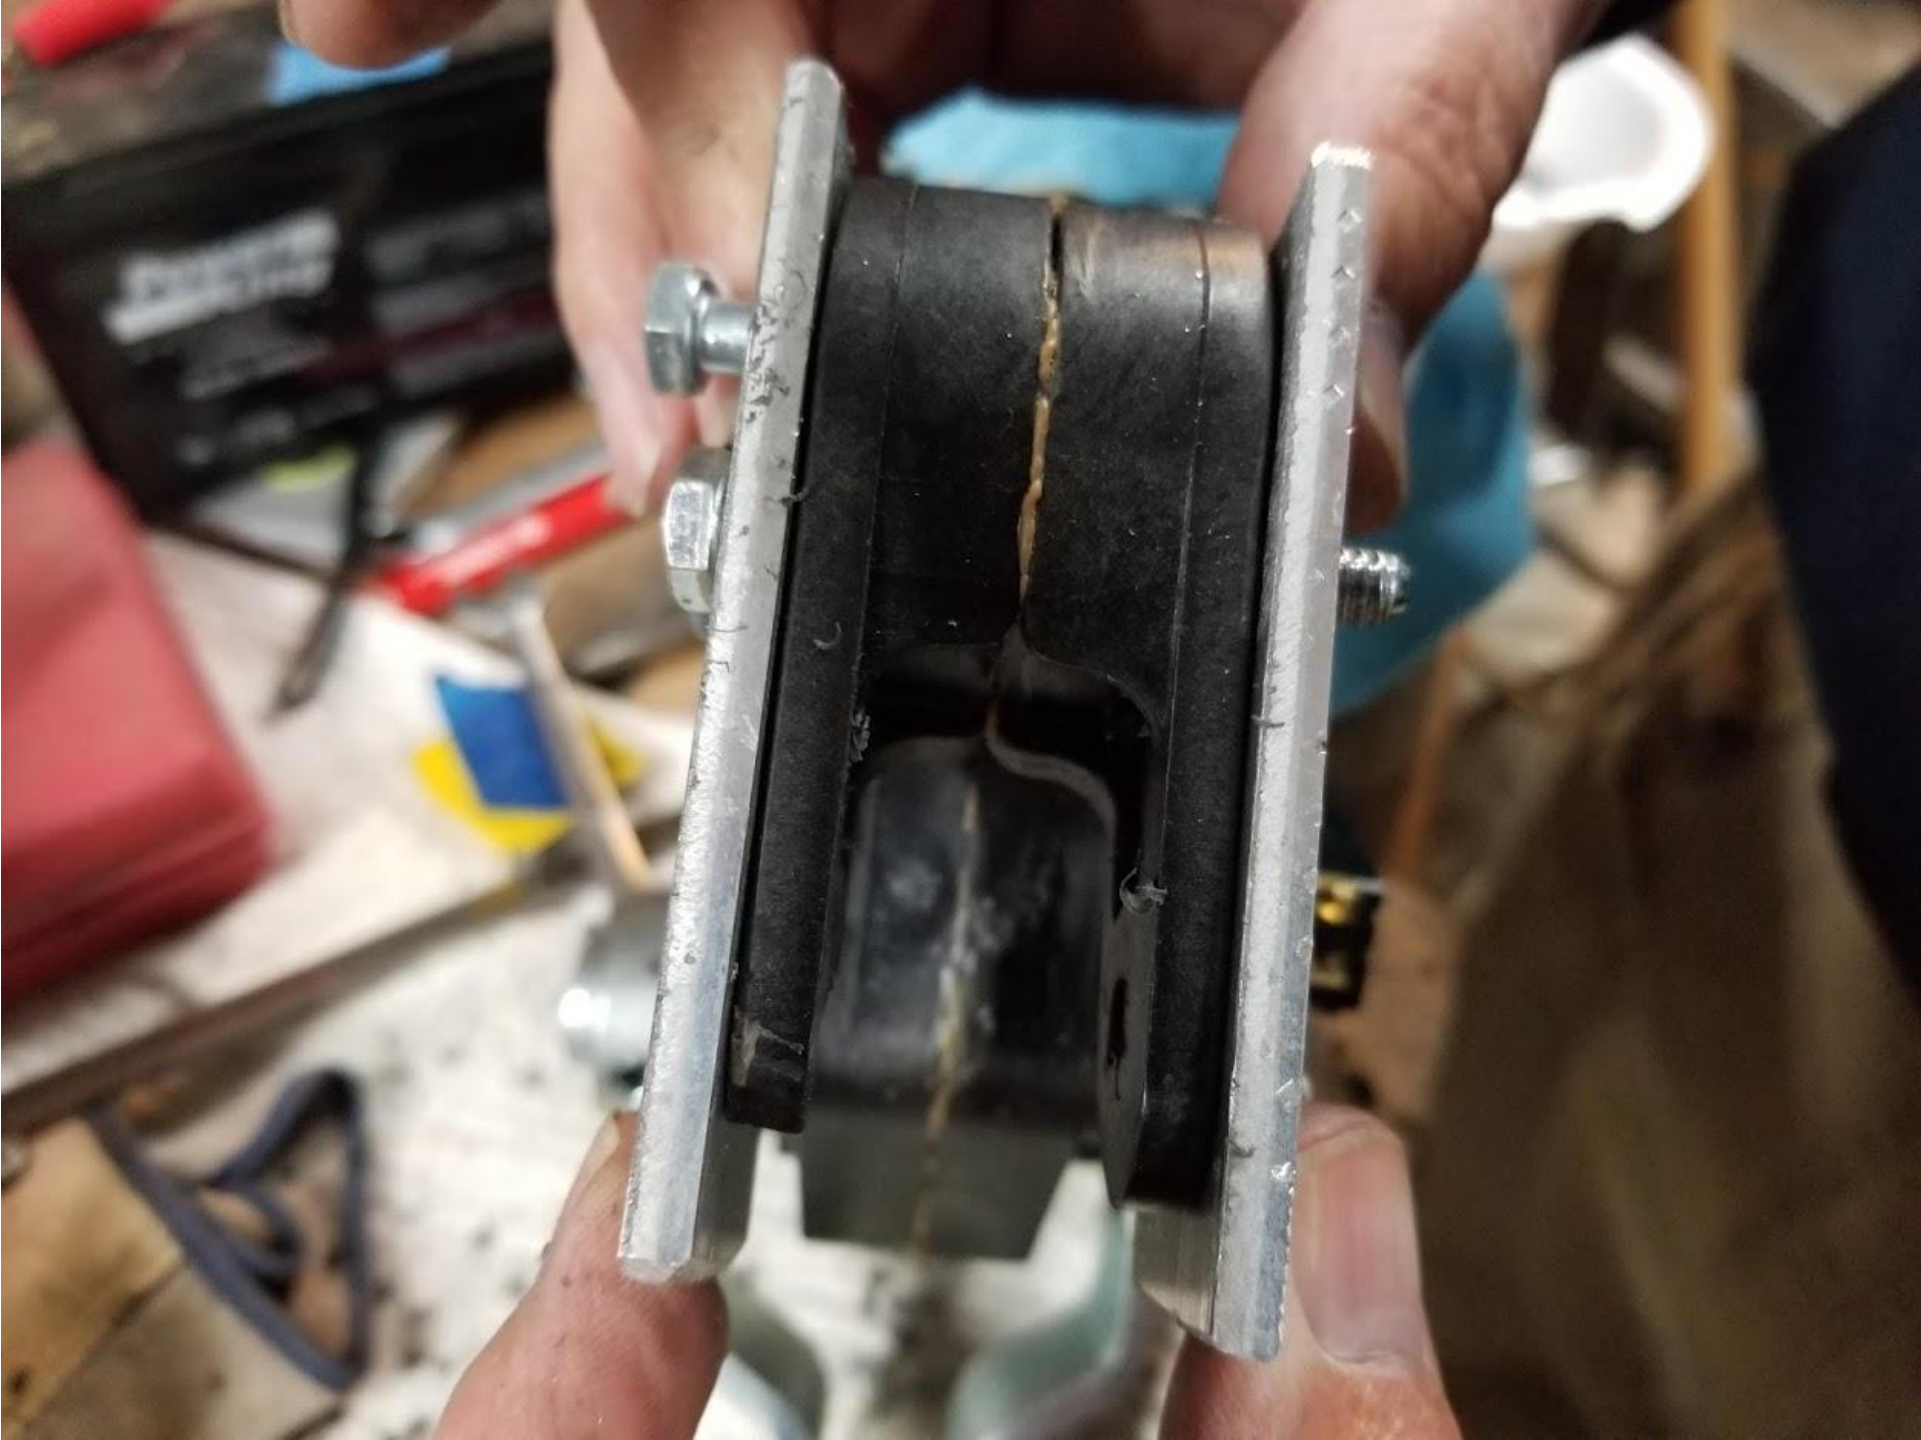
This slide shows the 2 rectangular, drilled plates installed on the motor mount.

Mark and drill a hole on each plate for the motor attachment.

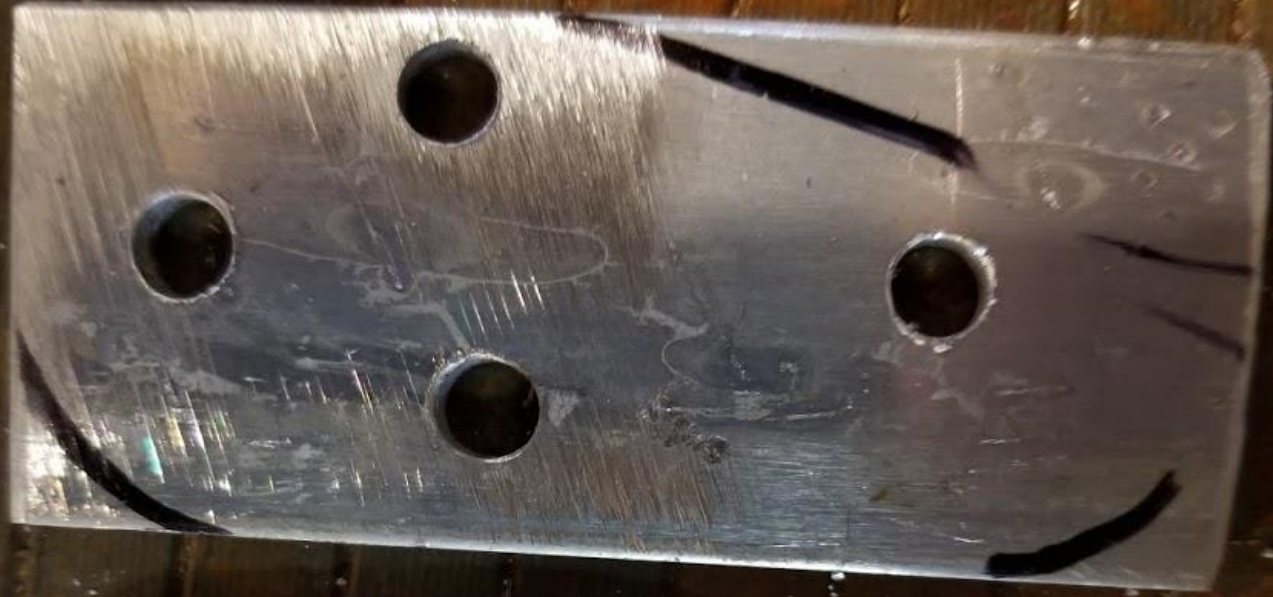
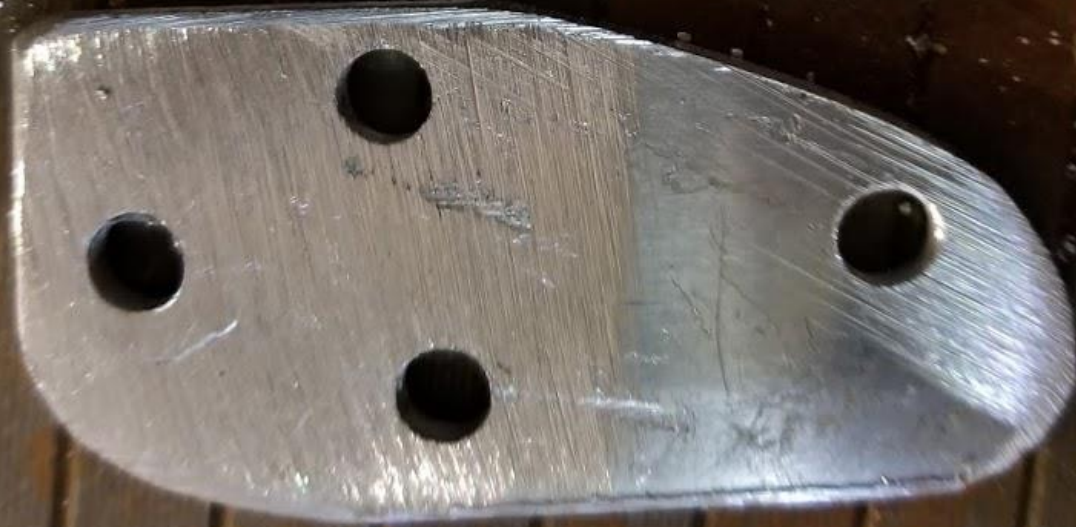
**These photos show the 4 drilled holes for each plate.
Mark the outline of the assembly mount on each plate
with a permanent marker.**

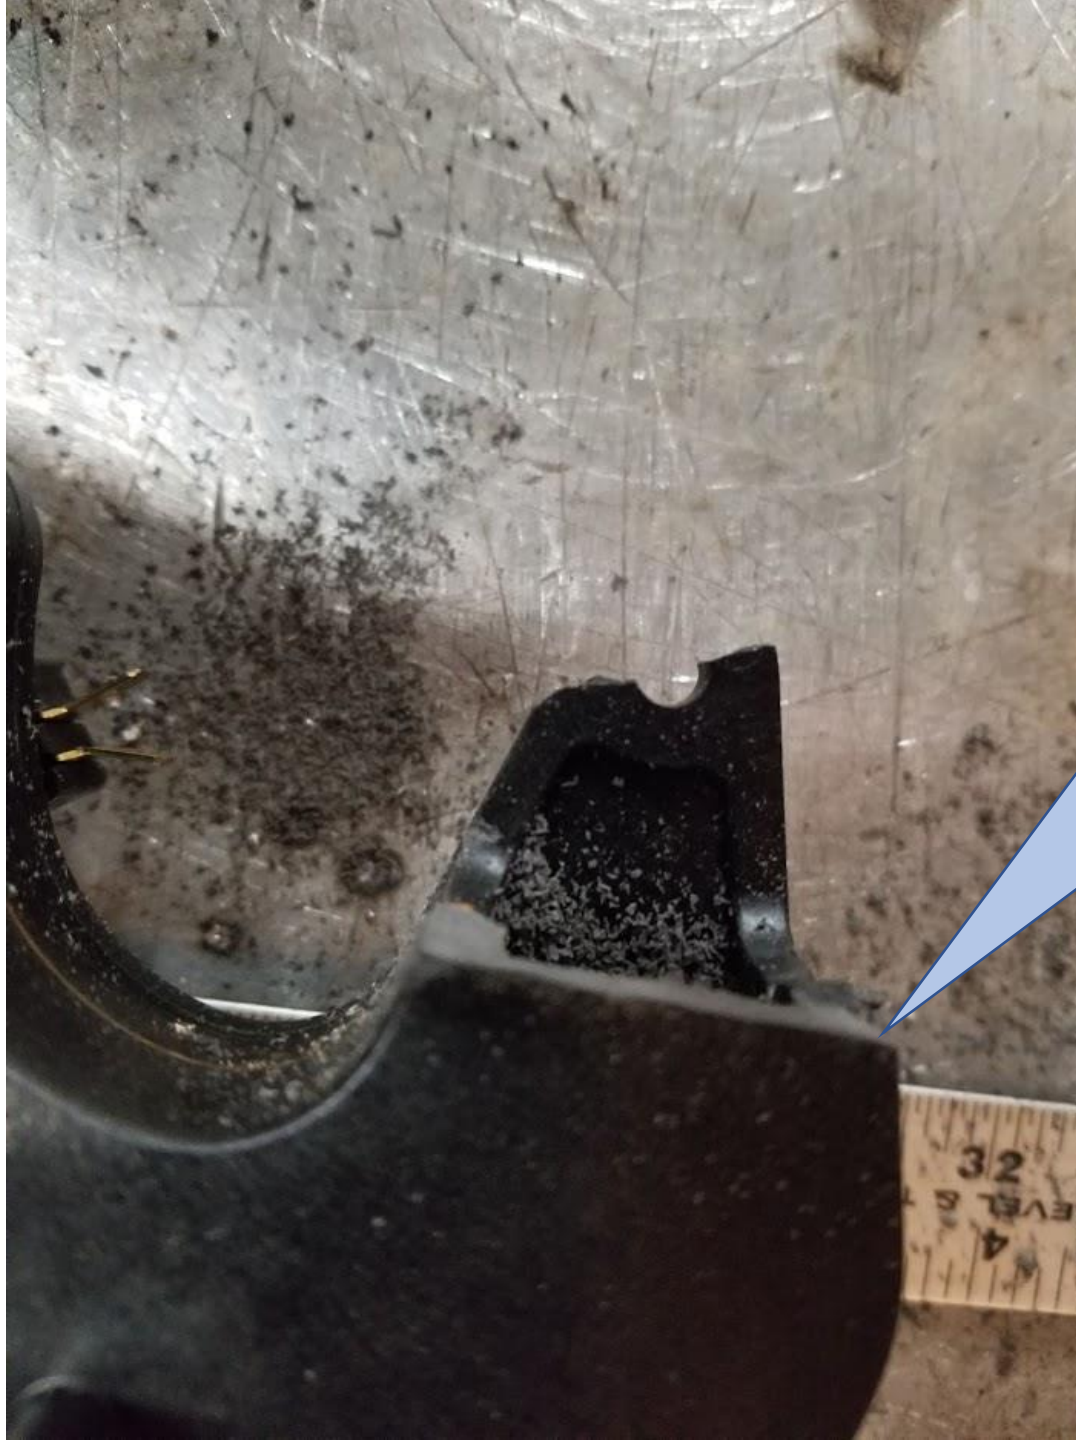
The ear on this side had to be removed to allow proper positioning of the motor. Part of the modified (welded) aluminum plate occupies this space. Exercise care to cut off the correct ear. After cutting, it may be necessary to taper off the cut in order for the modified ear to fit.

Rear tab on this mount is the one that is broken – obvious in this photo.

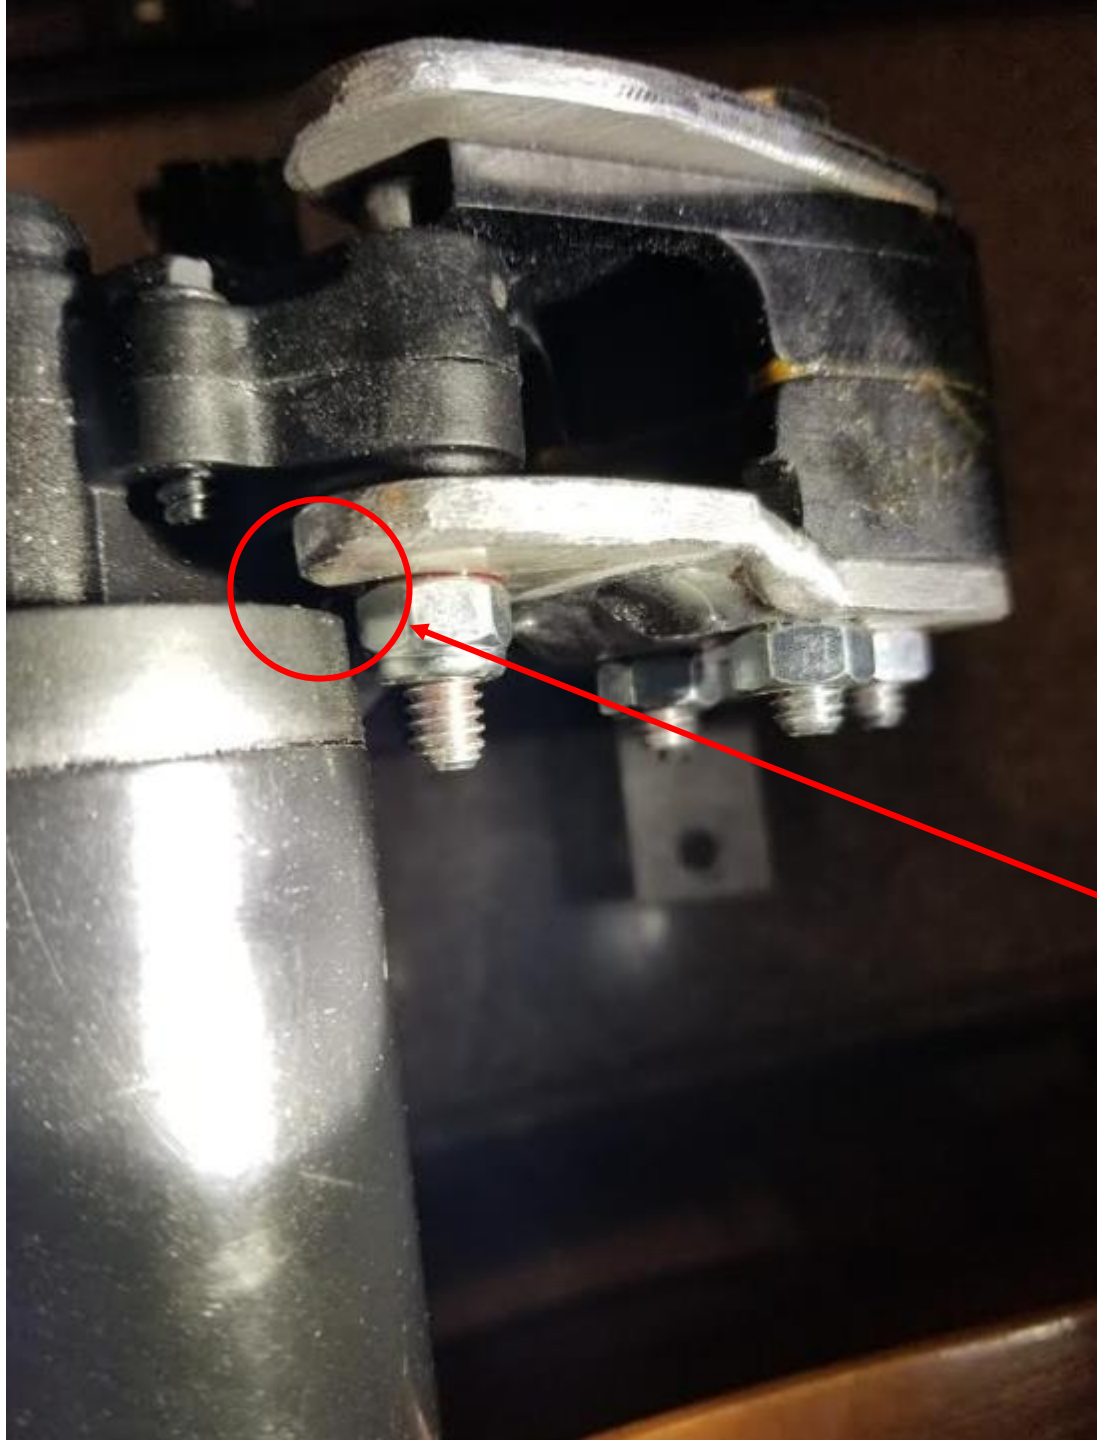
Notice how close the motor fits to the ear. This is the reason Kerry had to cut and weld one of the replacement aluminum mounts. There is only enough room on the motor side for a 1/4" thick ear. The other side doesn't matter.
