Repair of Broken Full-Wall Slide Lock Motor Mount

Rick Blaher

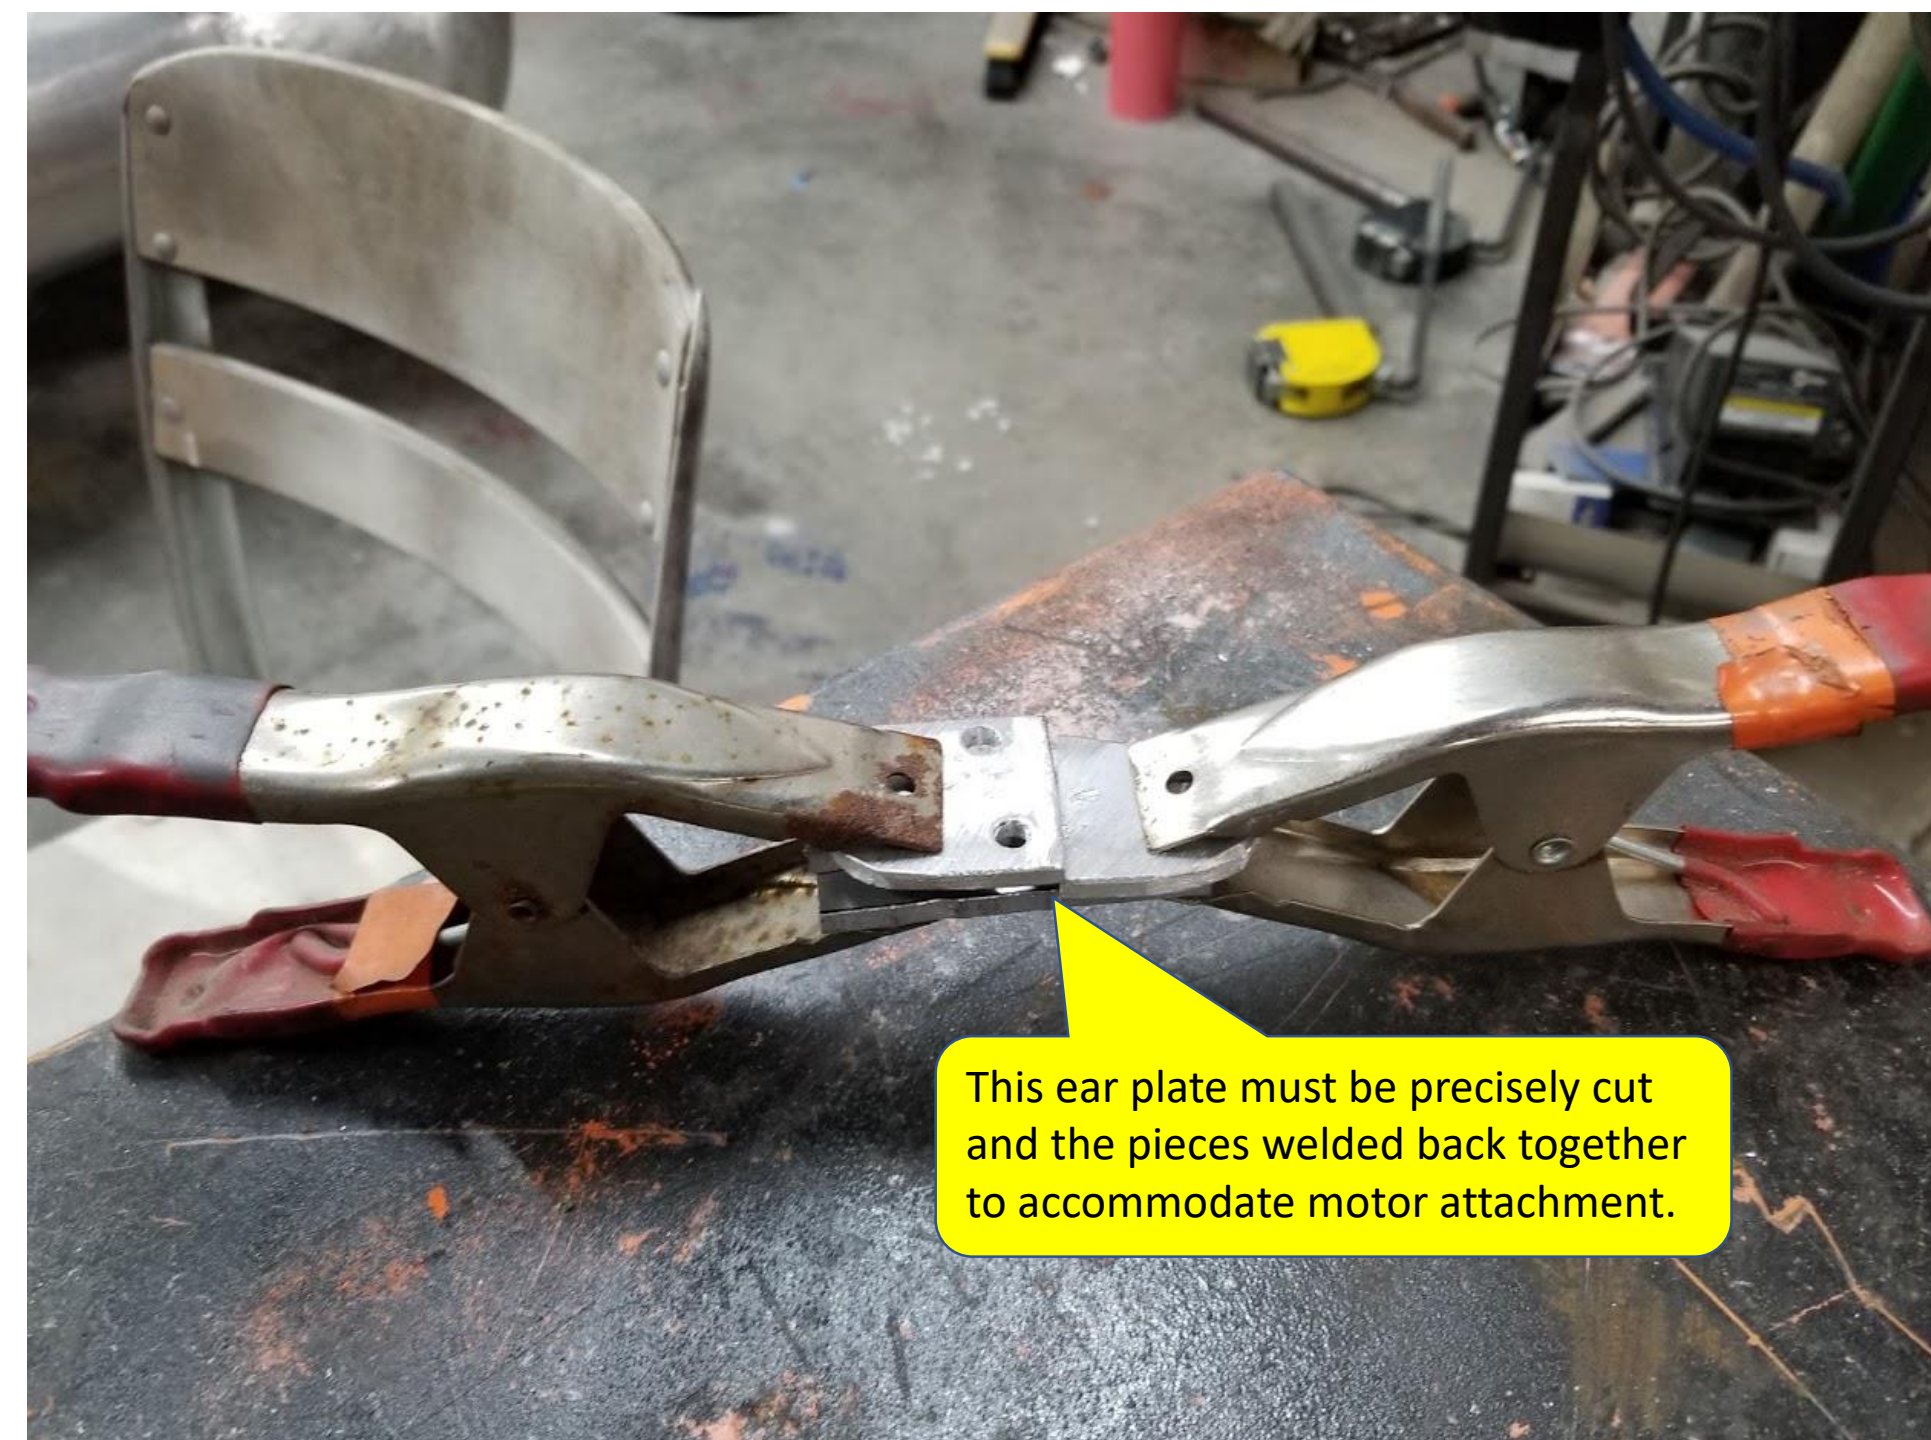
This ear plate must be precisely cut and the pieces welded back together to accommodate motor attachment.

Make sure you cut the tab in the correct place to go inside the cut off plastic ear, AND make sure it is oriented correctly. The ears are NOT reversible and if you do it wrong, the bolt holes won't line up or the intended step will go out instead of in.

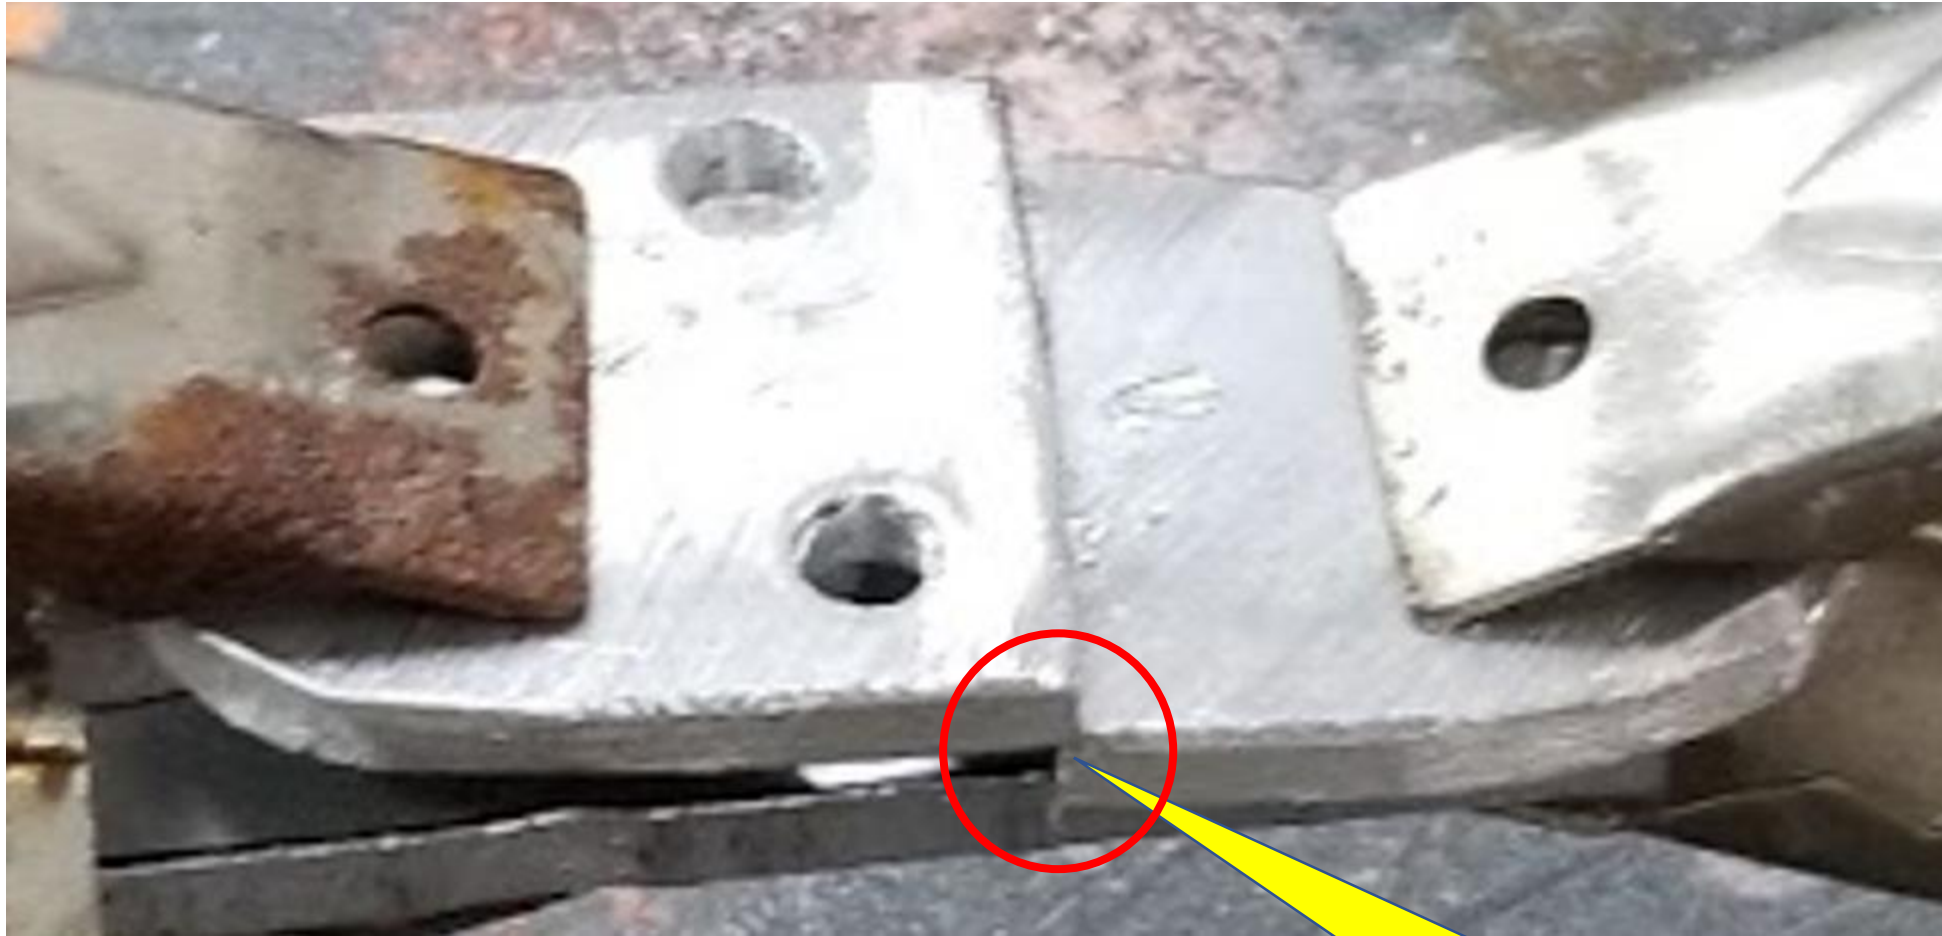
Weld 2 sections of plate here to produce a "step." Kerry welded the two pieces of aluminum together with a TIG welder.

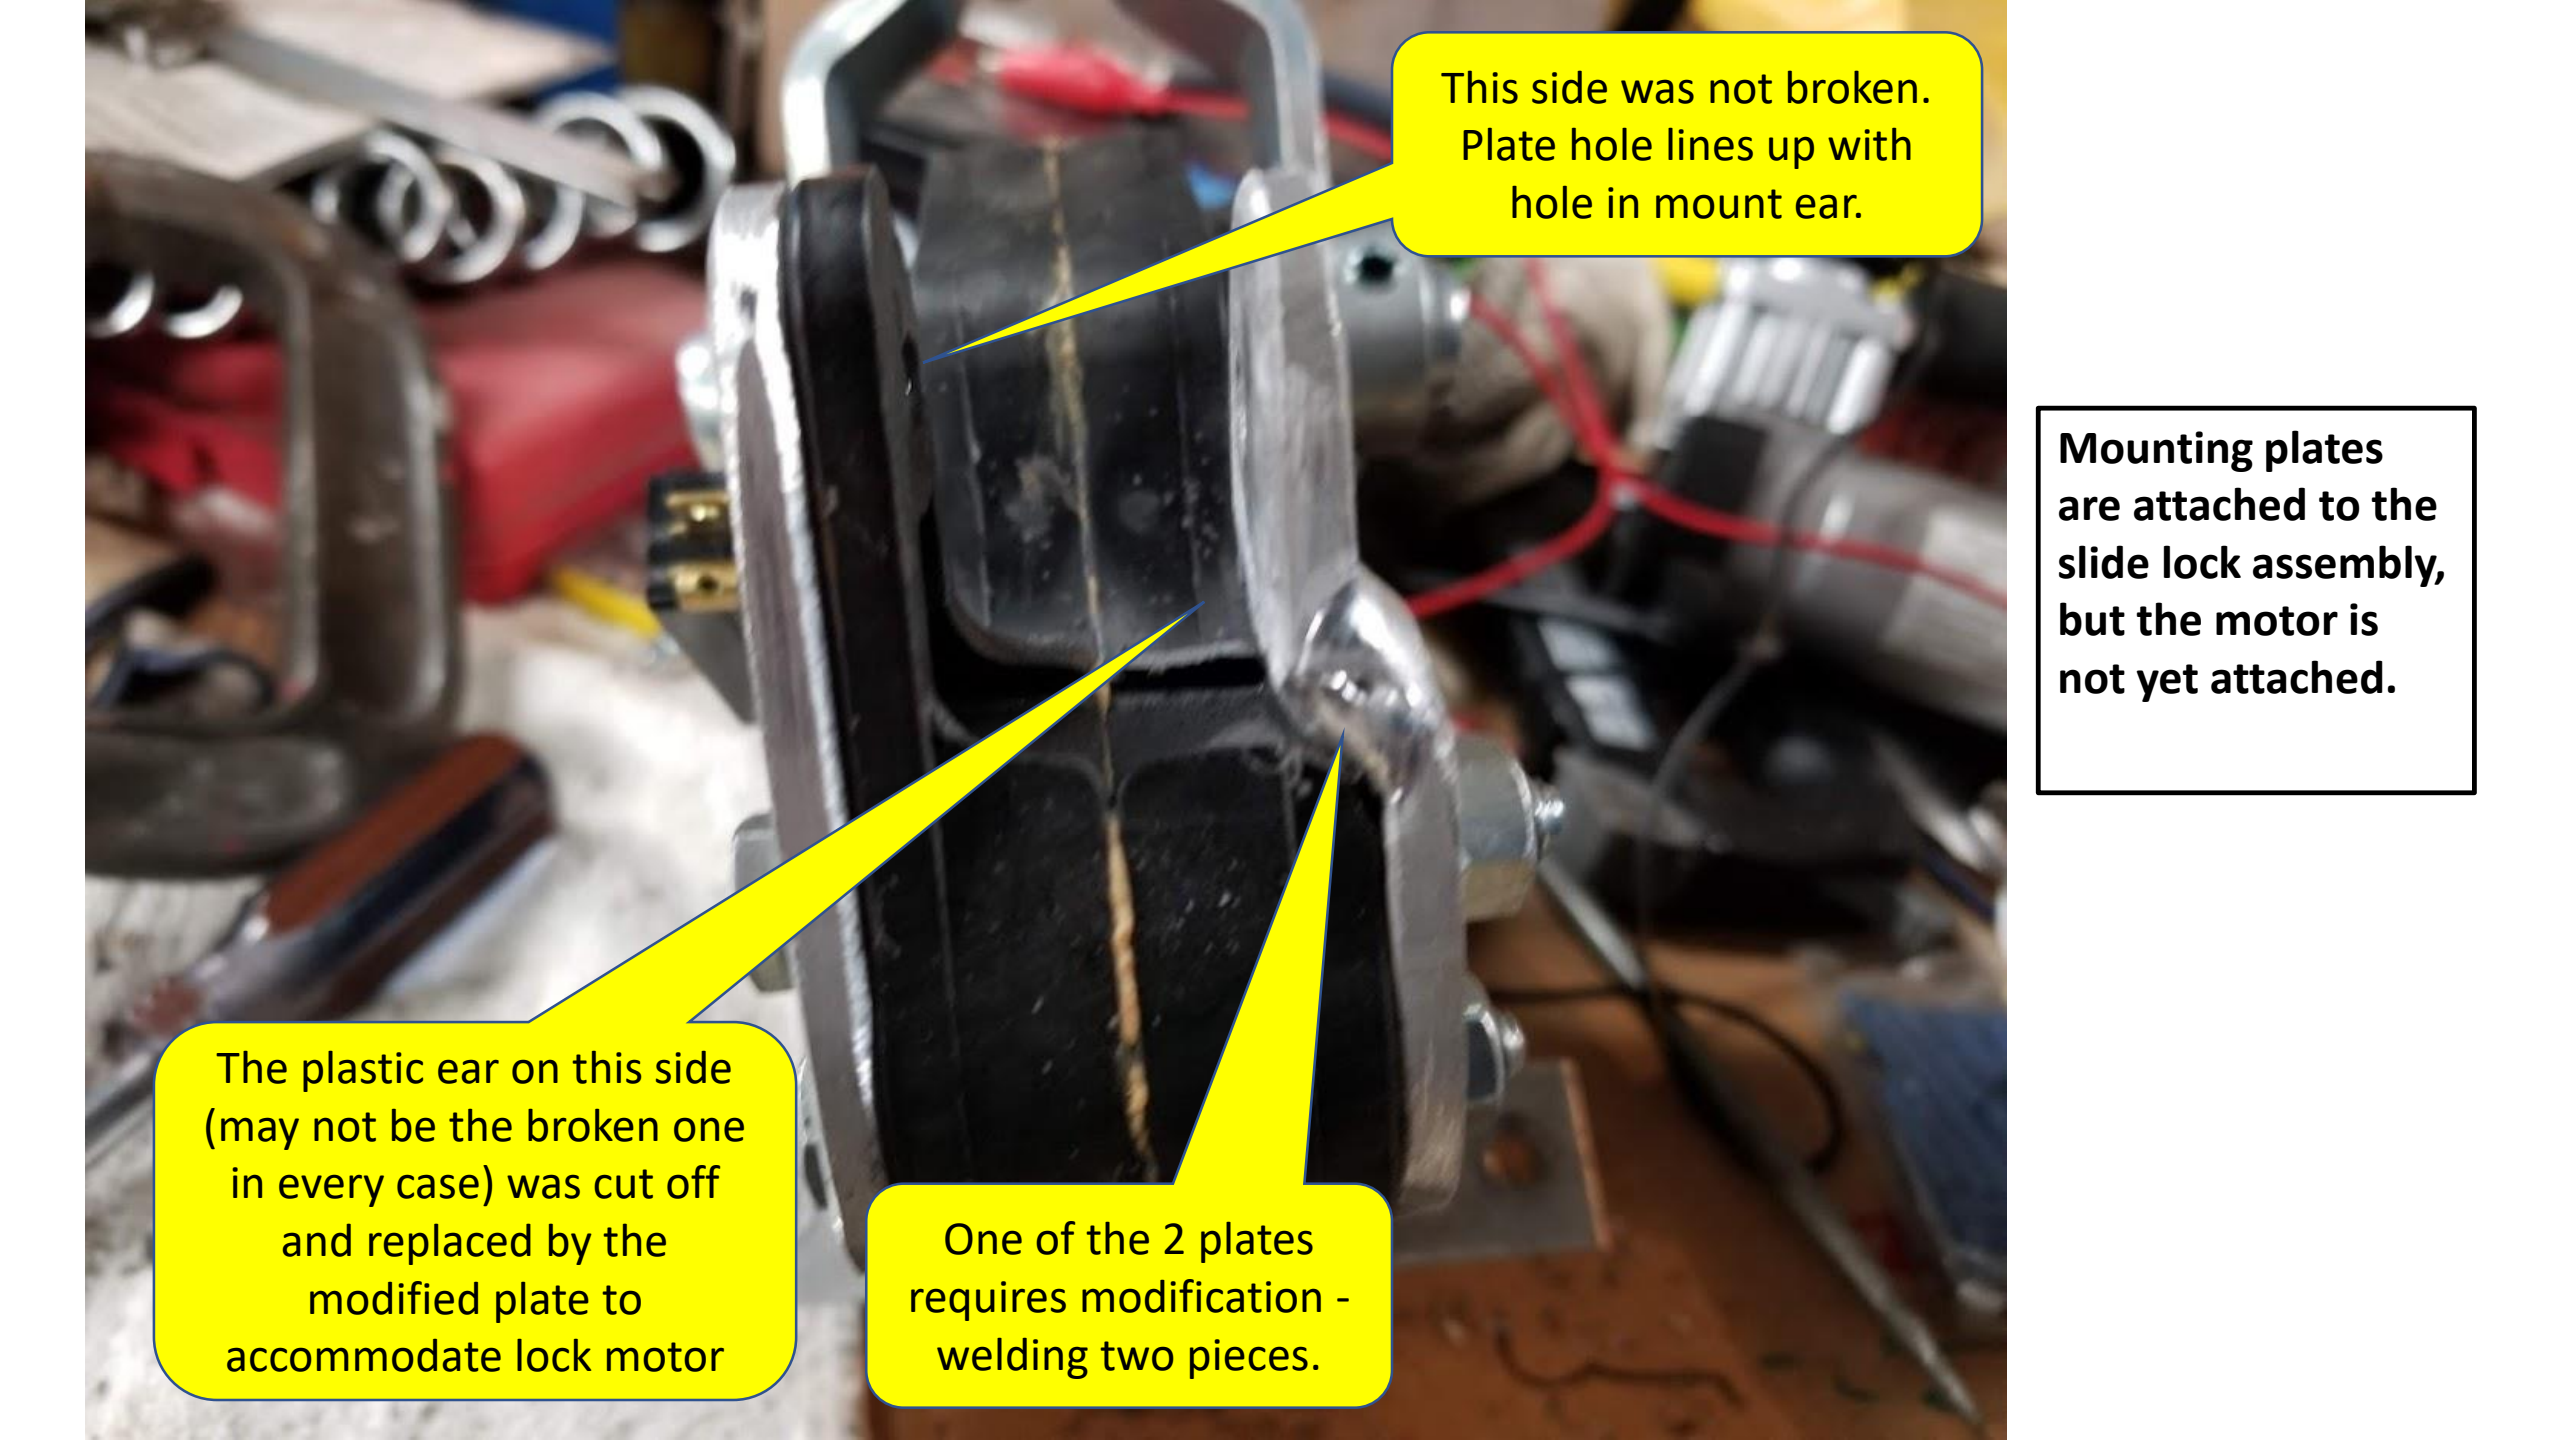
This side was not broken.
Plate hole lines up with
hole in mount ear.

**Mounting plates
are attached to the
slide lock assembly,
but the motor is
not yet attached.**

The plastic ear on this side
(may not be the broken one
in every case) was cut off
and replaced by the
modified plate to
accommodate lock motor

One of the 2 plates
requires modification -
welding two pieces.

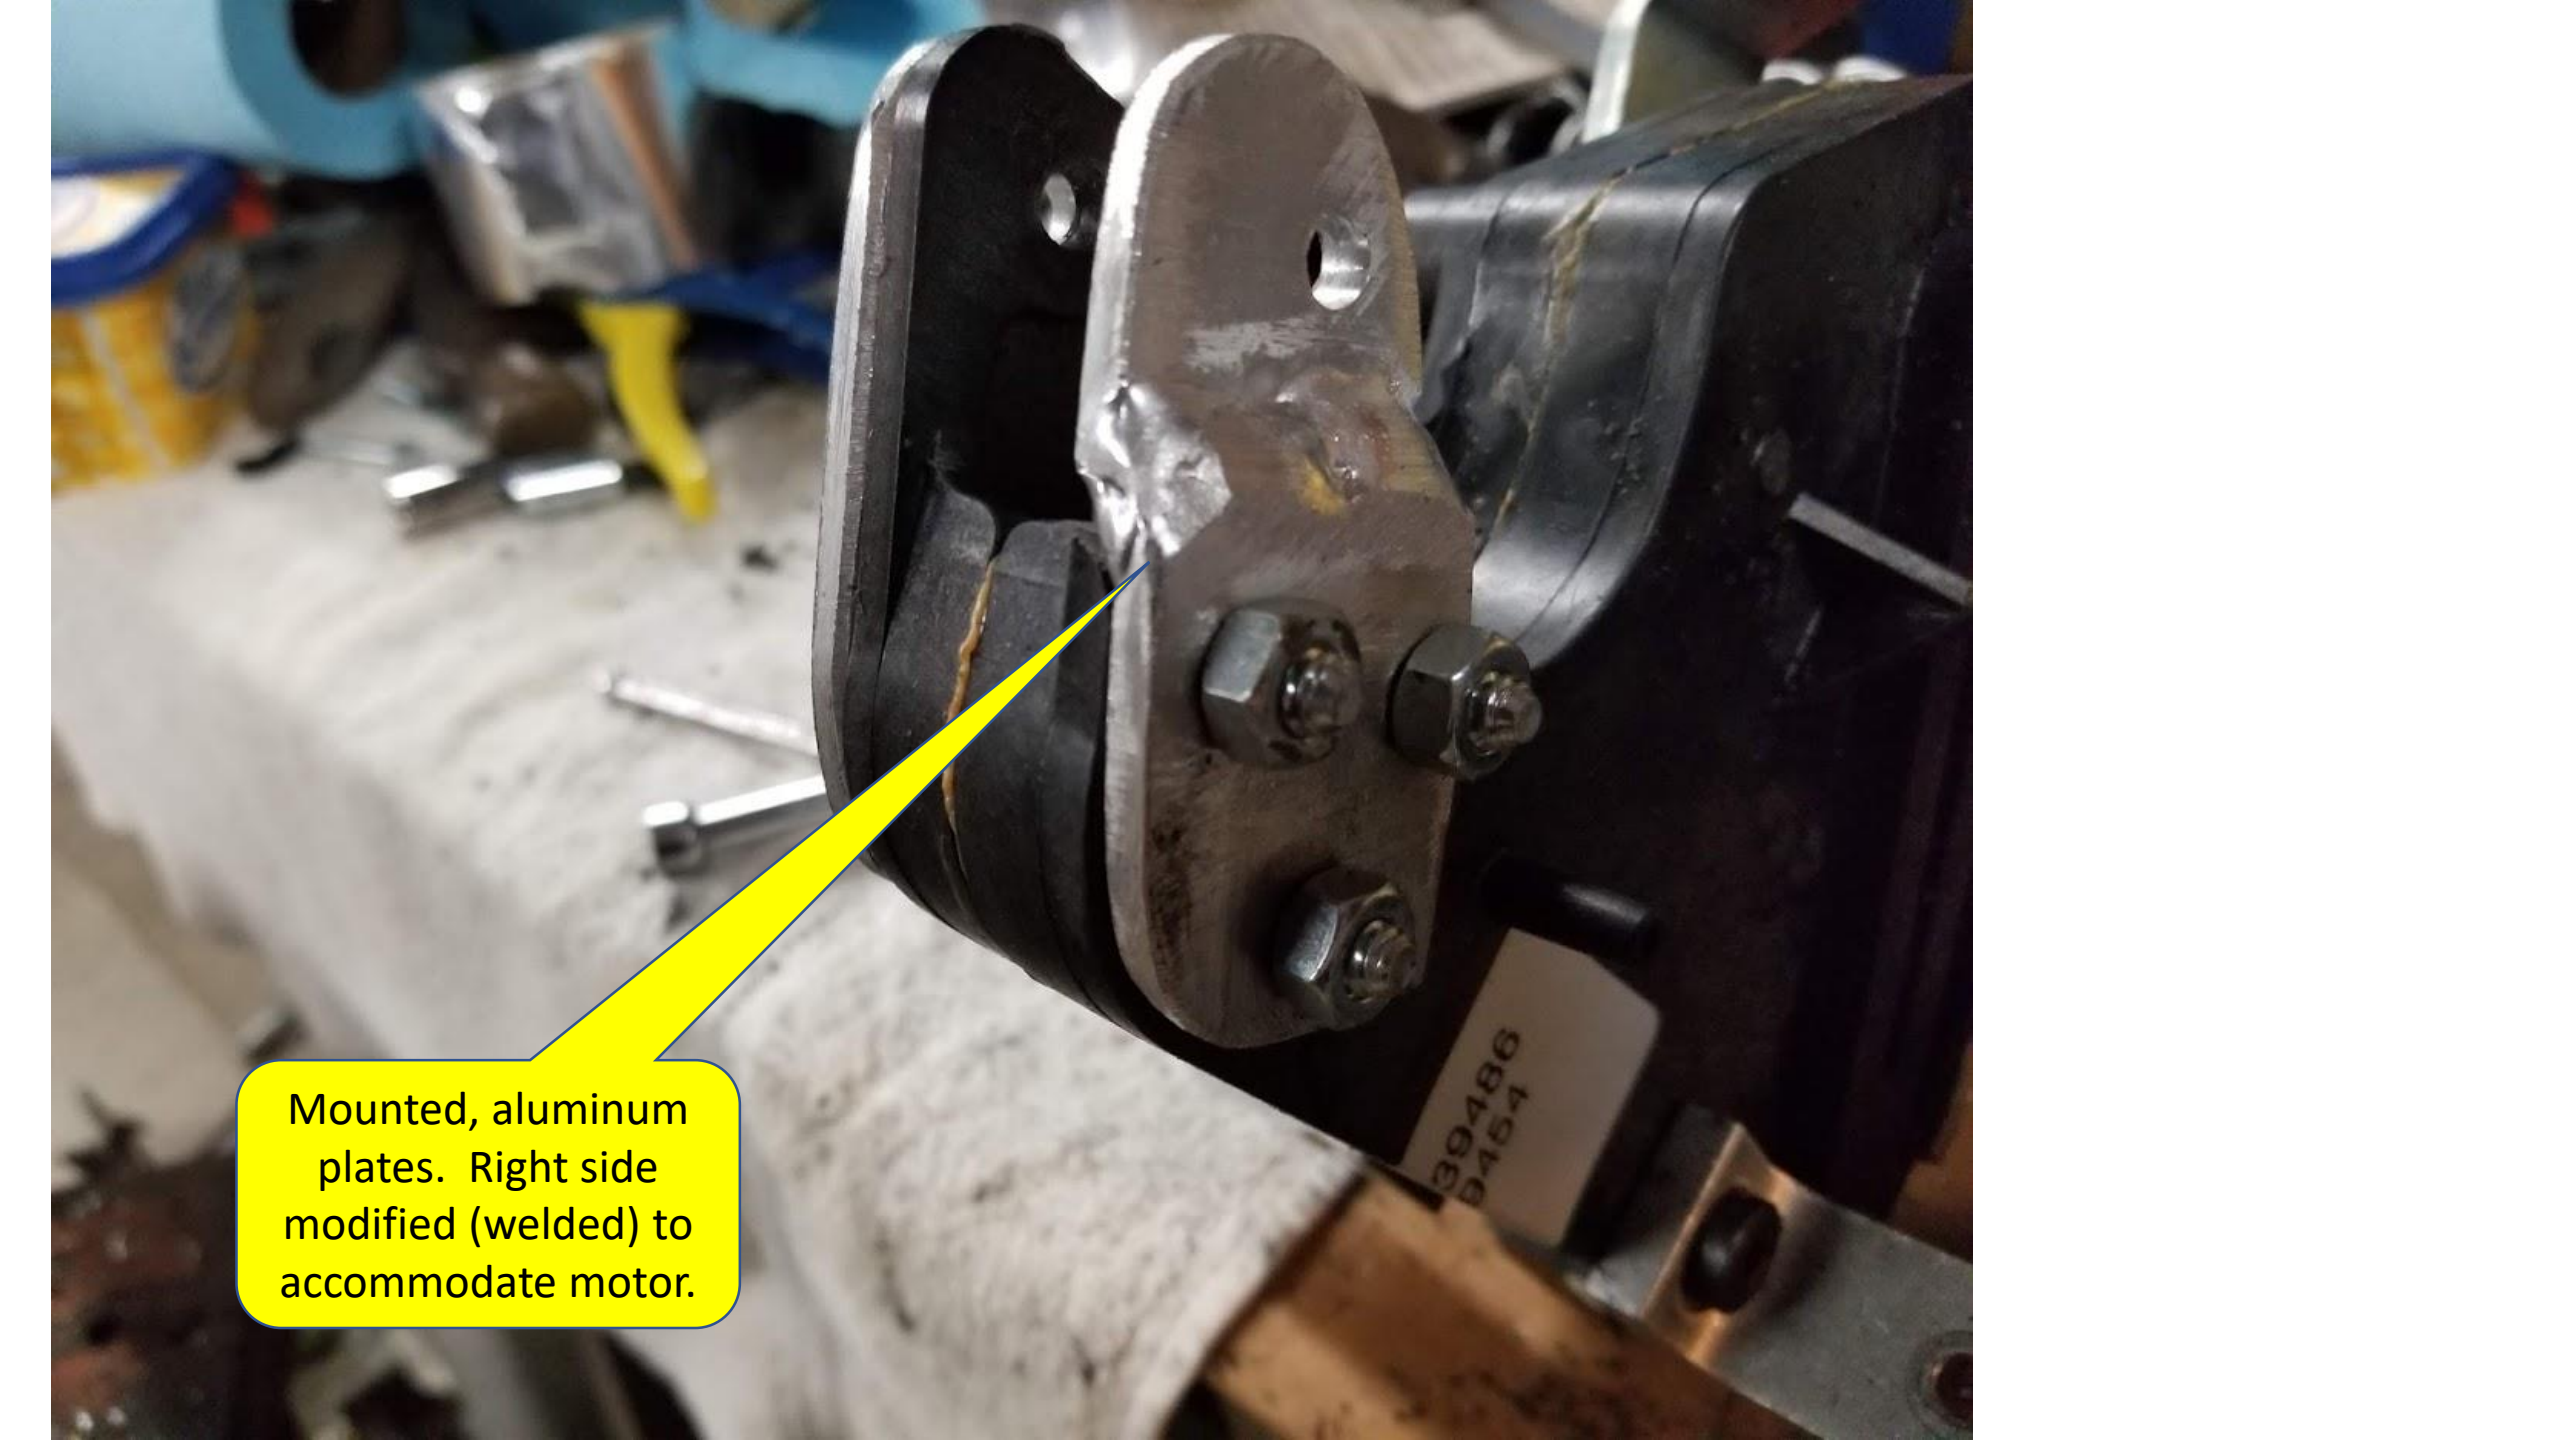
Mounted, aluminum plates. Right side modified (welded) to accommodate motor.

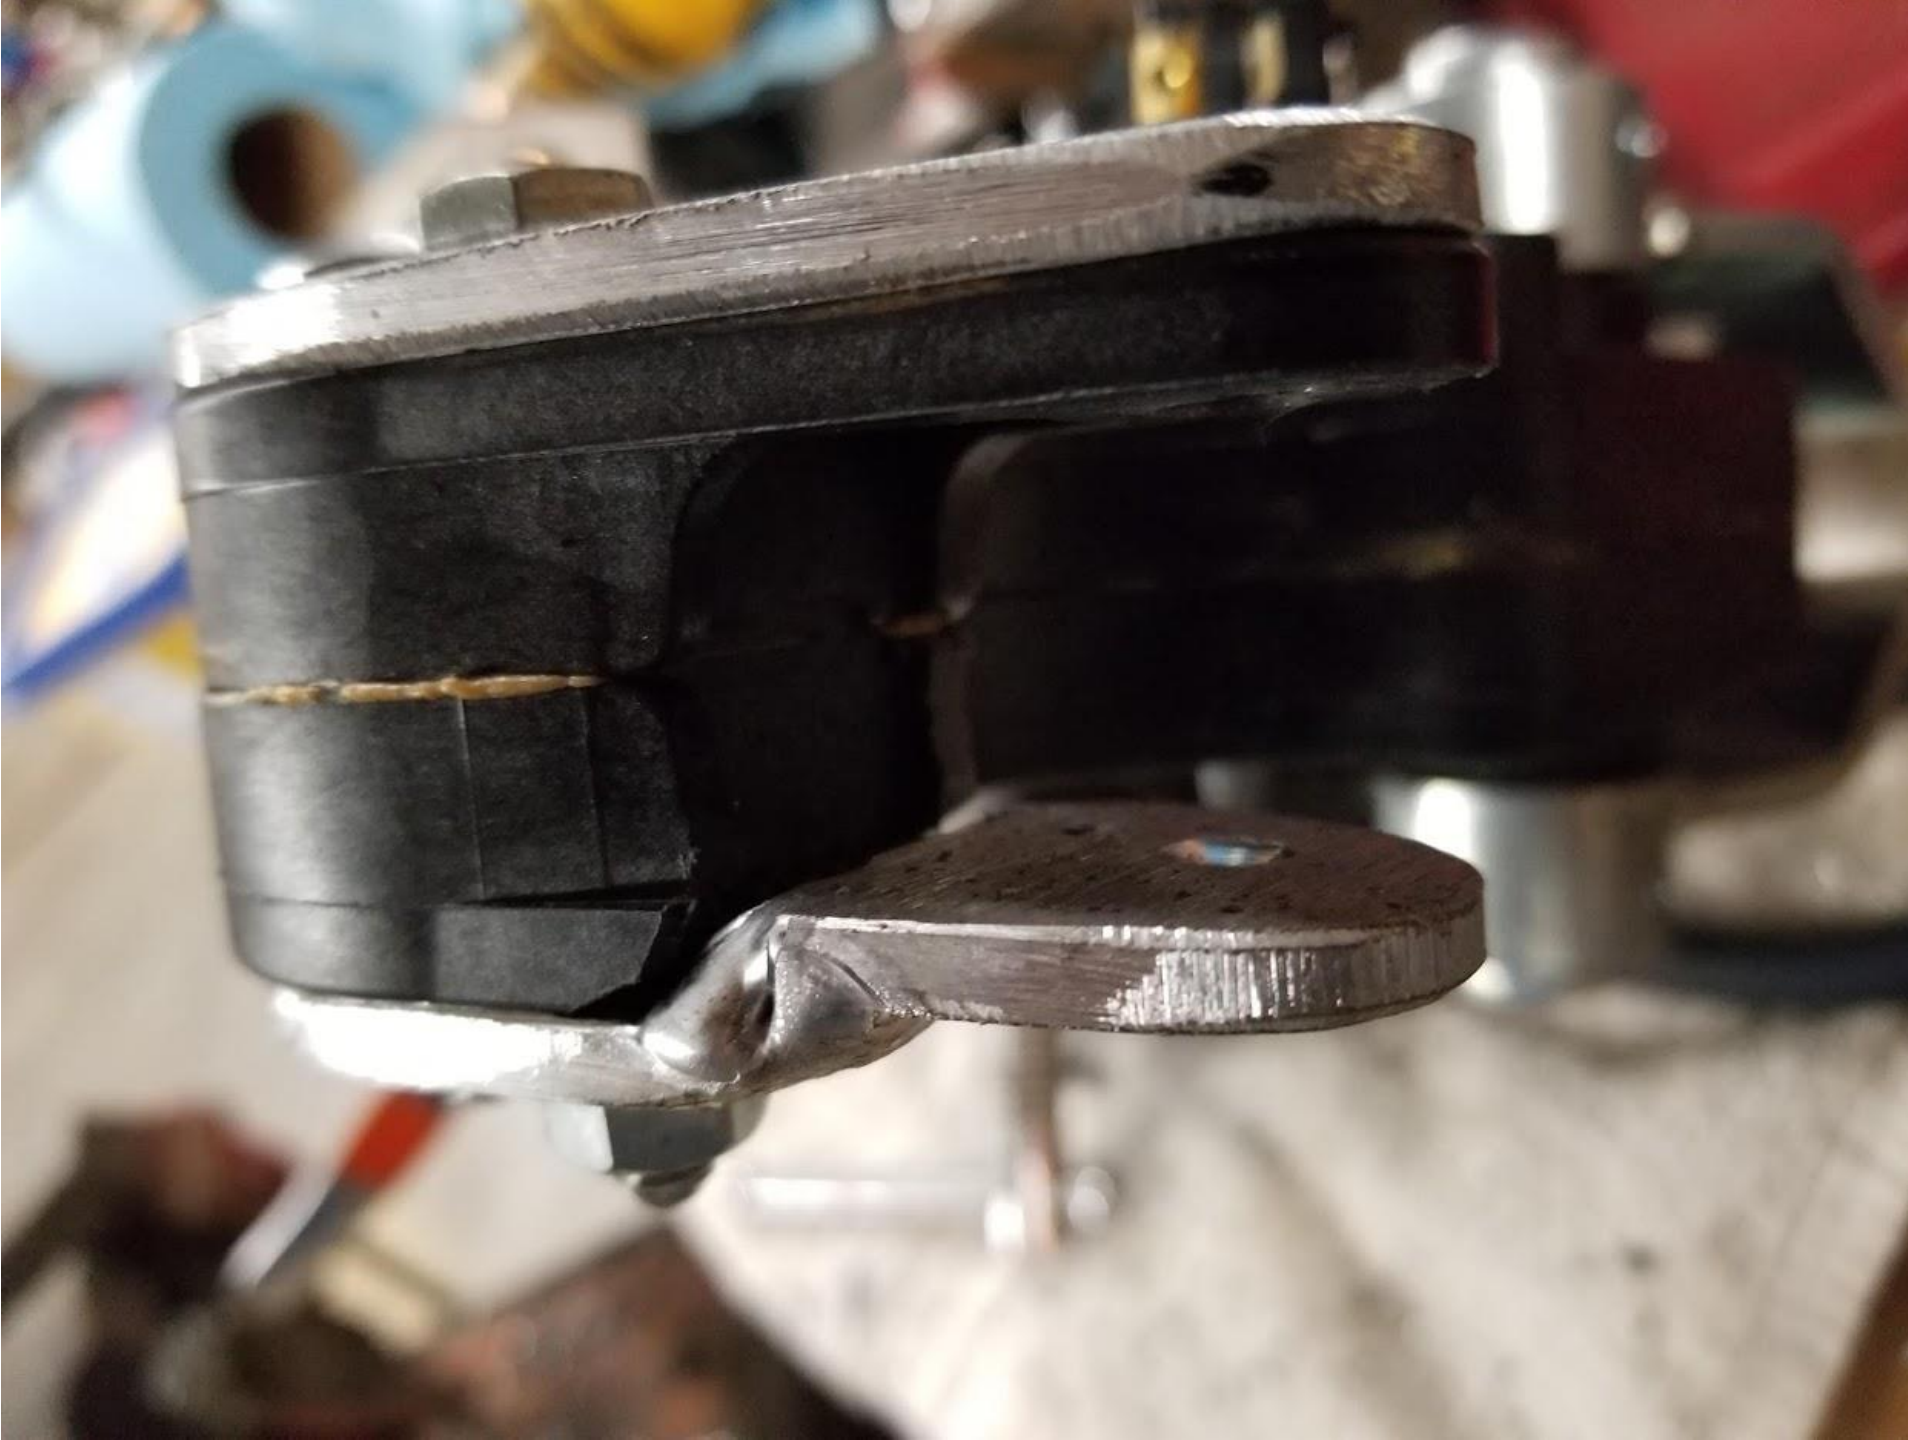
Side view of mounting plates attached to the slide lock assembly. The motor is not yet attached.

Modification of the bottom plate is clearly visible.

Also clearly visible, is the removed bottom plastic ear and the still existent top ear that, in this case, was not broken. If both ears are broken off, you'll want to put a 1/4" thick spacer (the broken ear will be fine) to keep the motor from moving around on the pivot bolt

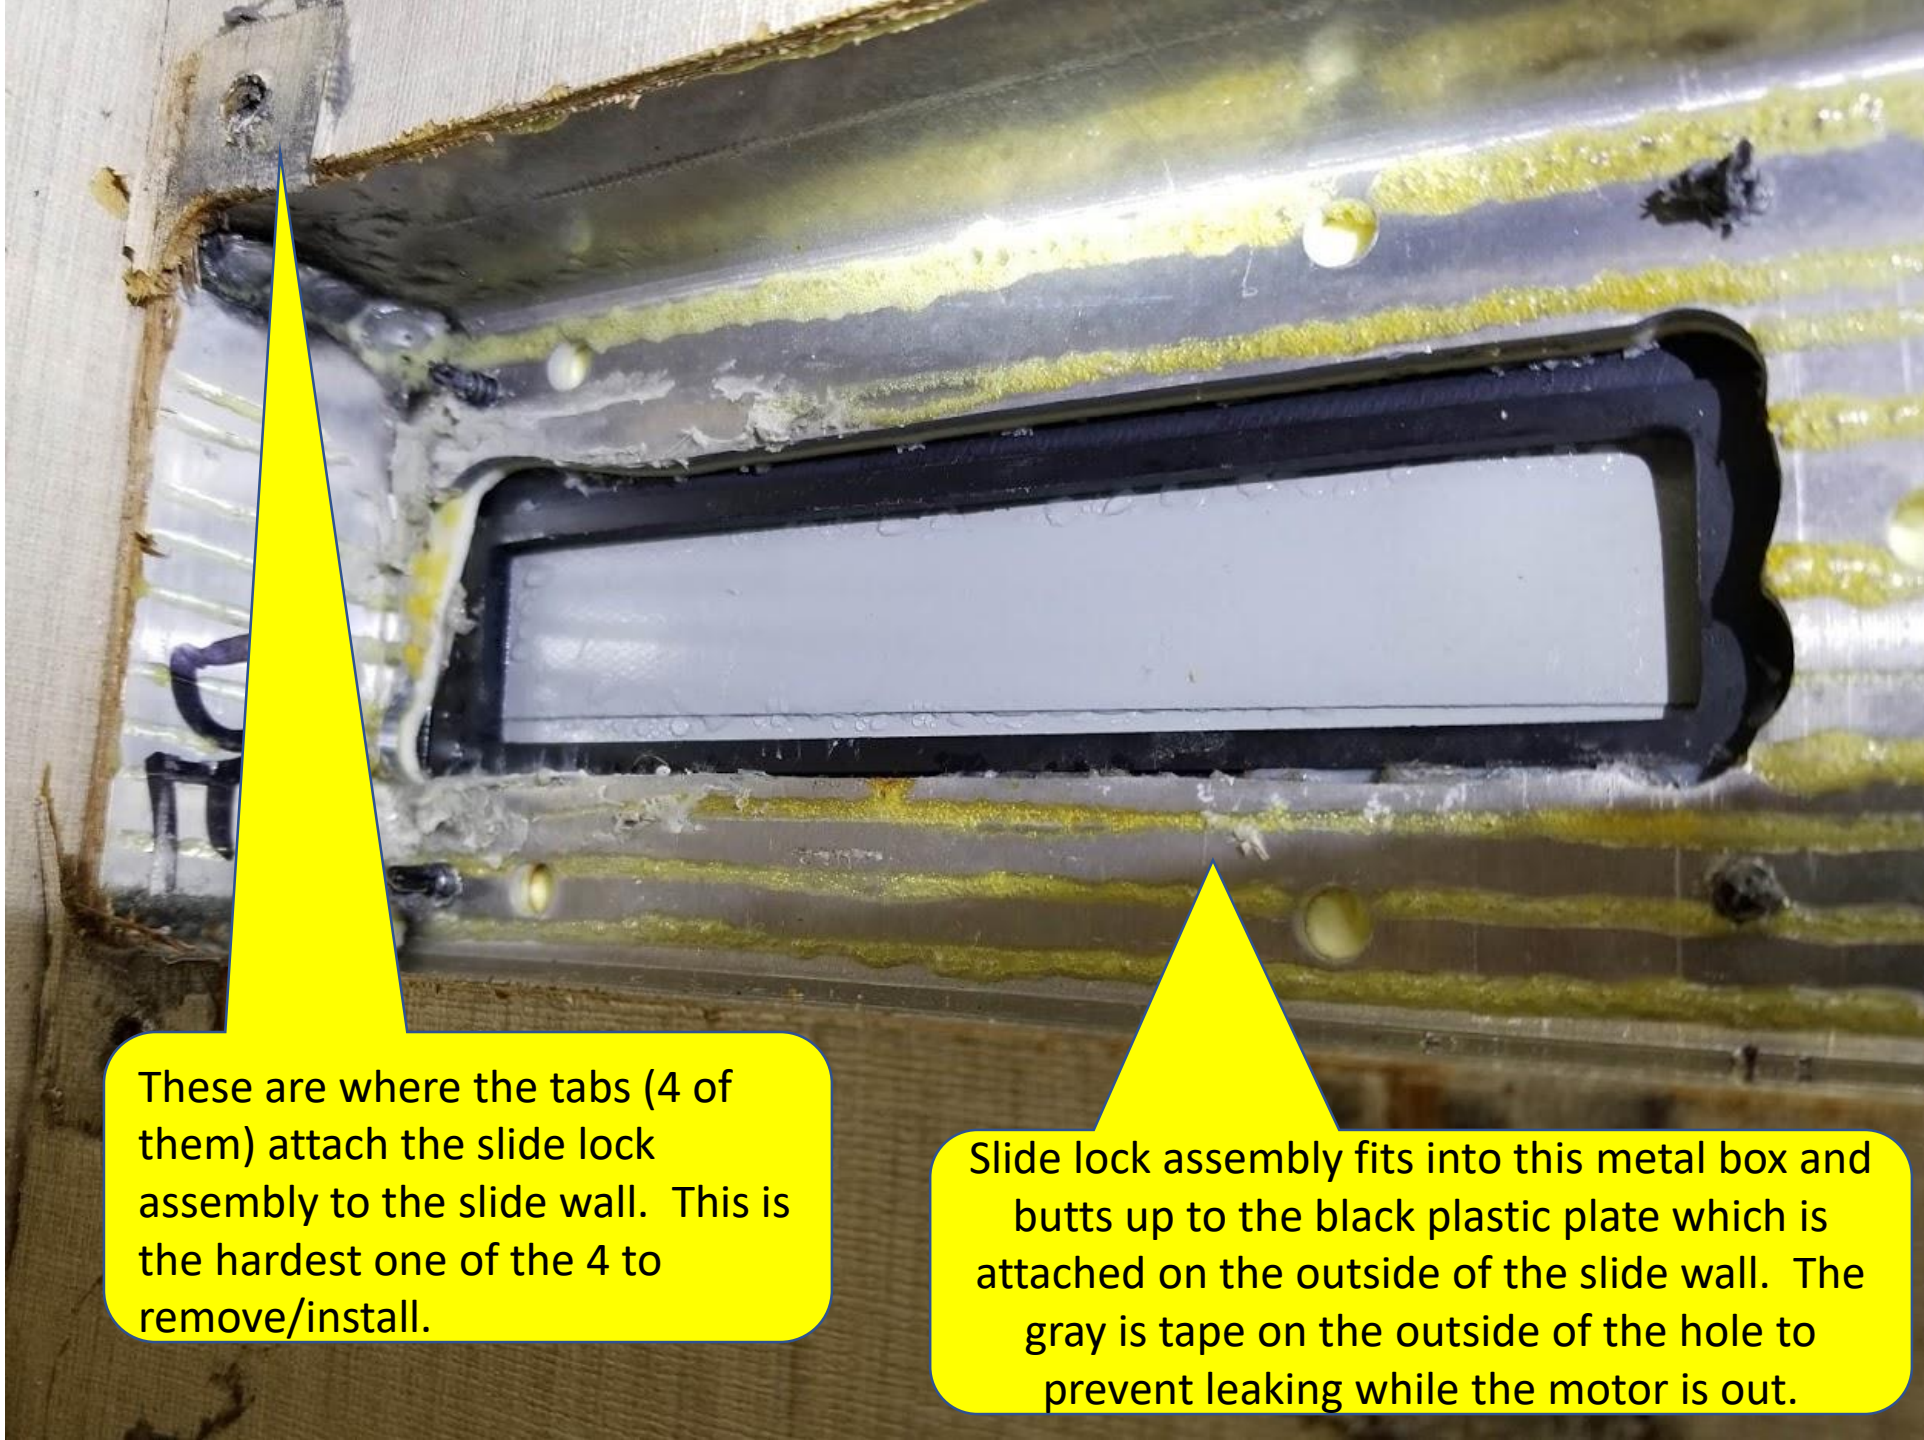
These are where the tabs (4 of them) attach the slide lock assembly to the slide wall. This is the hardest one of the 4 to remove/install.

Slide lock assembly fits into this metal box and butts up to the black plastic plate which is attached on the outside of the slide wall. The gray is tape on the outside of the hole to prevent leaking while the motor is out.

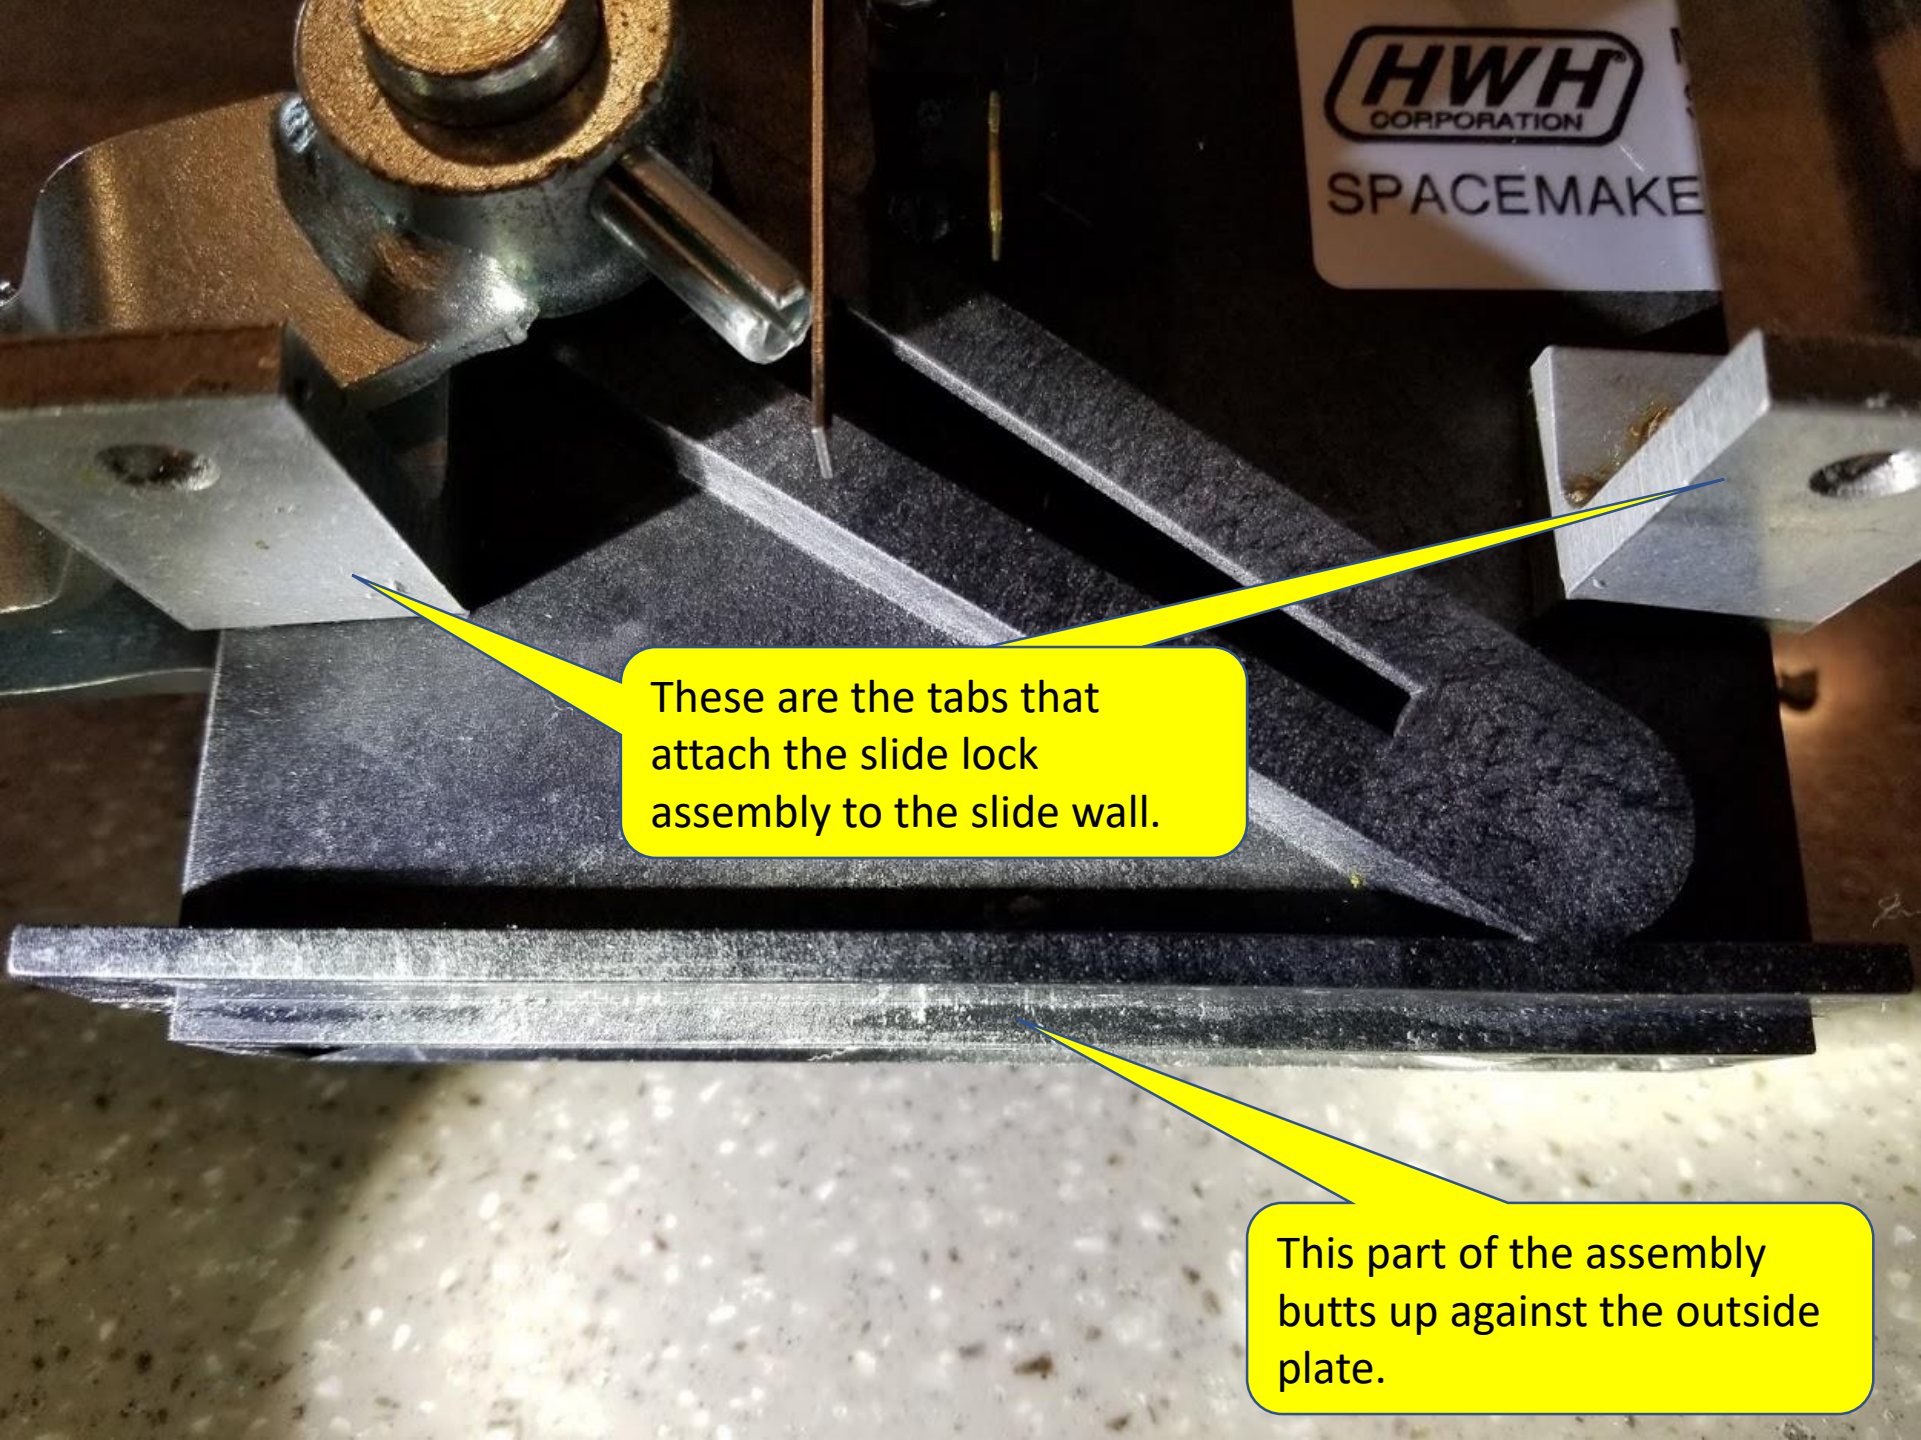
These are the tabs that attach the slide lock assembly to the slide wall.

This part of the assembly butts up against the outside plate.
