Repair of Broken Full-Wall Slide Lock Motor Mount

Rick Blaher

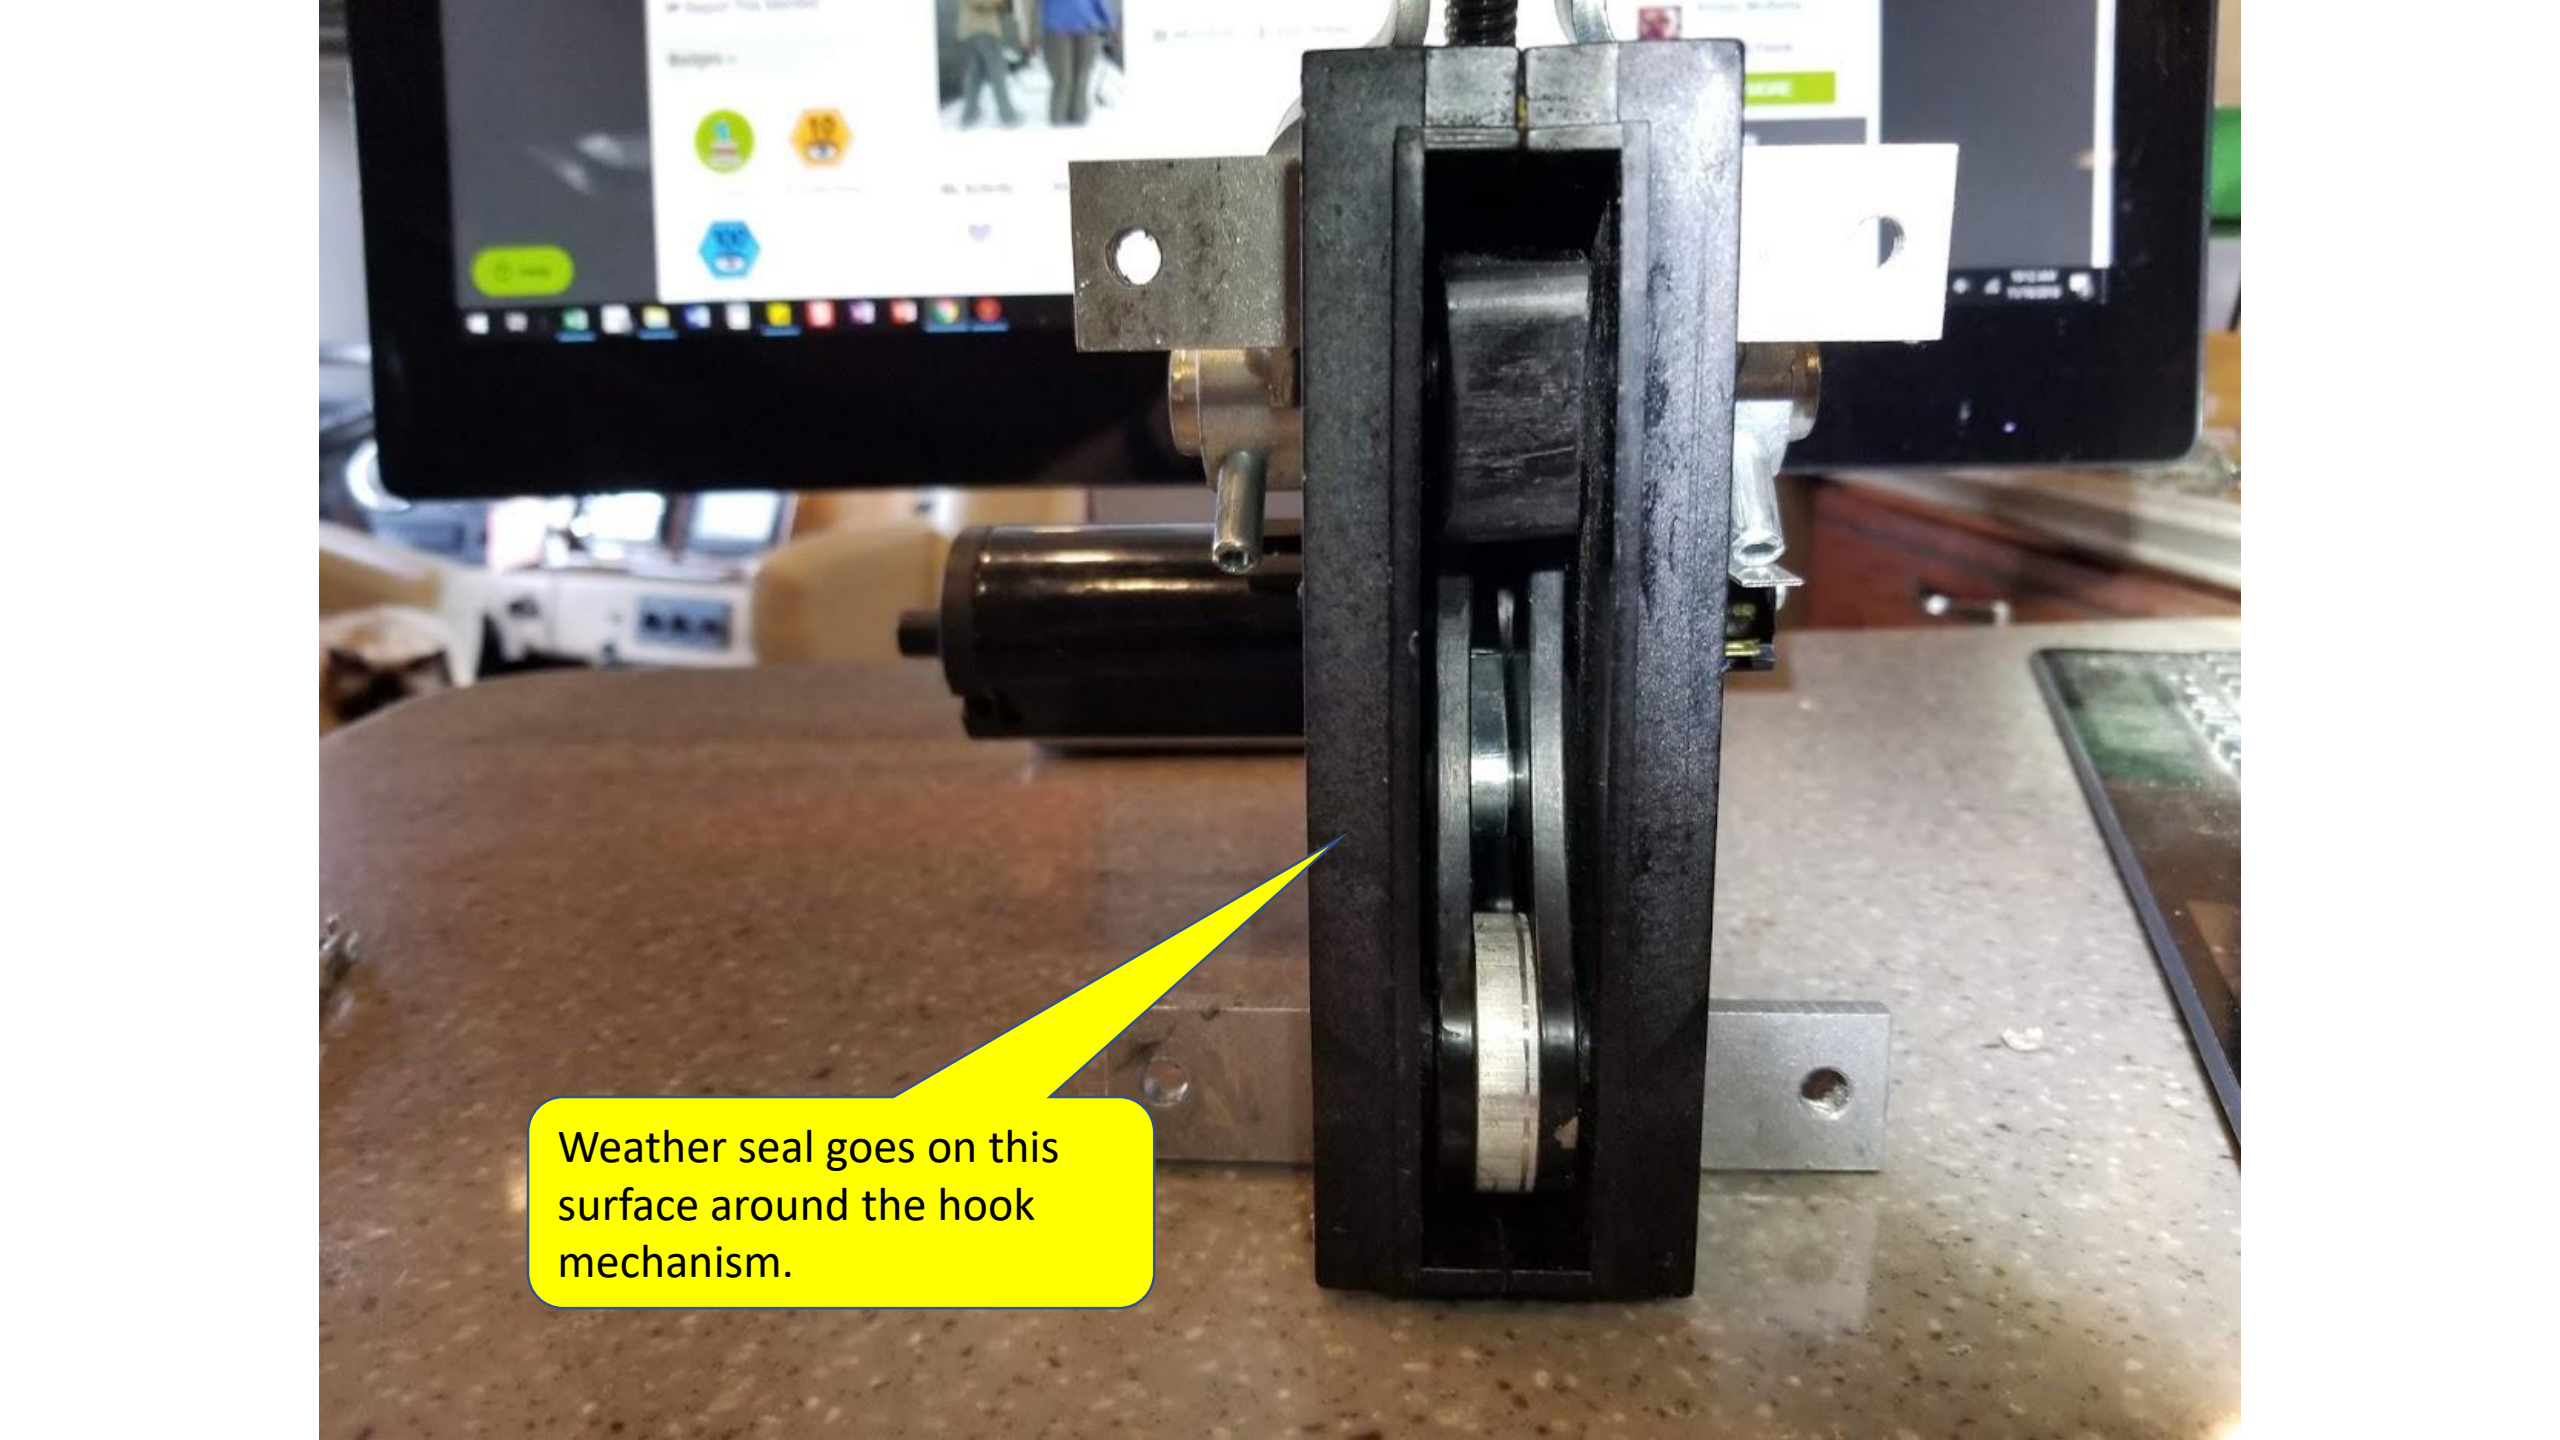
Weather seal goes on this surface around the hook mechanism.

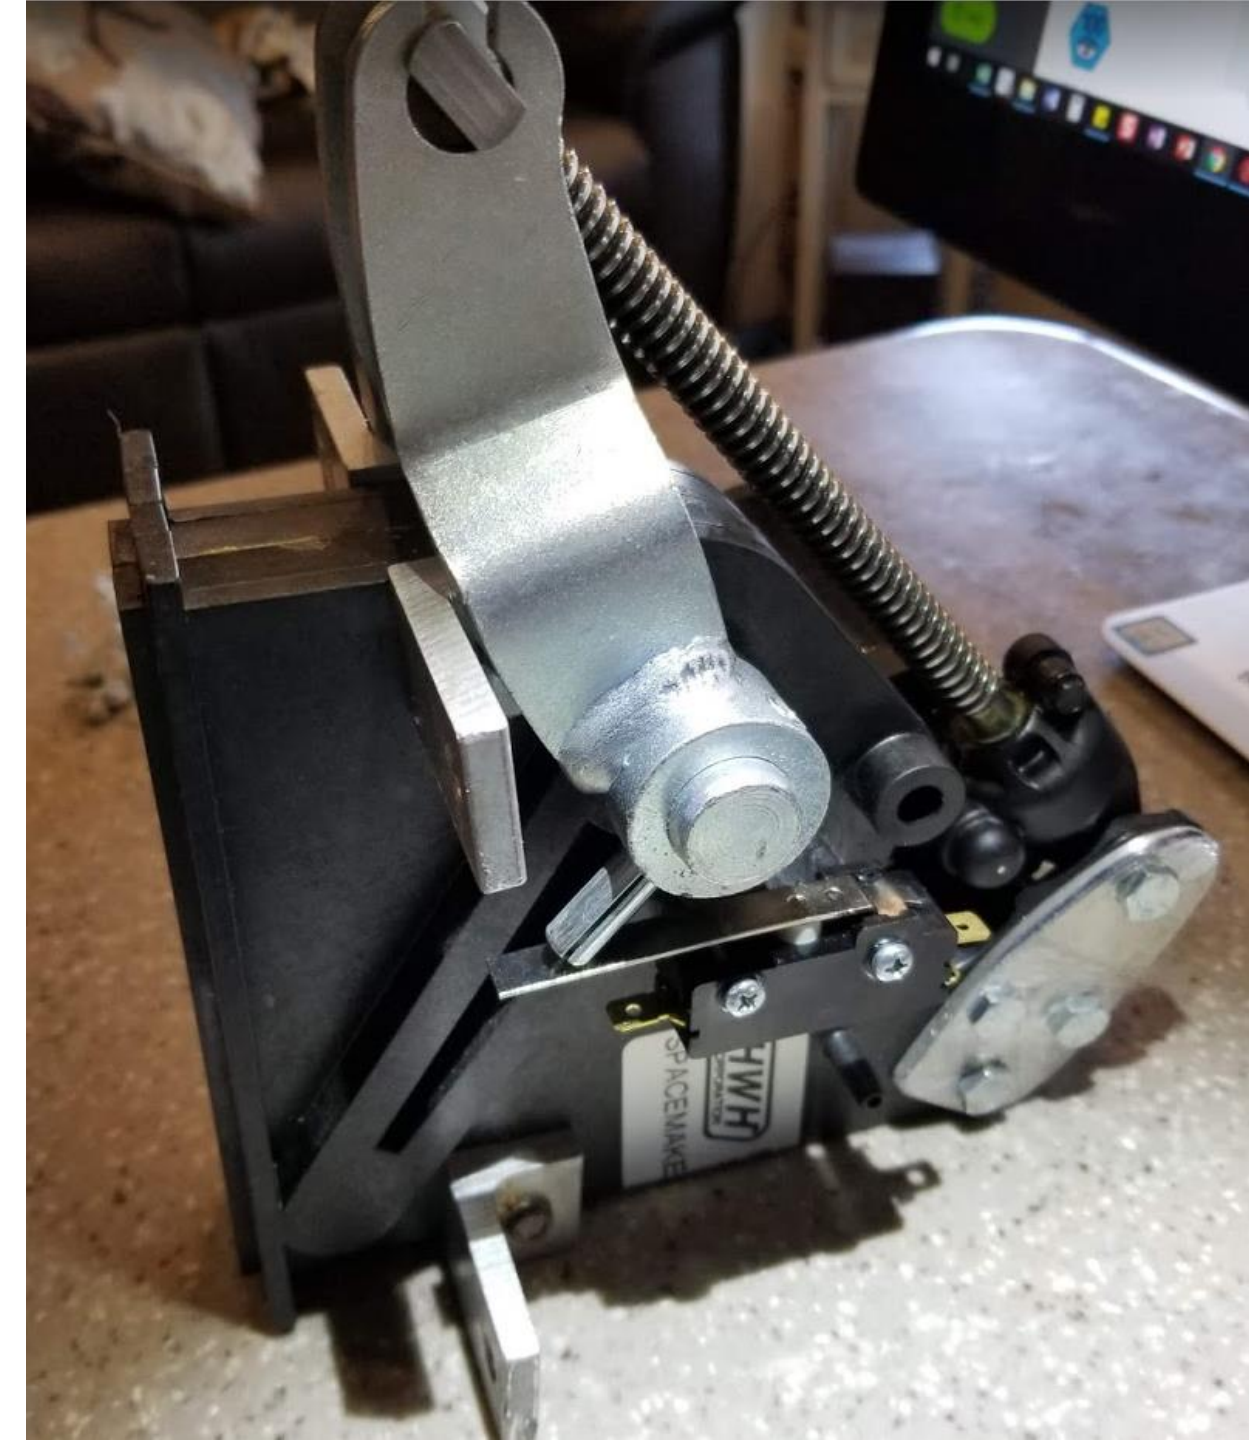
Completed assembly with motor attached. Ready to be installed. 'The original ears are just unsupported plastic tabs with a single bolt going through them. The repaired aluminum ears mount into the plastic housing with THREE bolts clamped through a SUPPORTED plastic box. It is MANY times stronger than the original design. However, if the slide lock motor continues to push against side of the coach, considerable force will be applied to the motor mount. If whatever mechanism causes the red light to display indicating the locks are fully deployed is not calibrated correctly, it is conceivable (but doubtful) that this too can fail.
