These are the simple steps to replace a broken latch plunger in a 2003 Discovery 39S. The steps are applicable to all Discos with pull rod type latches.

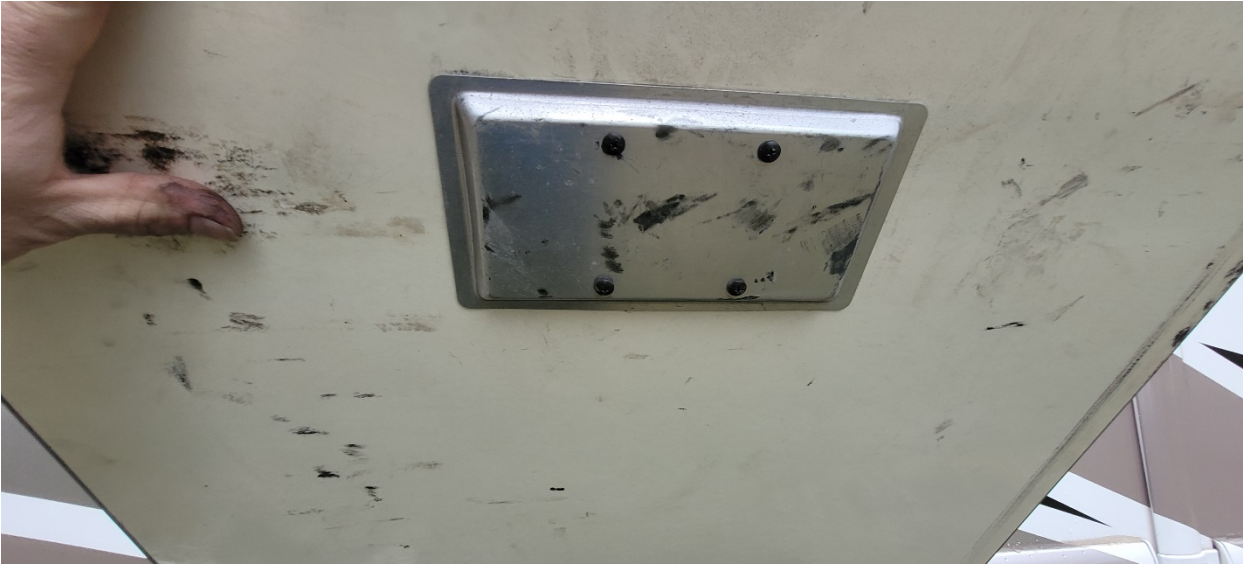
Step 1: Remove the backing plate from the latch mechanism in the middle of the door.

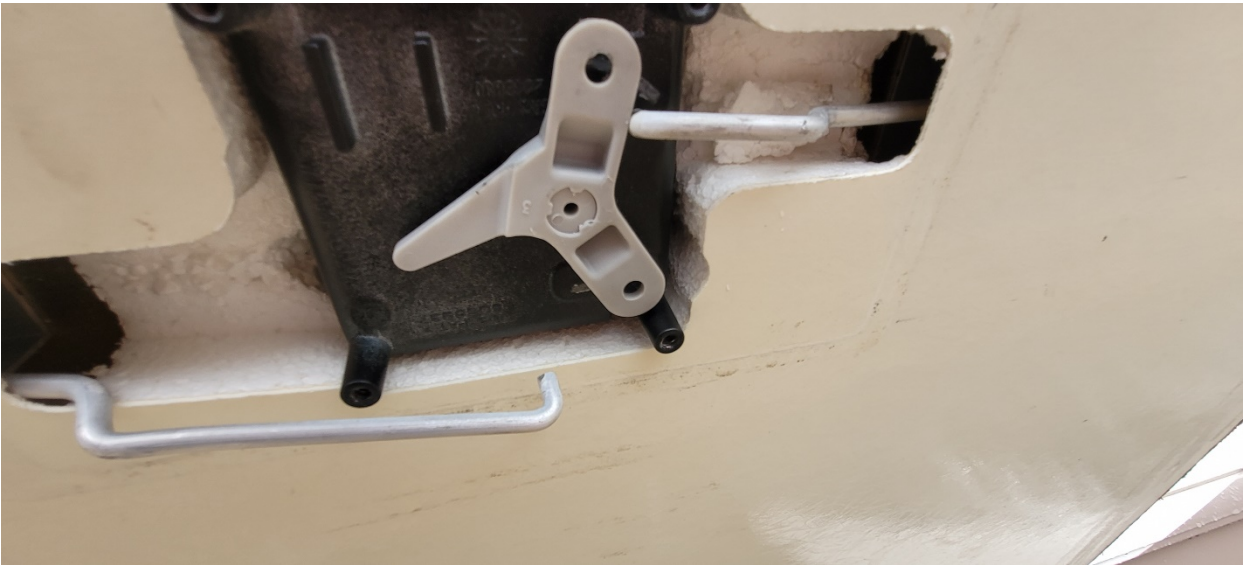
Then remove the latch rods from the paddle lever.

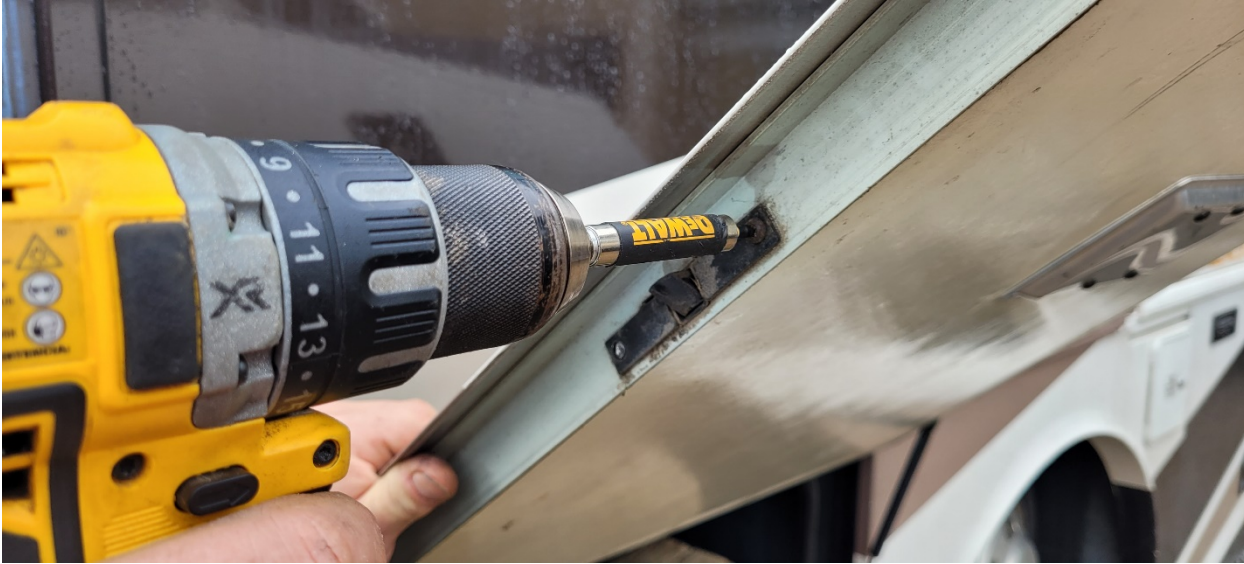
Step 2: Remove the square drive screws from the latch mechanism(some latches are riveted, and some may have a hidden nut in the door, and [improvedrvparts.com](http://improvedrvparts.com) has a great instruction set for those who may need it.)

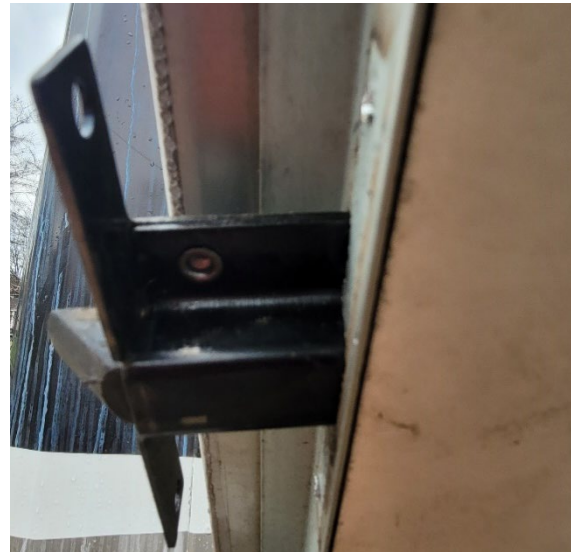
Step 3: Slowly work the unit free from its hole. Some are rather stubborn and may need “convincing”. I had several that needed to be flattened back into shape after wriggling free. Be careful not to let the pull rod get caught as you pull it through.

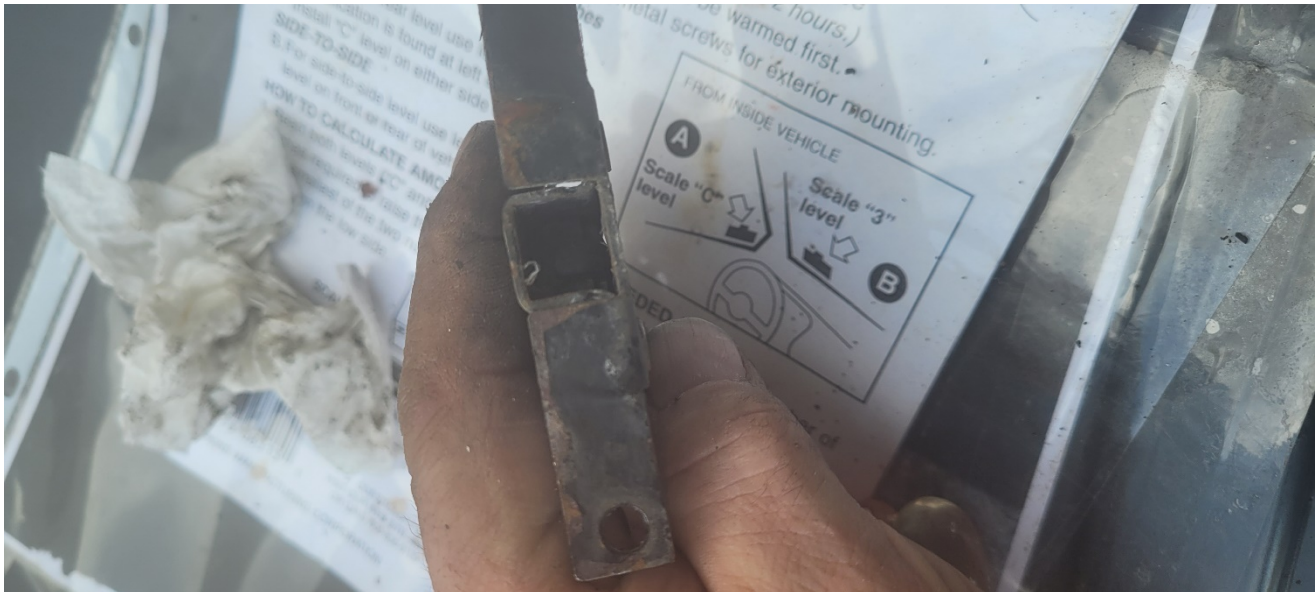
SUCCESS: Note the missing plunger in this one!

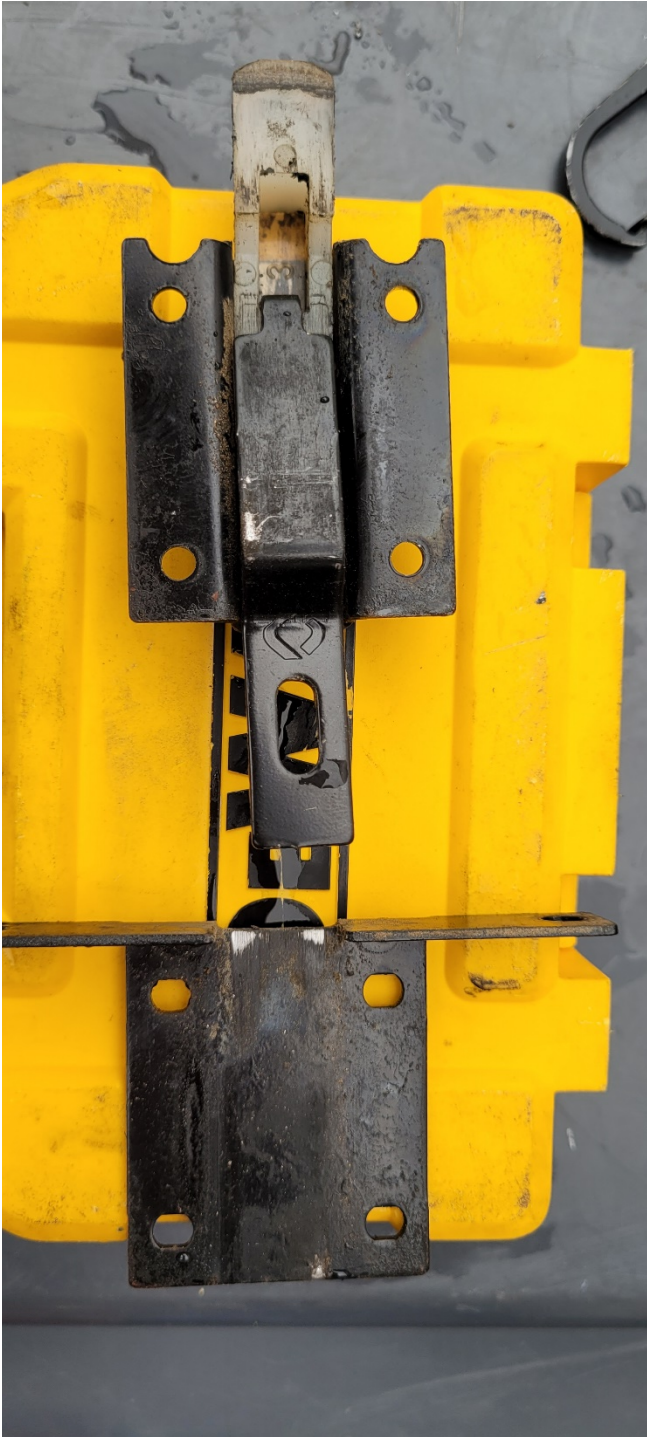
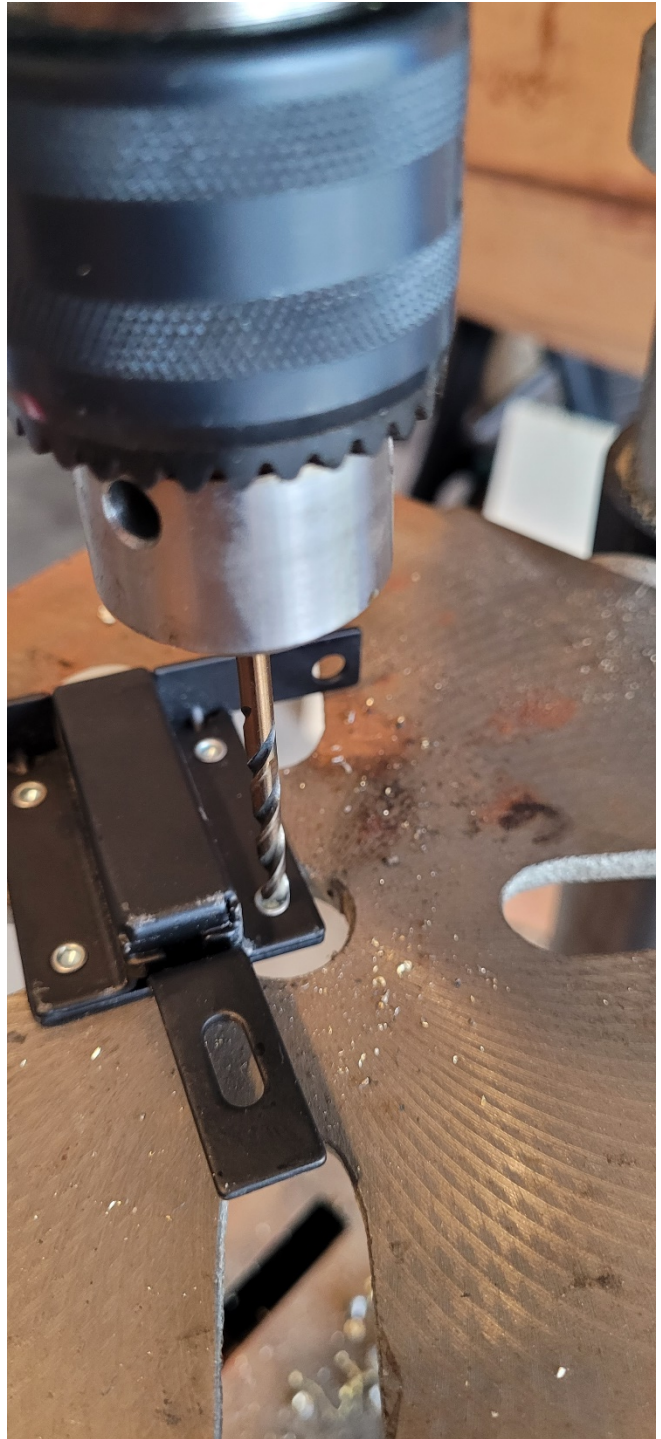
This is what the inside looks like, the spring is under the pull actuator and behind the plunger

Step 4: Using a 5/32" bit (and I do recommend a drill press if available) drill out each of the four rivets. The rivets are usually brass or aluminum. Be careful not to let the spring get away from you when you pop off the last rivet.

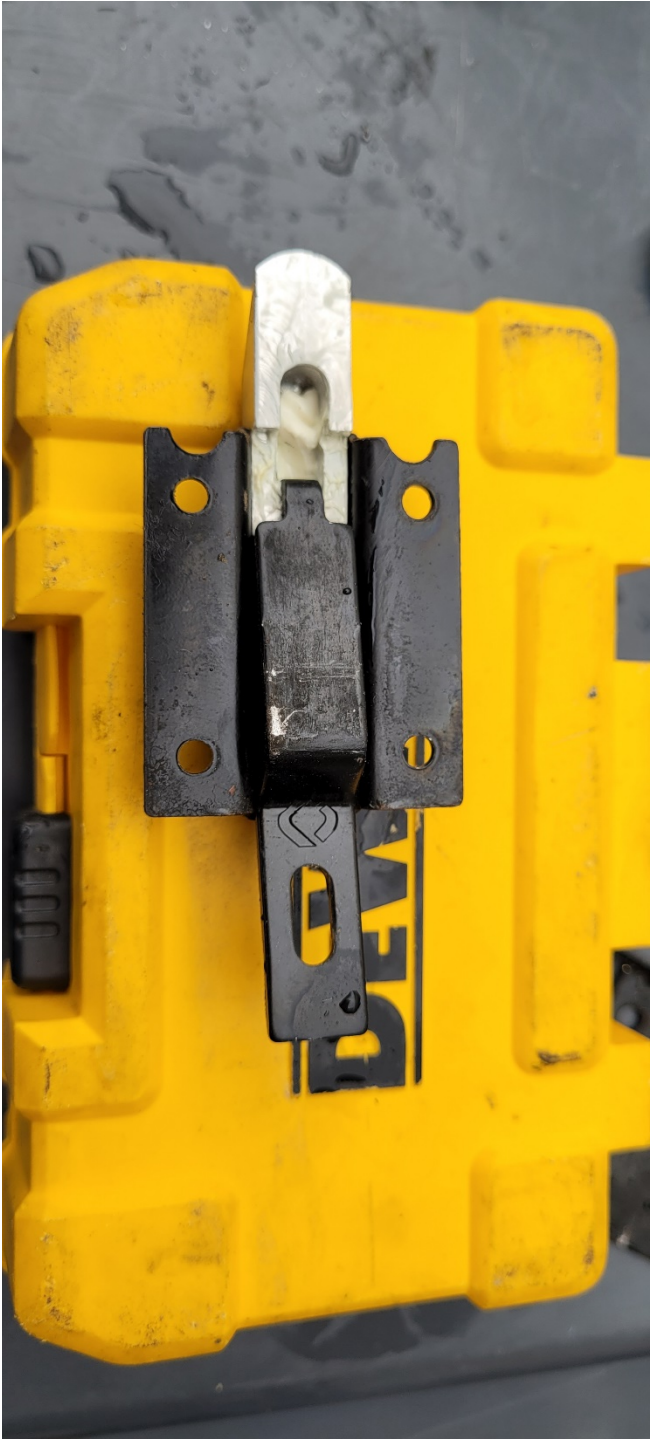
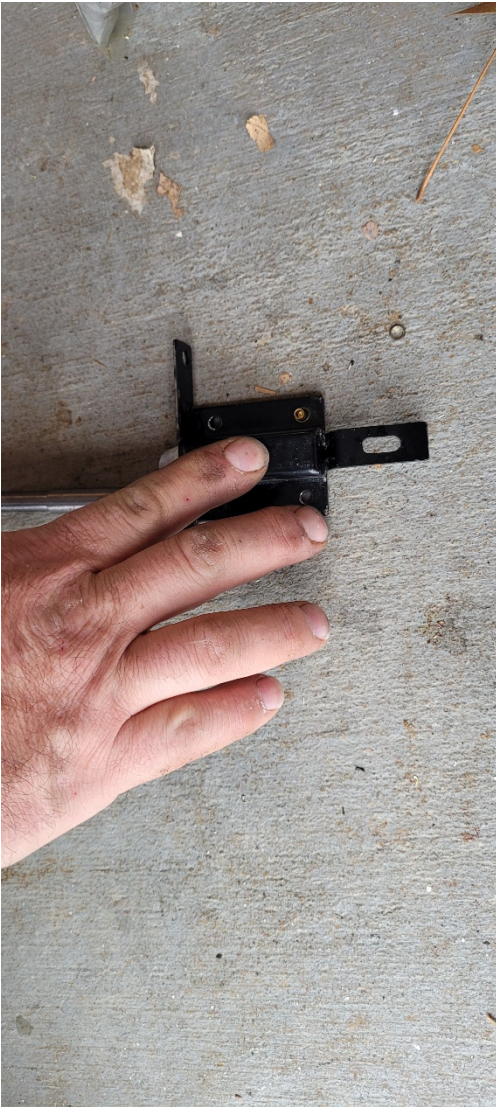
STEP 5: Install the aluminum plunger. Be sure it is installed in the correct direction. Again, the spring is under that black actuator, and behind the plunger.

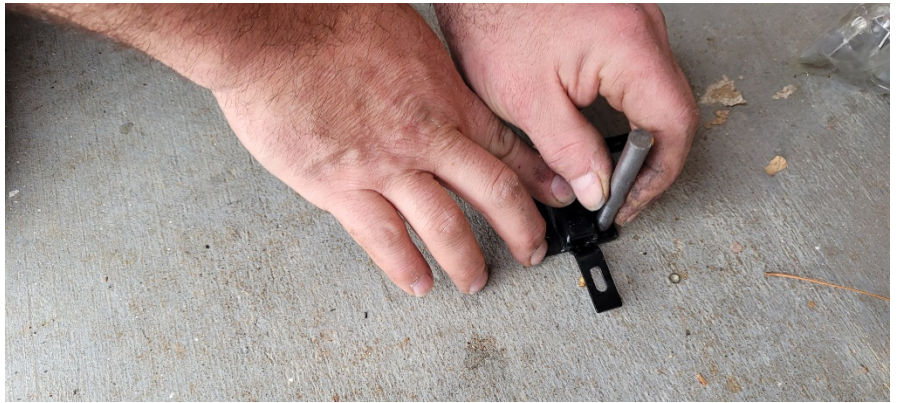
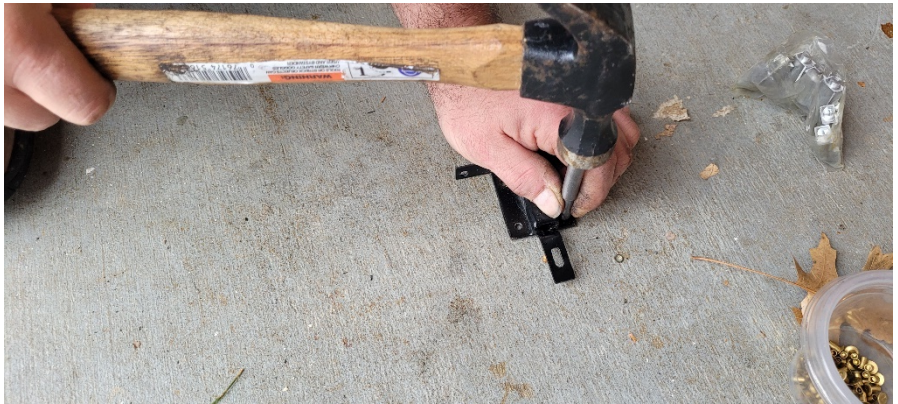
Step 6: Put the latch assembly together and put on top of a rivet (use a hard surface such as a metal table or in my case I used the shop floor.) Then while holding the assembly together tightly, place the rivet tool over the rivet and hit it with a hammer. Repeat with all four rivets and inspect the assembly to ensure that it is snug and no rivets are loose.

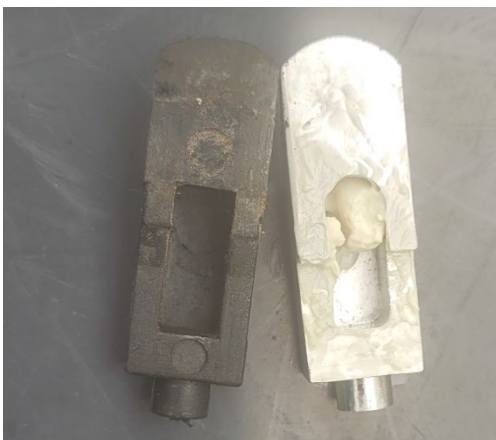
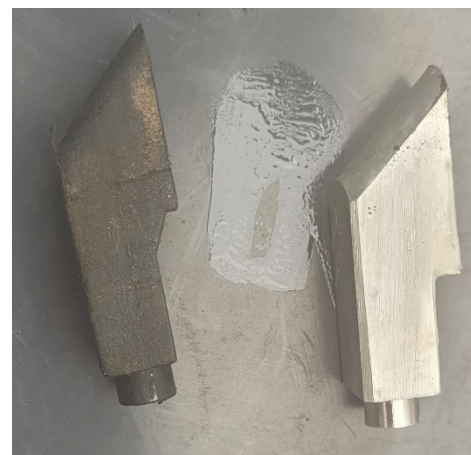
Note the difference between the nylon and the aluminum plungers, along with the hairline crack evident in the side of the black nylon. We replaced all of our plungers with the aluminum ones and what a difference!
