Repair of Broken Full-Wall Slide Lock Motor Mount

Rick Blaher

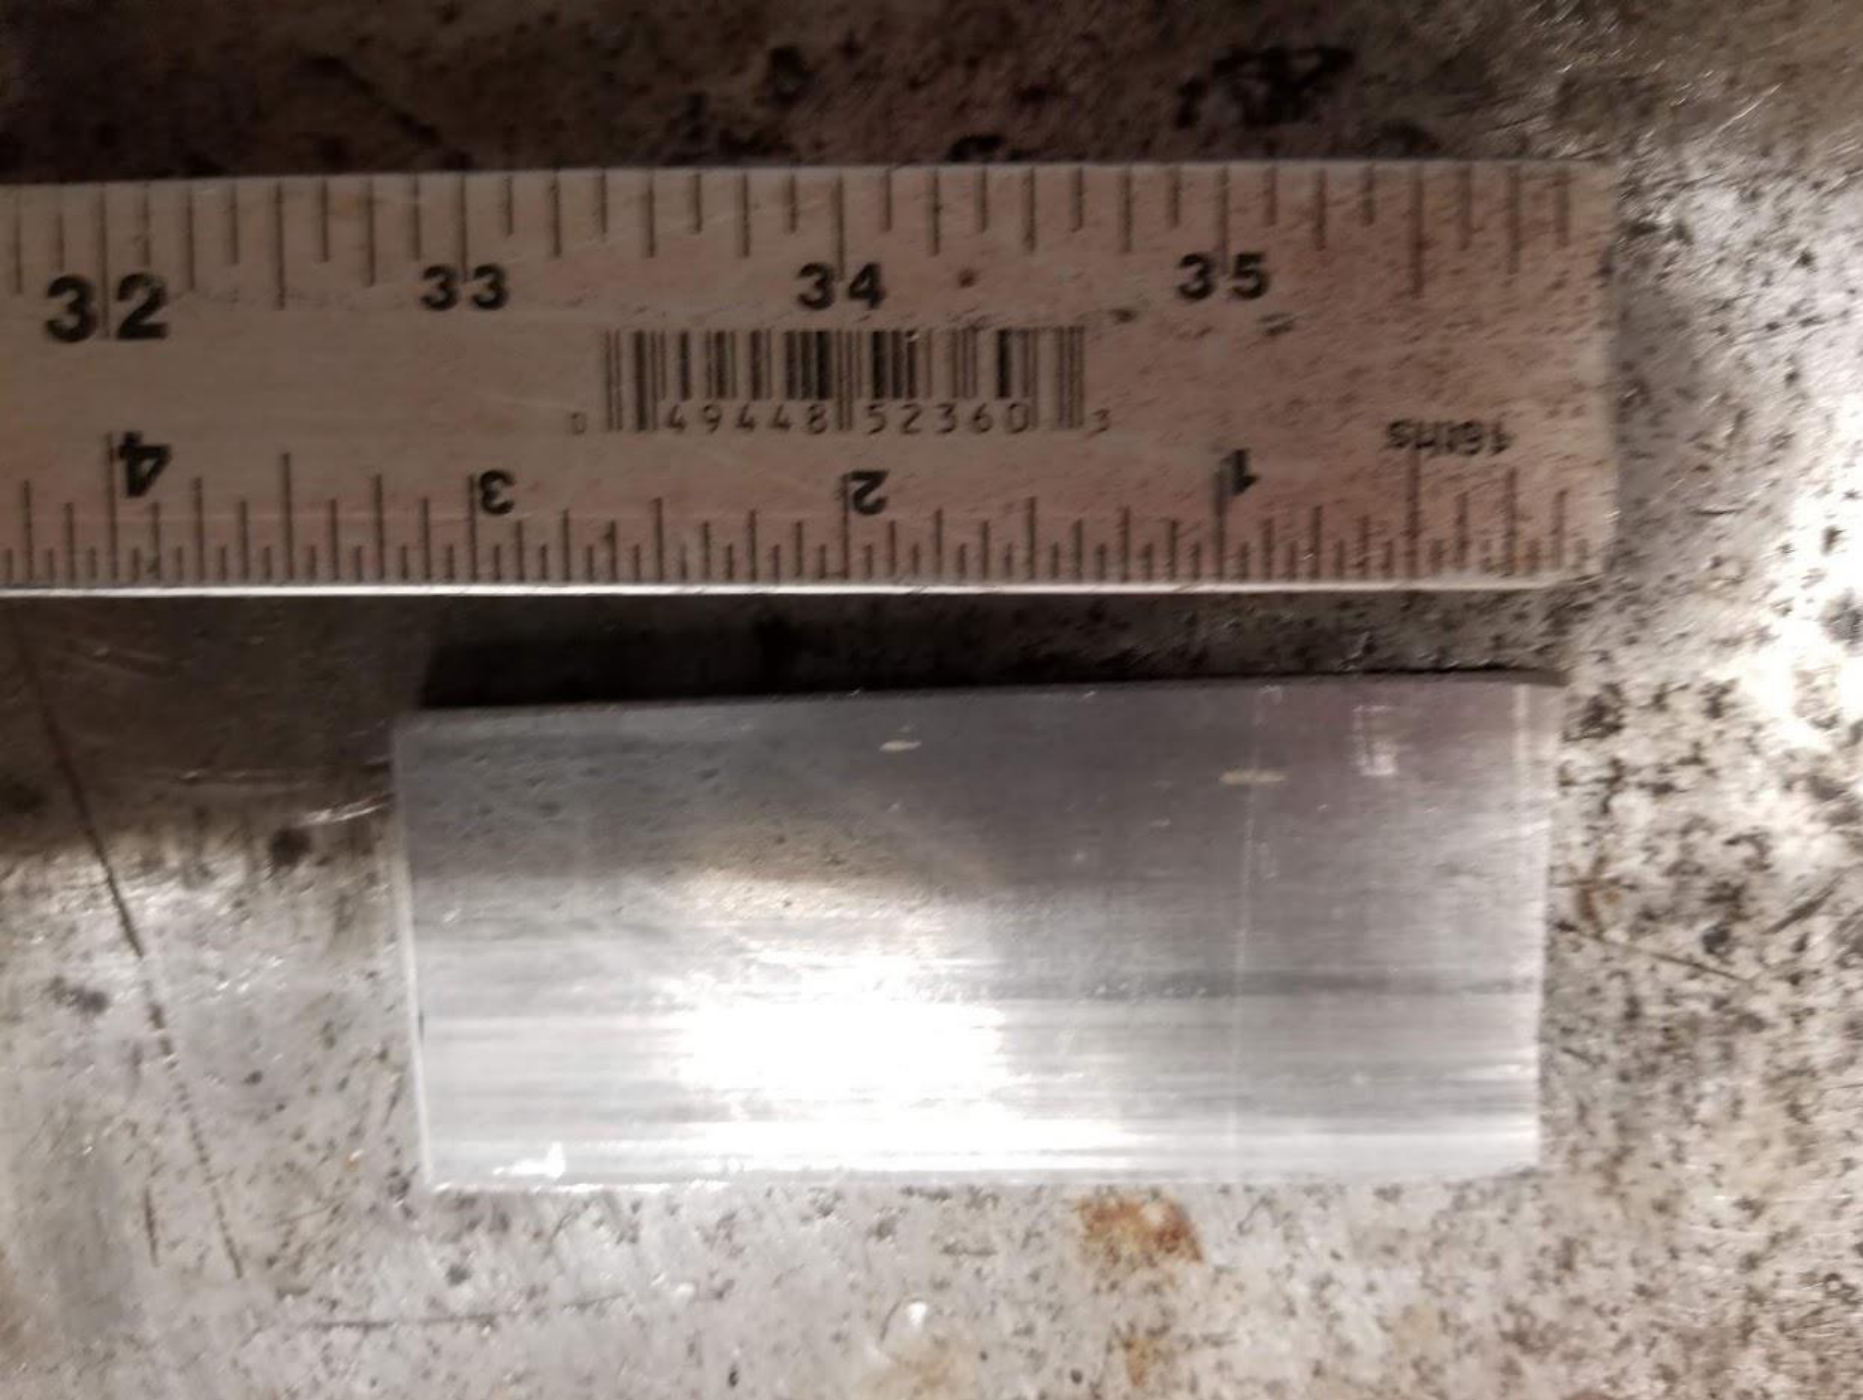
**Start repair with 2
'plates' of $\frac{1}{4}$ "
aluminum,
approximately $3\frac{1}{4}$ "
x $1\frac{1}{2}$ "**

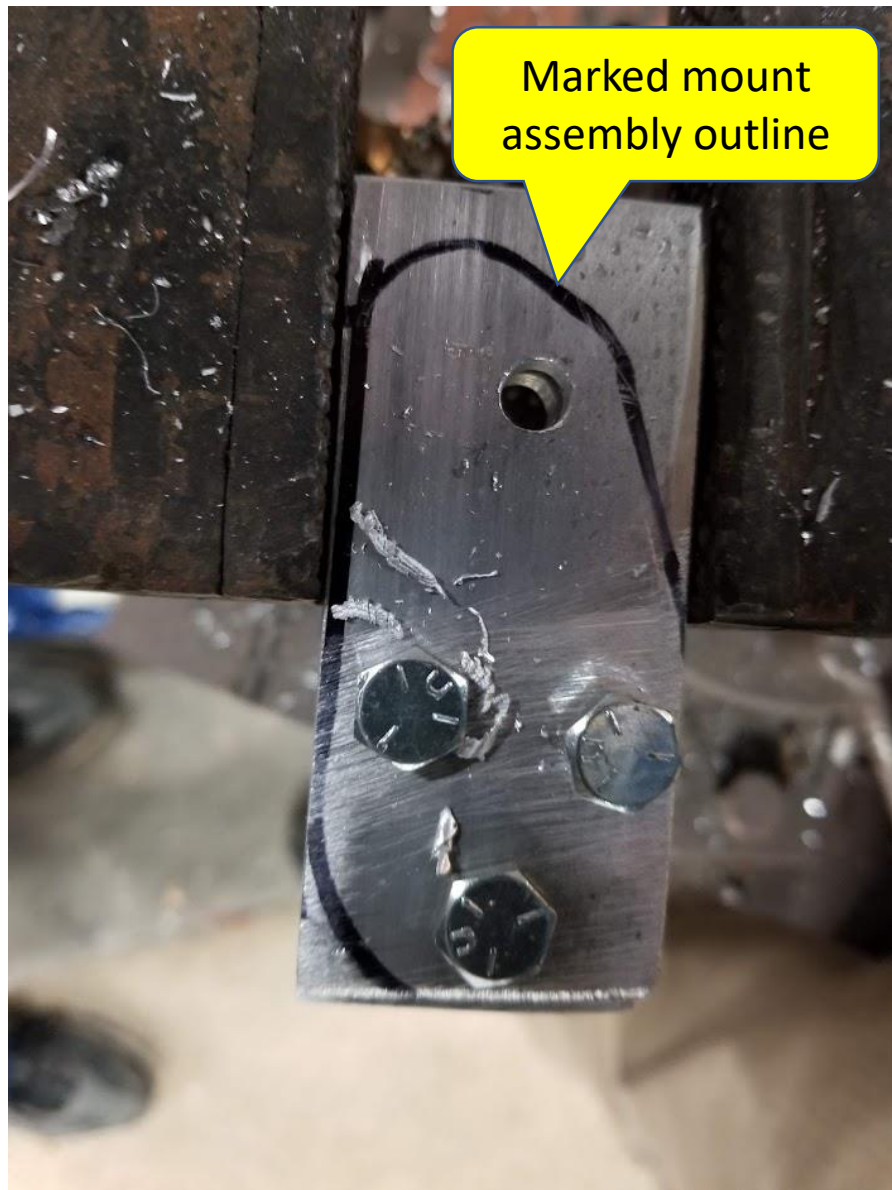
Marked mount
assembly outline

**These photos show the 4 drilled holes for each plate.
Mark the outline of the assembly mount on each plate
with a permanent marker.**

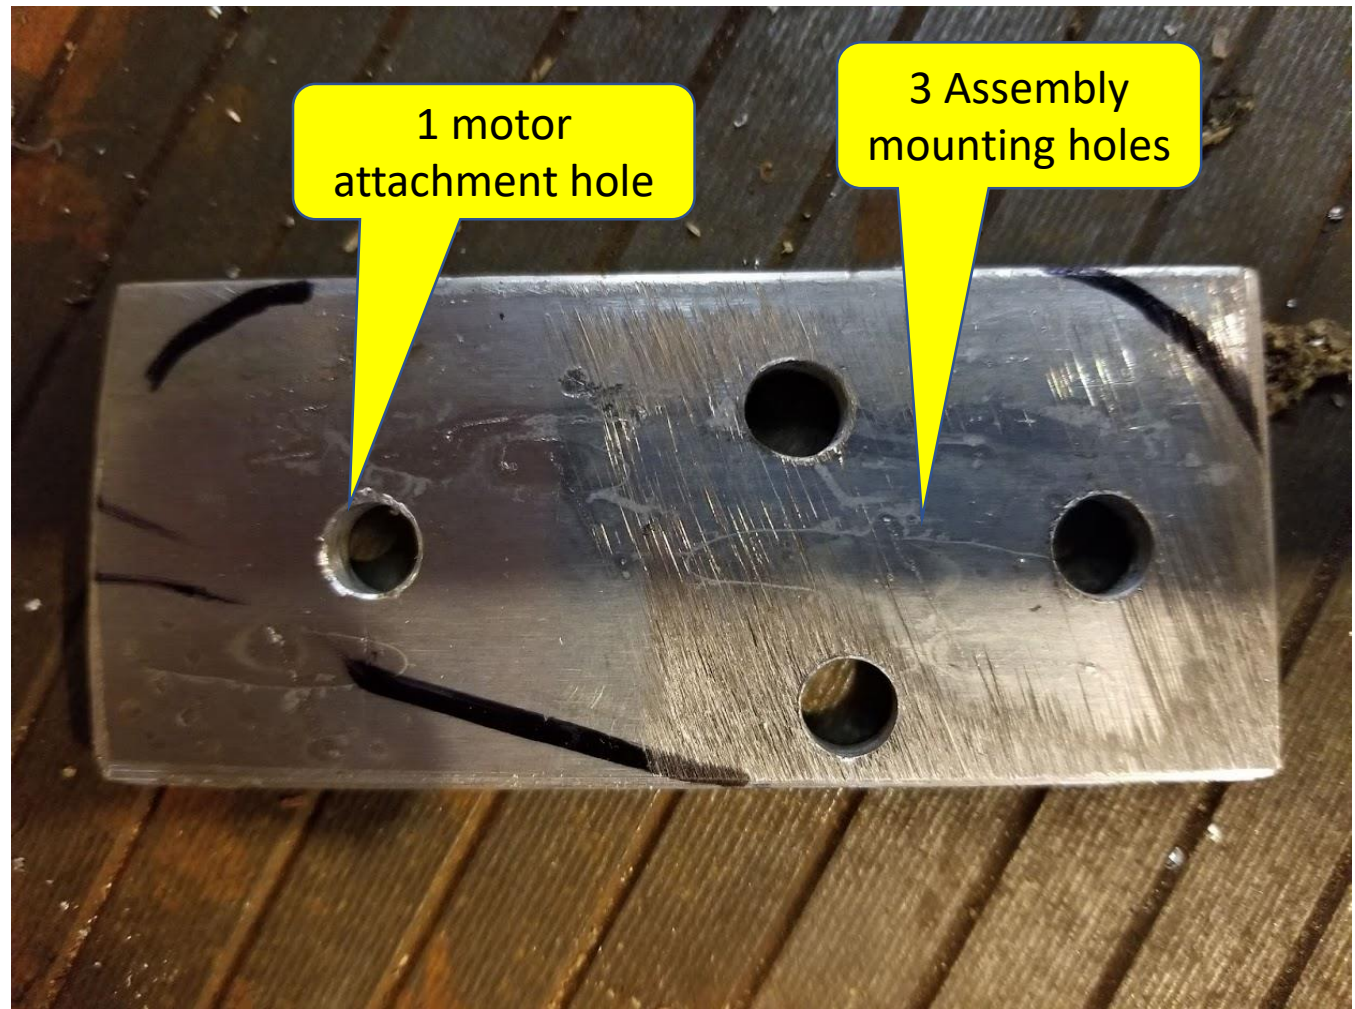
1 motor
attachment hole

3 Assembly
mounting holes

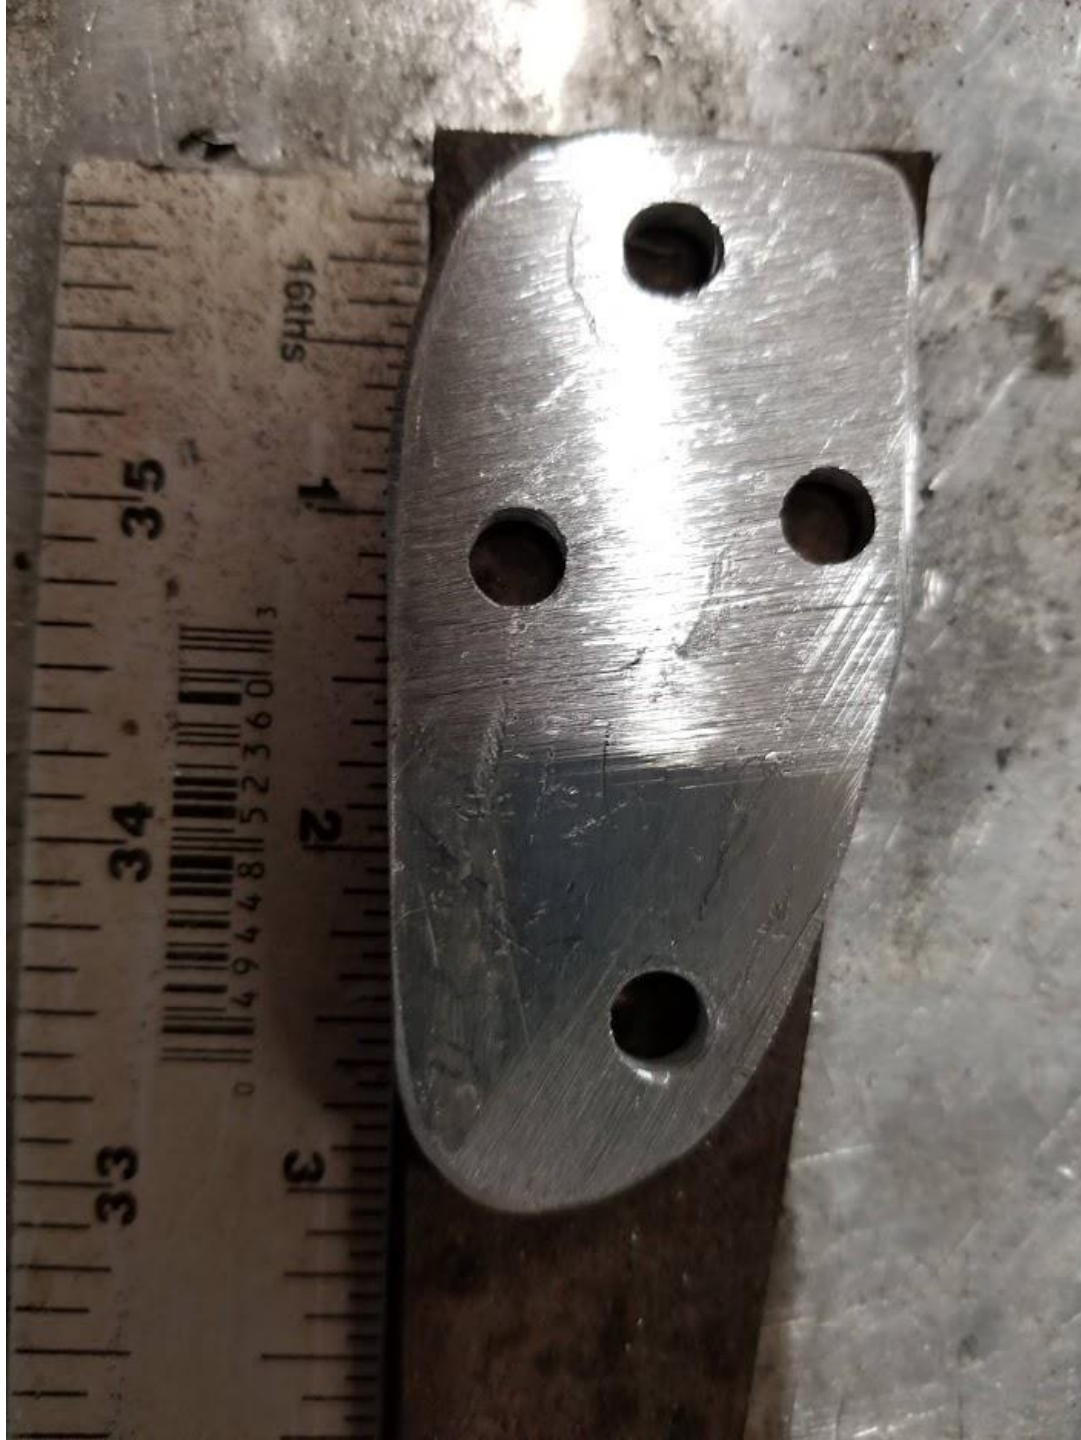
Completed mounting plate
Note that each motor assembly
will require modification of one
of the two plates to provide
clearance for the slide lock
motor.

Use appropriate tools and safety procedures to trim and shape each of the motor mount plates. Kerry used a bandsaw and belt sander to cut these parts. They are small and will be difficult to hold and cut with a handheld jig saw and handheld belt sander.
